Photographic survey of the pitched roof

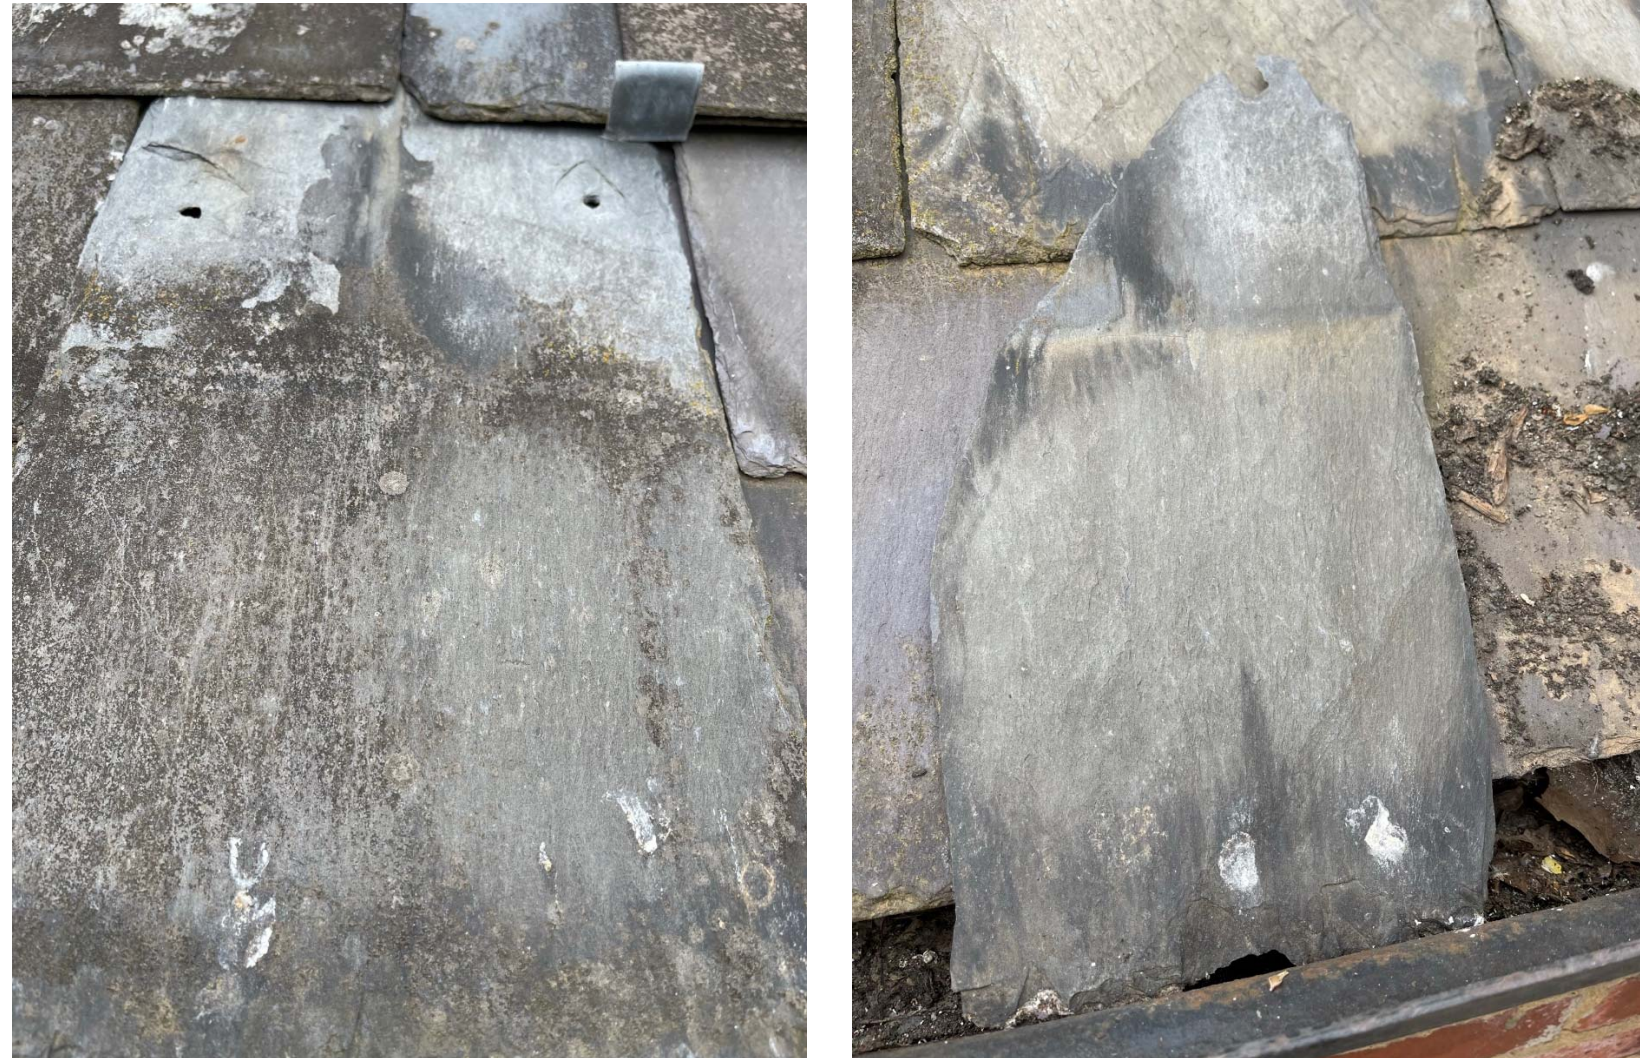
4. East and West Elevation

Slipped slates. Typical in numerous locaitons throughout the roof. Indicitatve of nail rot.

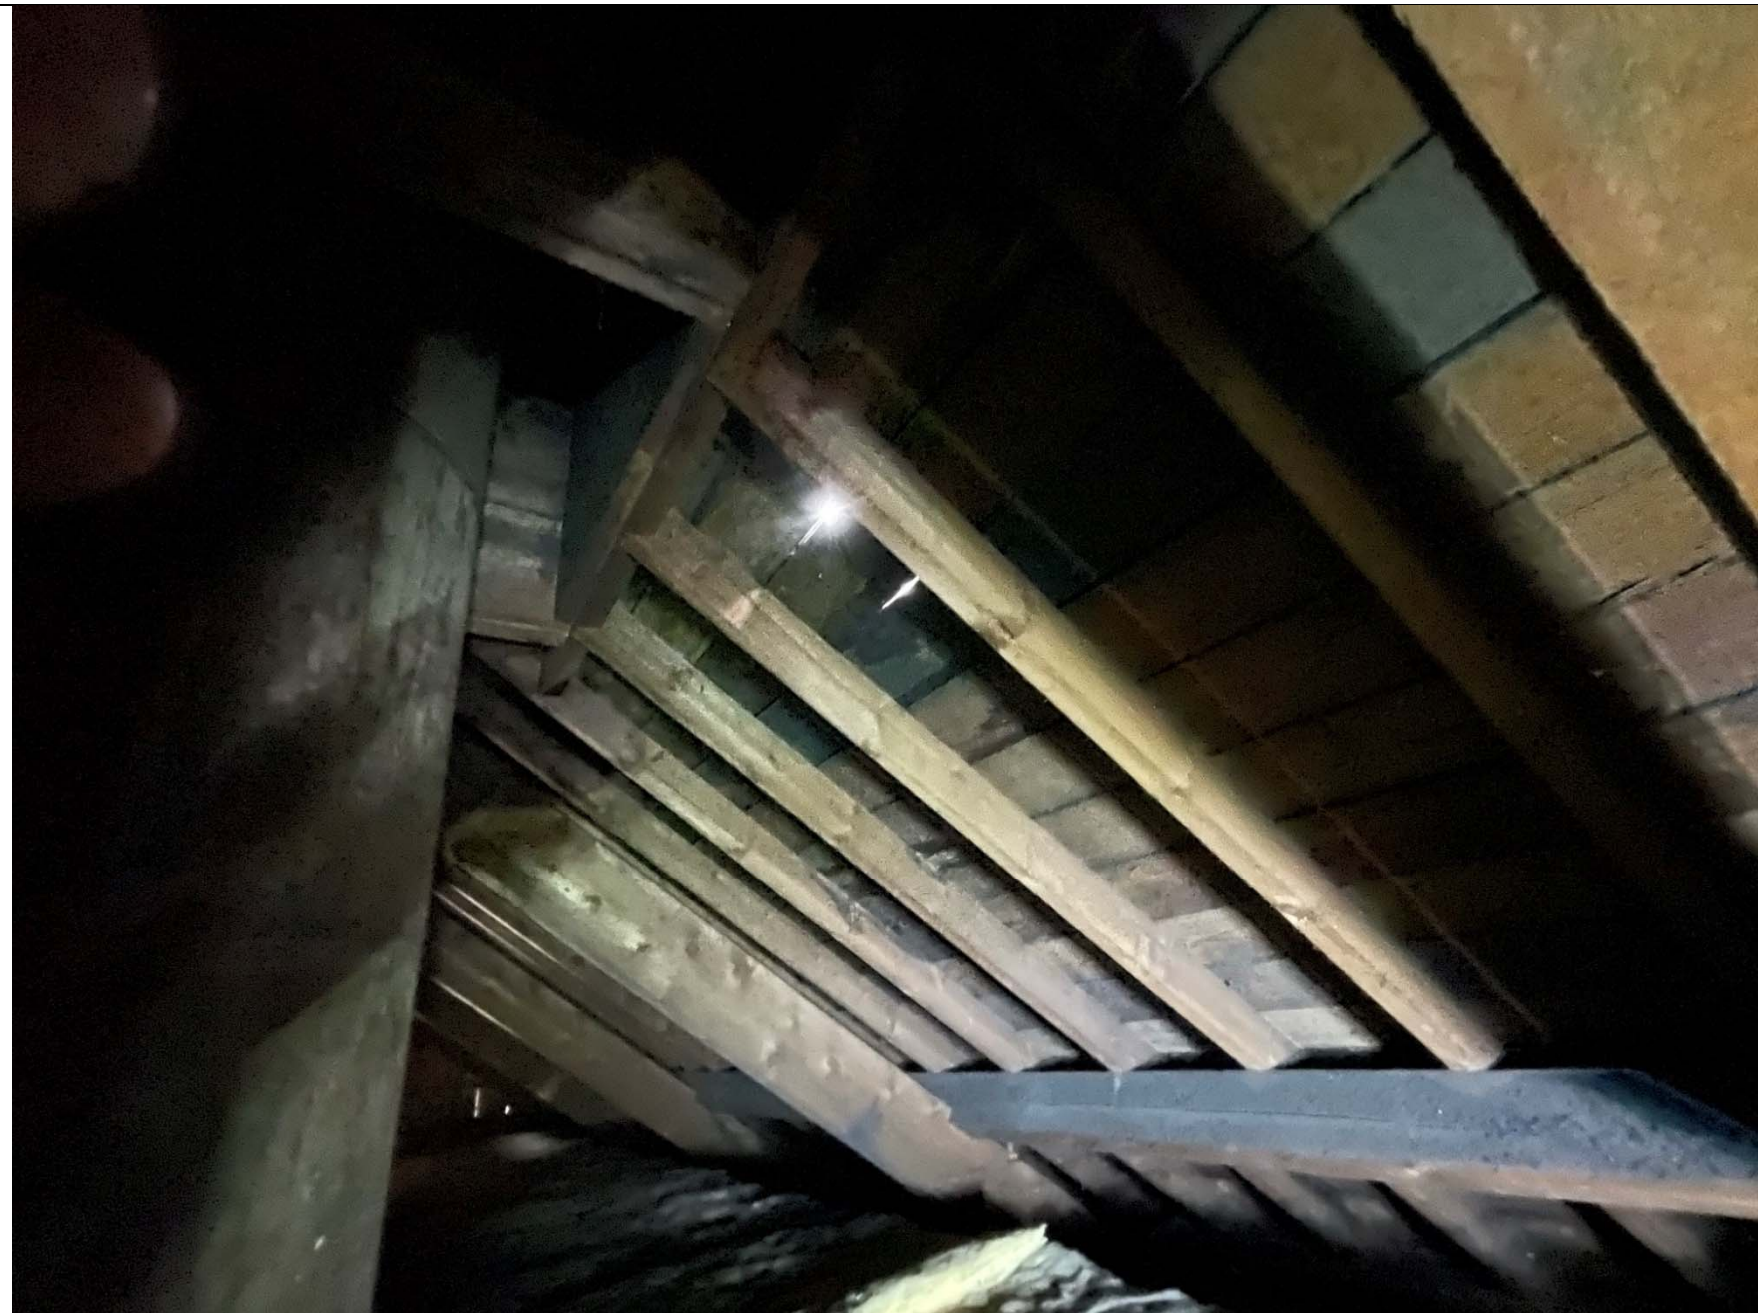
9. Internal loft space (East elevation)

Daylight through the sarking boards and staining to the same is indicative of penetrating damp.

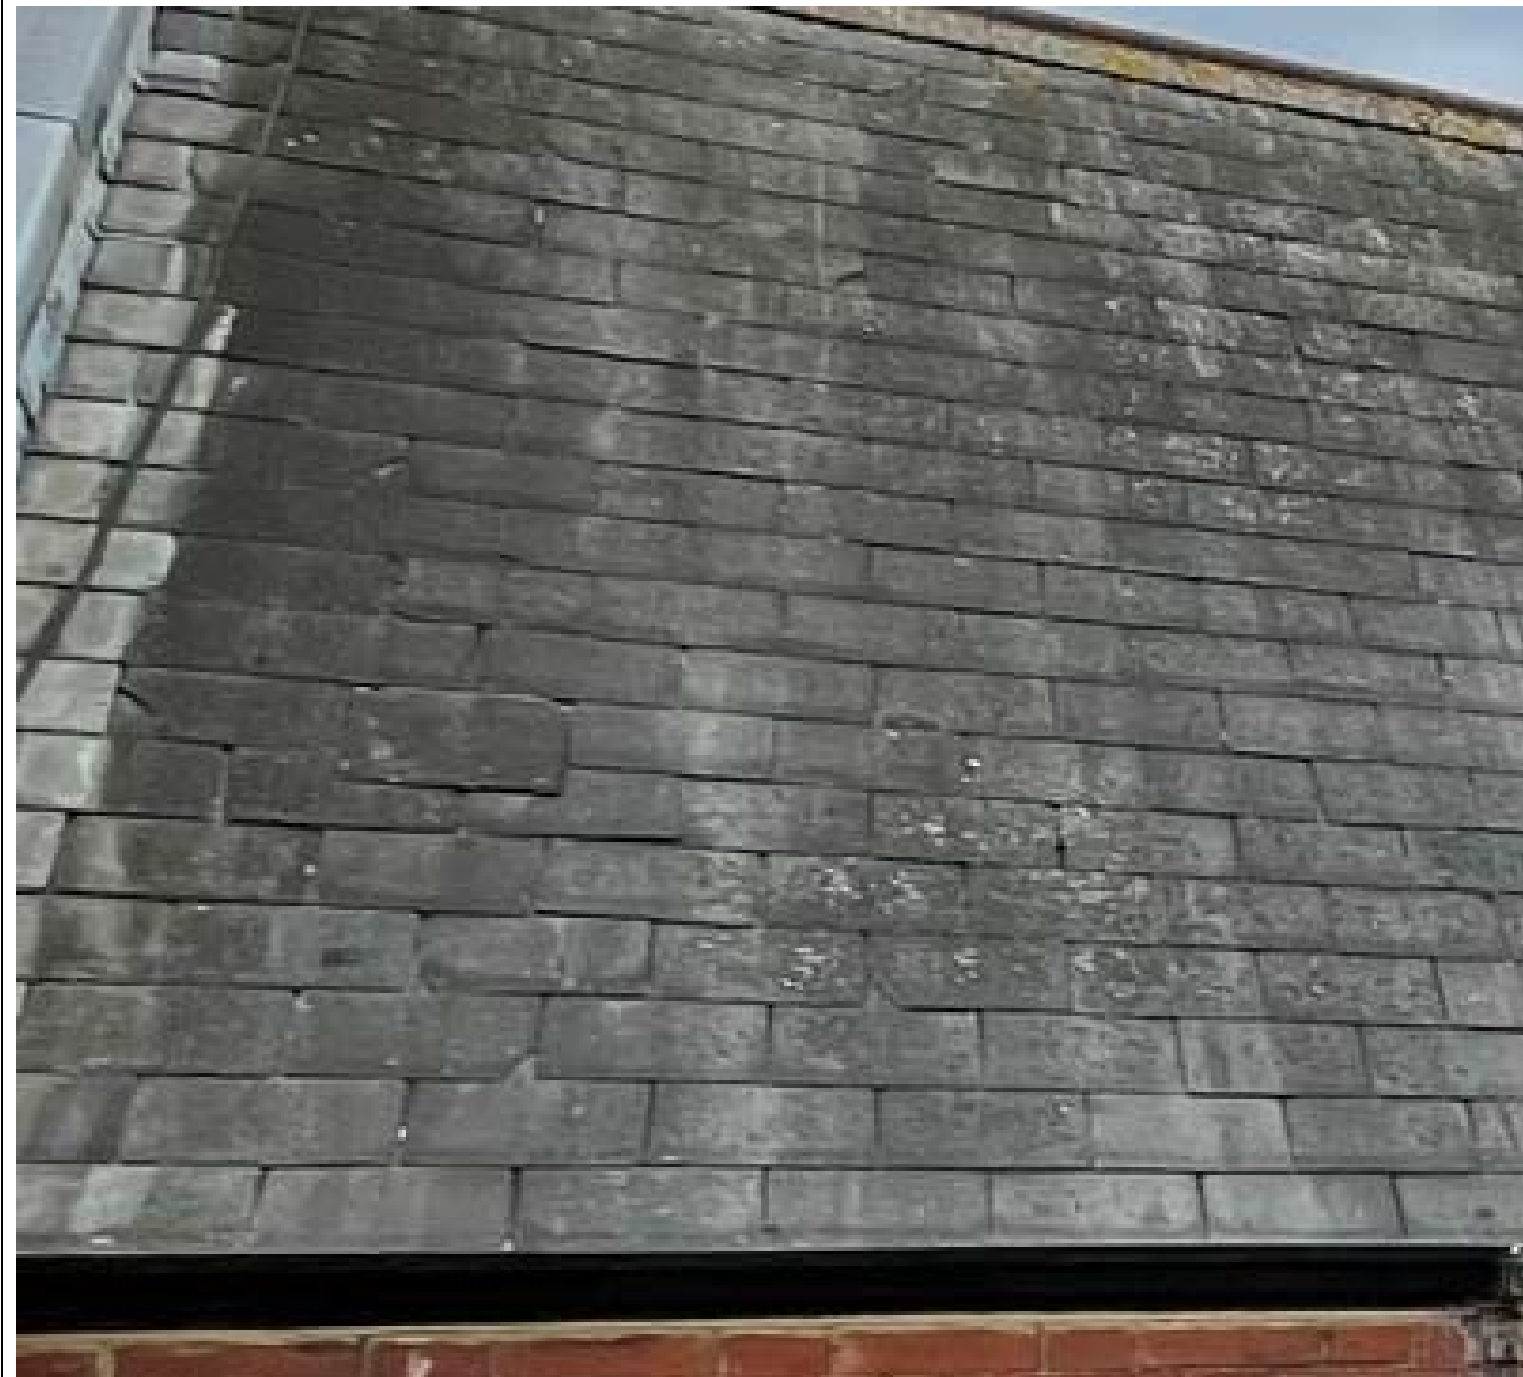
11. West Elevation

Slipped and broken slate.
