101721 – Euston Tower Inspection

October 2018

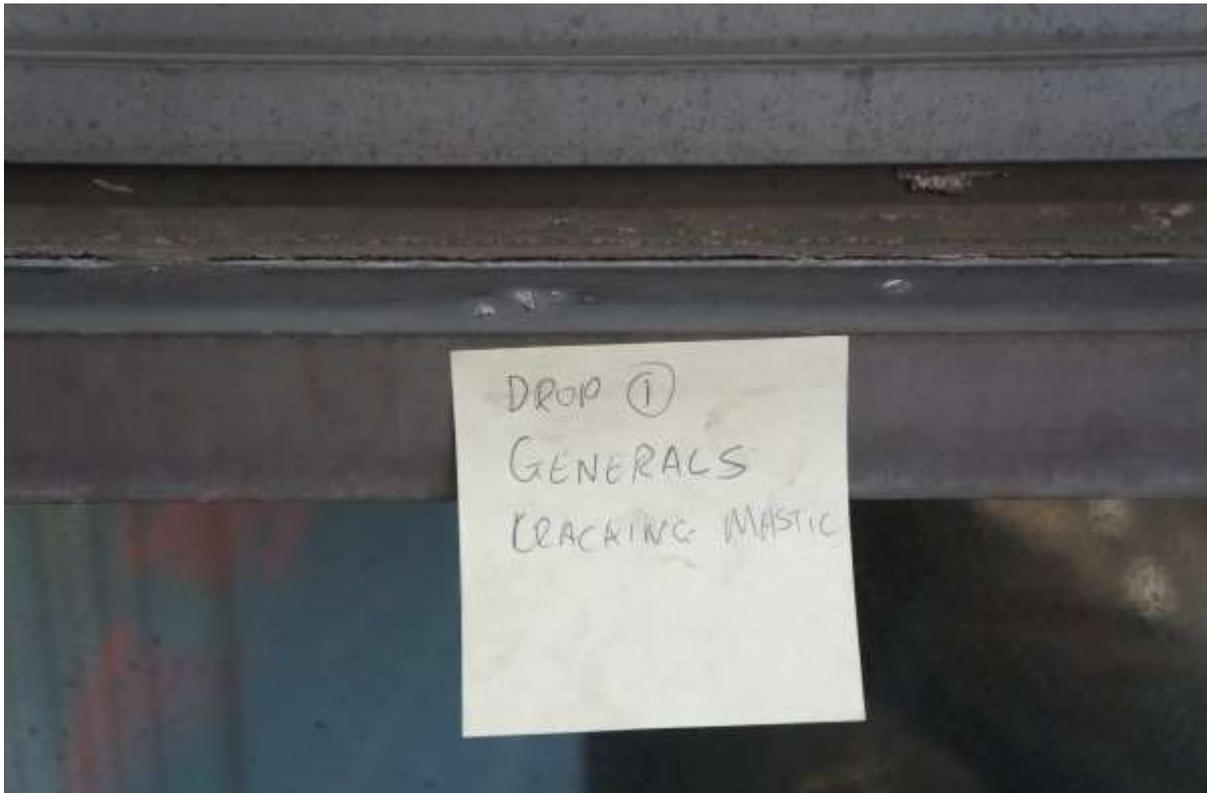
Overall summary – 90% of the glazing seals are heavily Perished or delaminating.
 15% of the sealant on the spandrel panels overhead is heavily Perished or delaminated.

Example of perished mastic above viewing panels

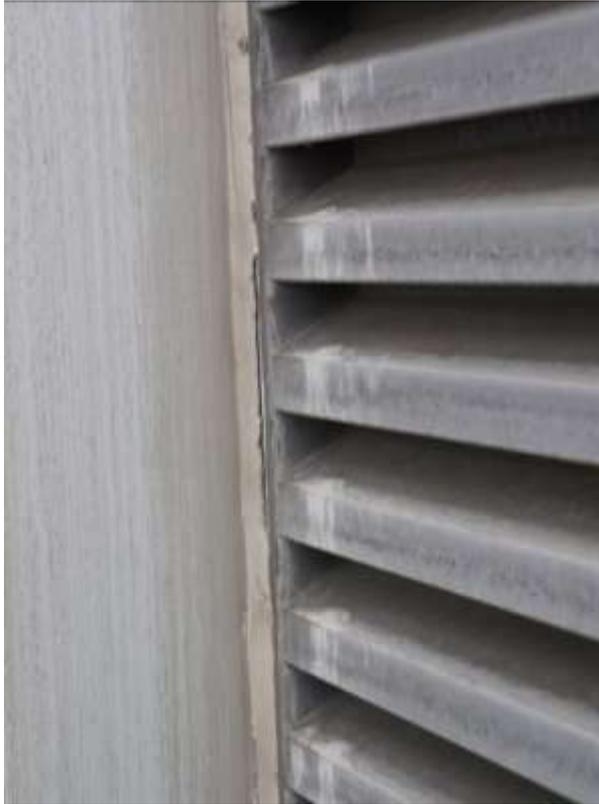
Perished mastic to louvre

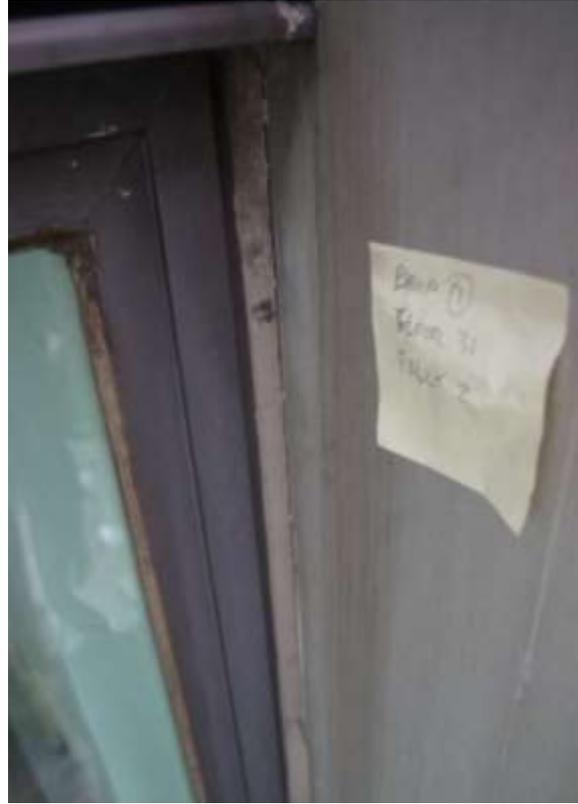
Perished mastic to viewing panels

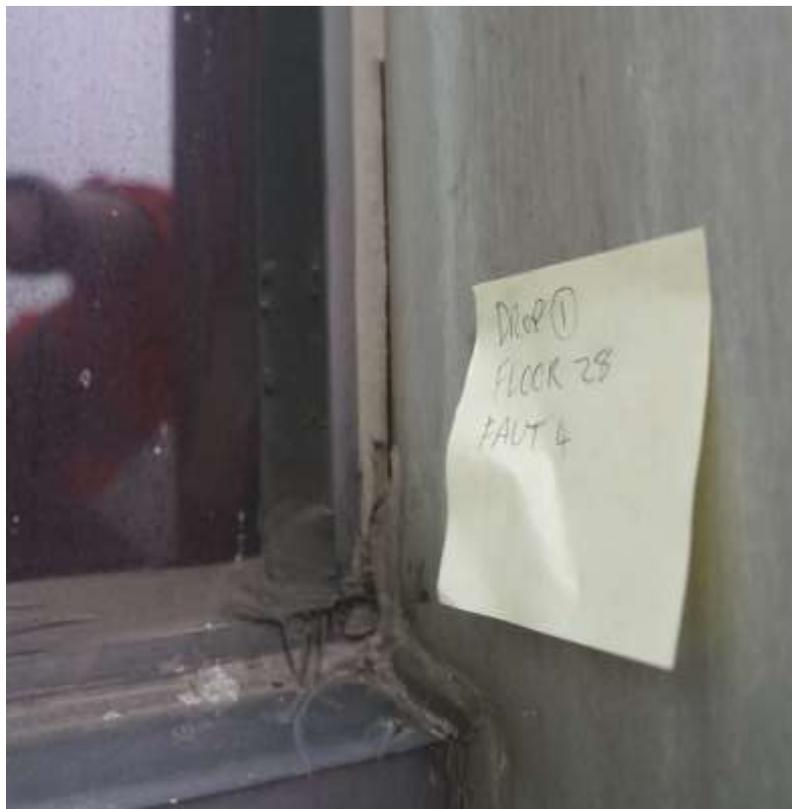
Perished Mastic – vision unit

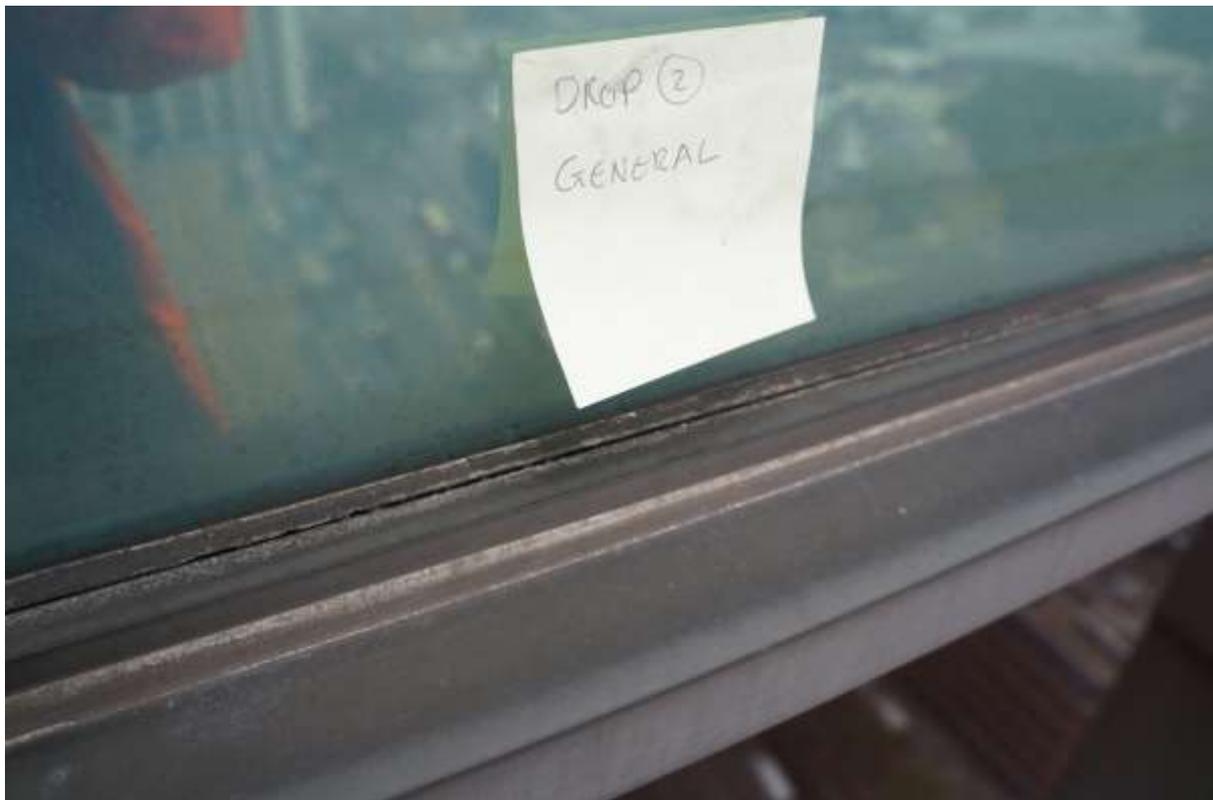
Example of perished mastic on viewing panel

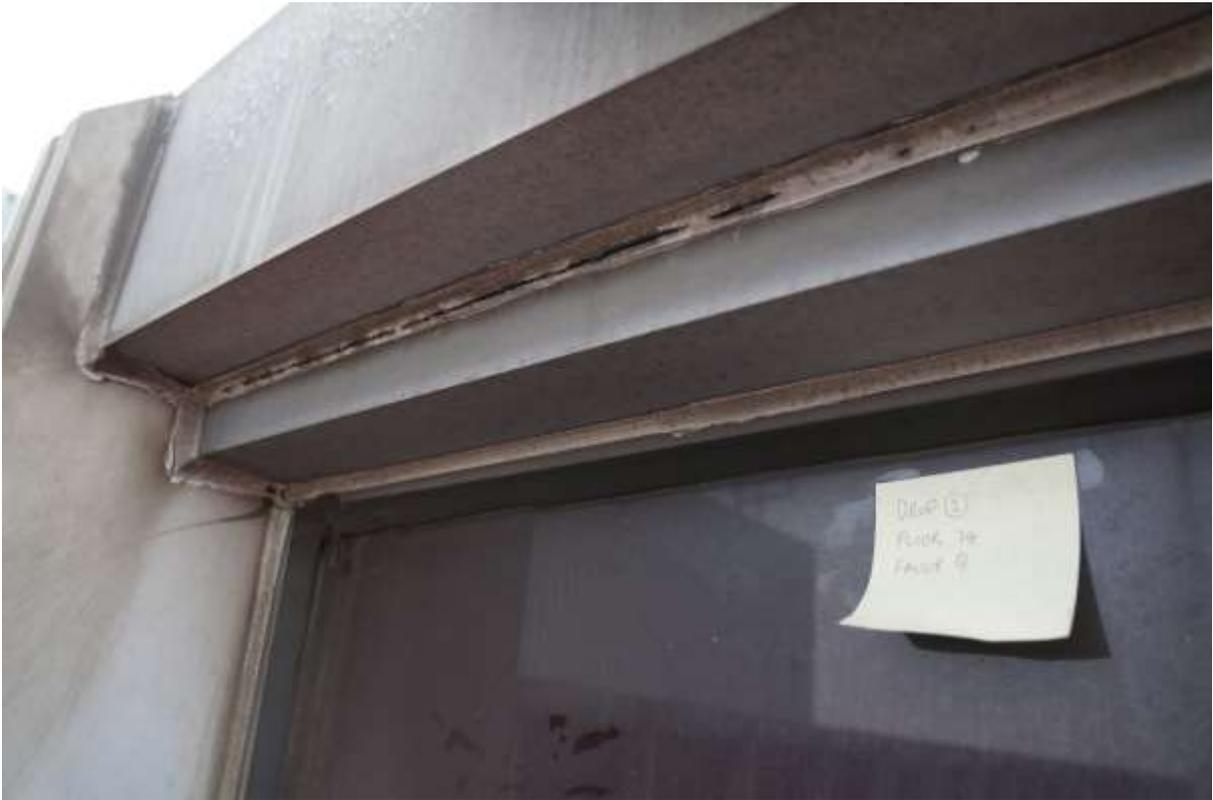
Example of perished parapet seal

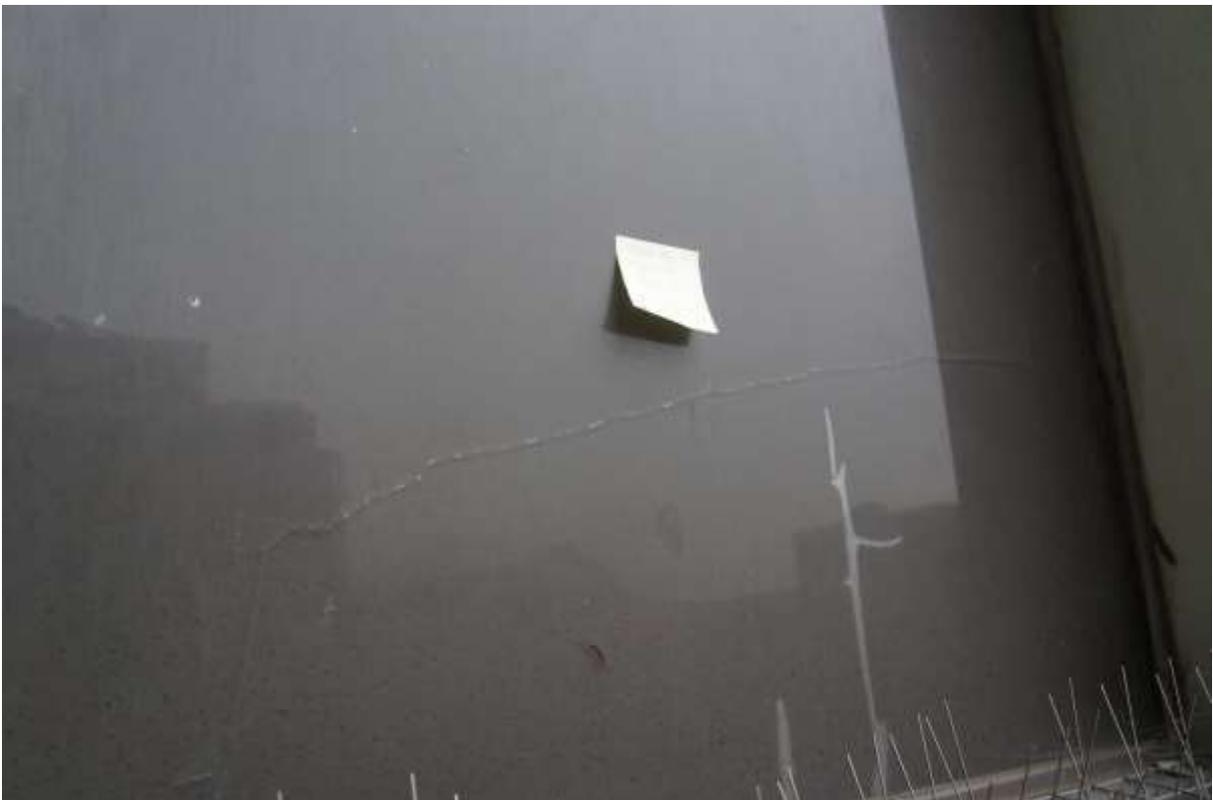
Example of cracking to spandrel panel

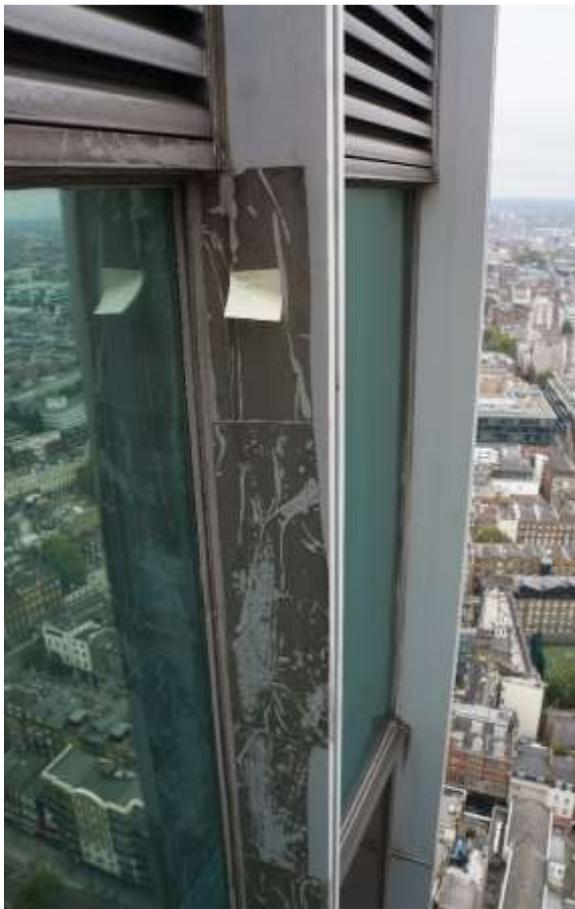
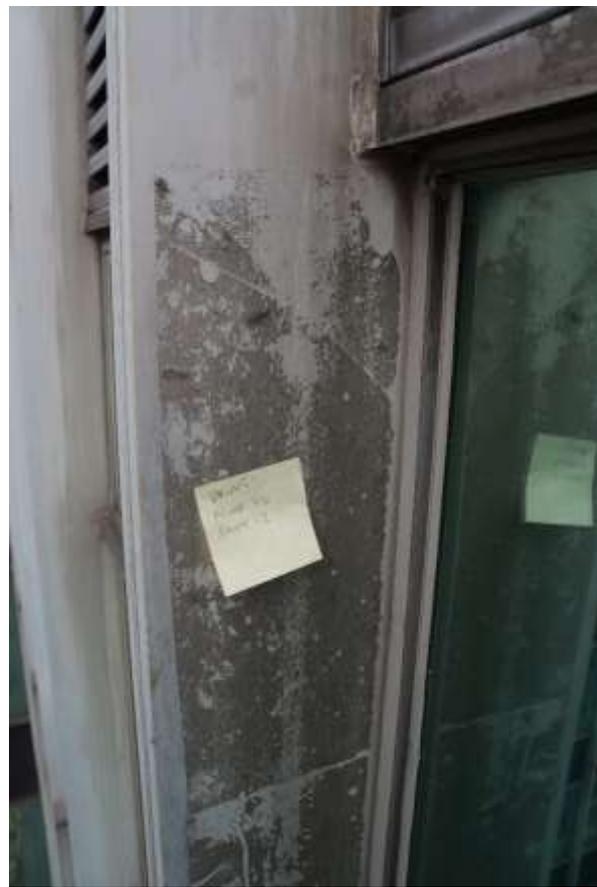
Fault Number	Floor Number	Defect	Photo Number
12	32	Historic Residue to both sides of cradle guides/mullions approx. 1500mm x 200mm each side of glazing panel	Drop 3 – 1/2/3/4

Historic residue marking to cradle guides/mullions

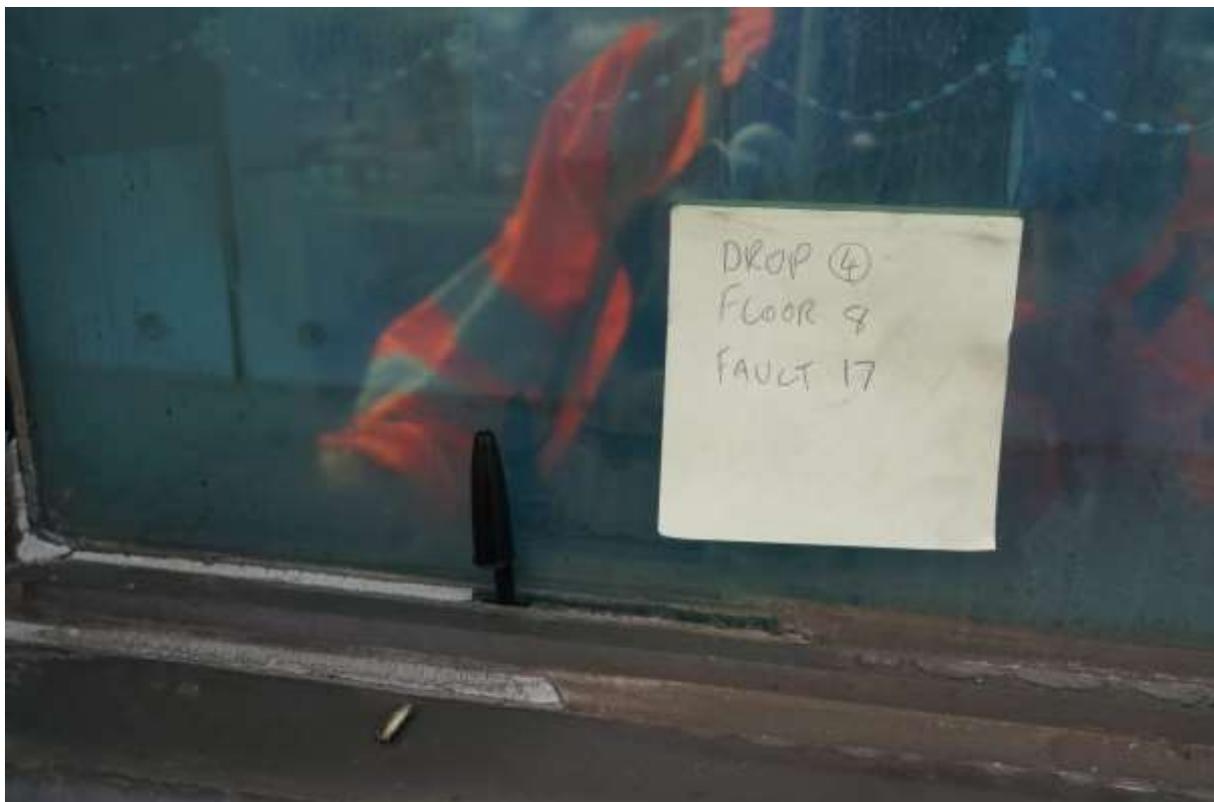
Example of failed mastic and gap behind perished butyl tape

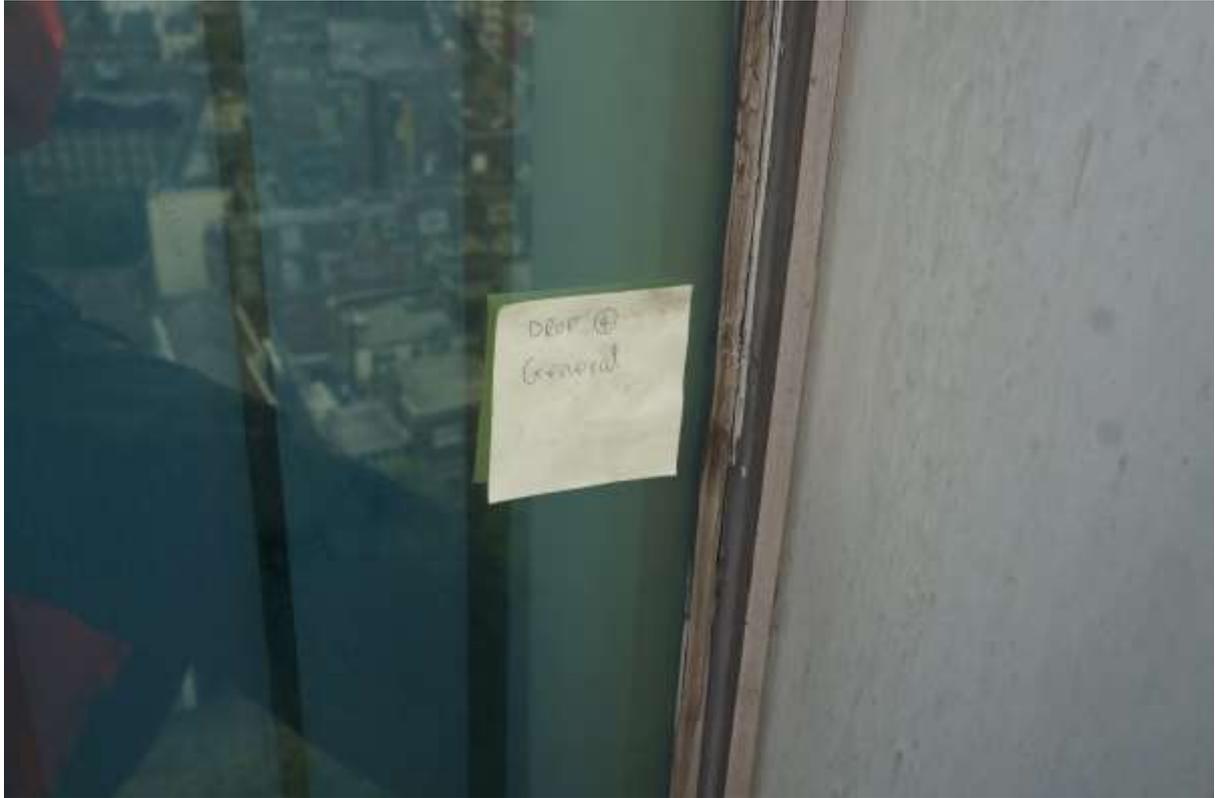
Example of delaminated mastic to viewing panel

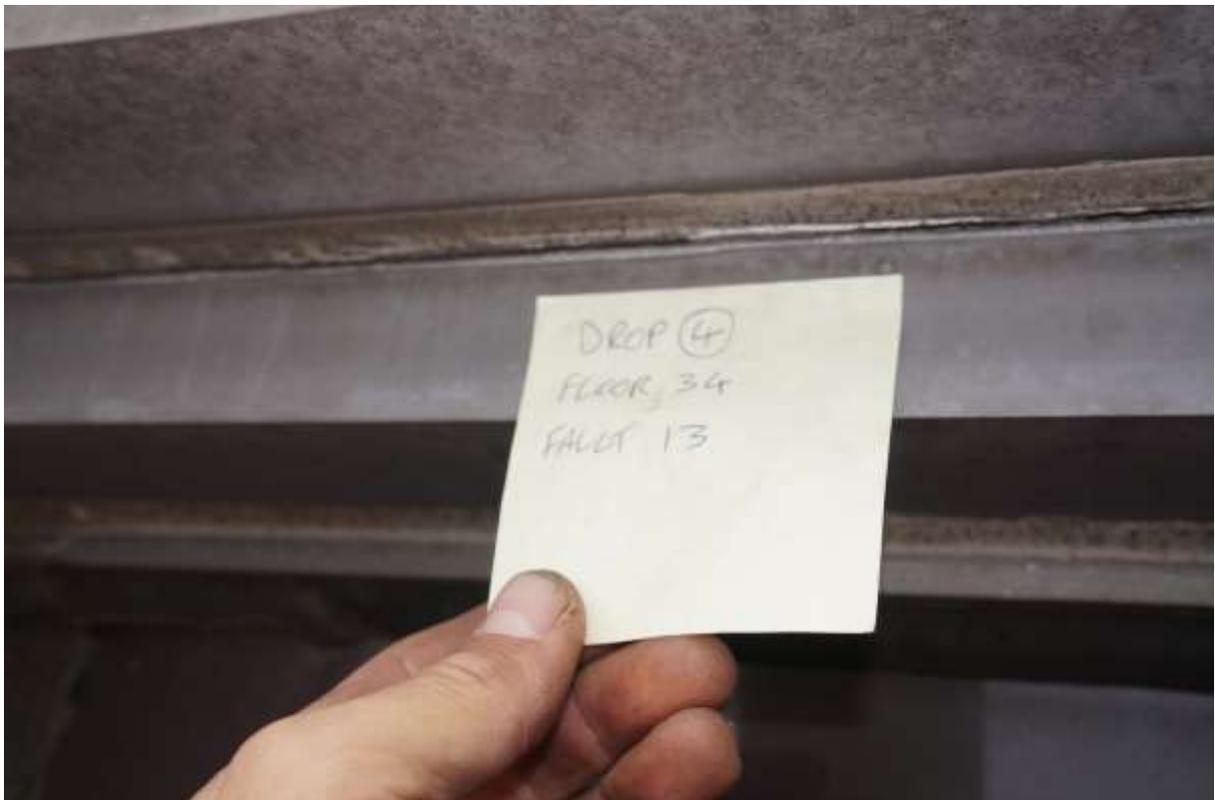
Example of de-bonded mastic to frame of viewing panel

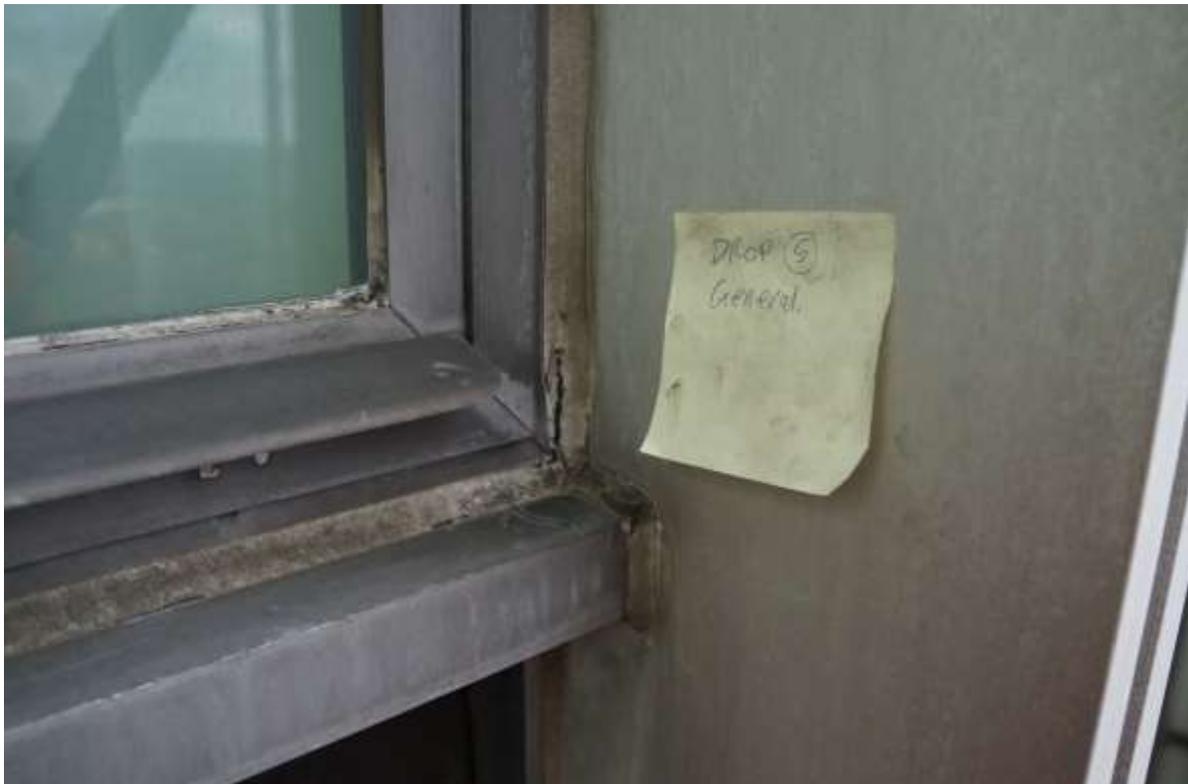
Example of perished mastic to frame of viewing panel

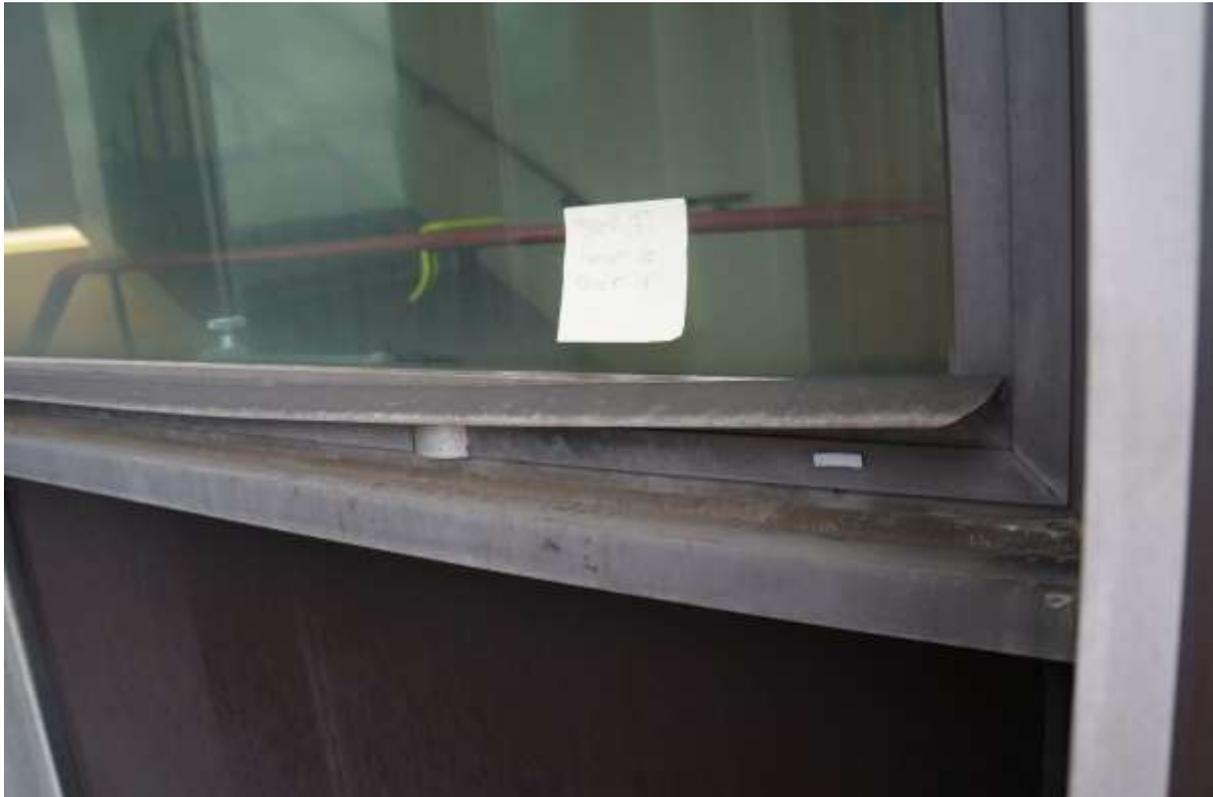
Loose vent on north facing west return – 16th floor

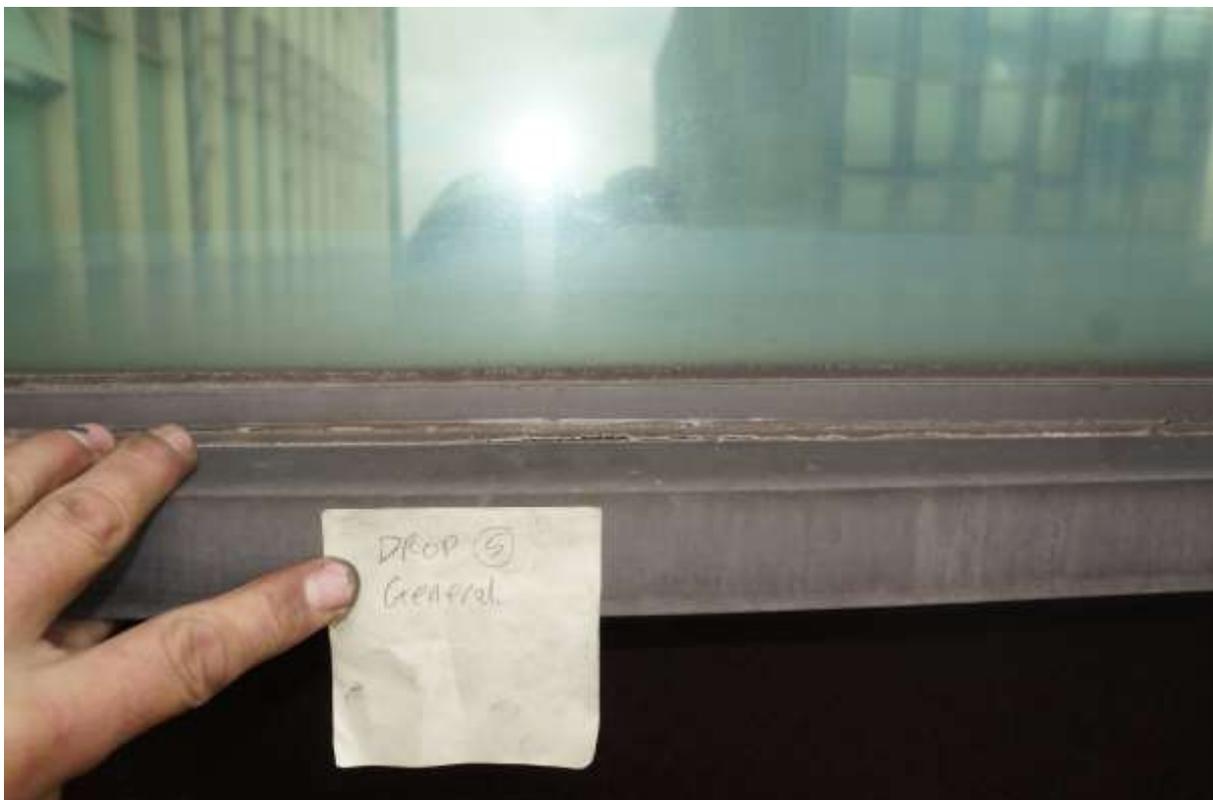
Example of delaminated mastic at the base of viewing panel

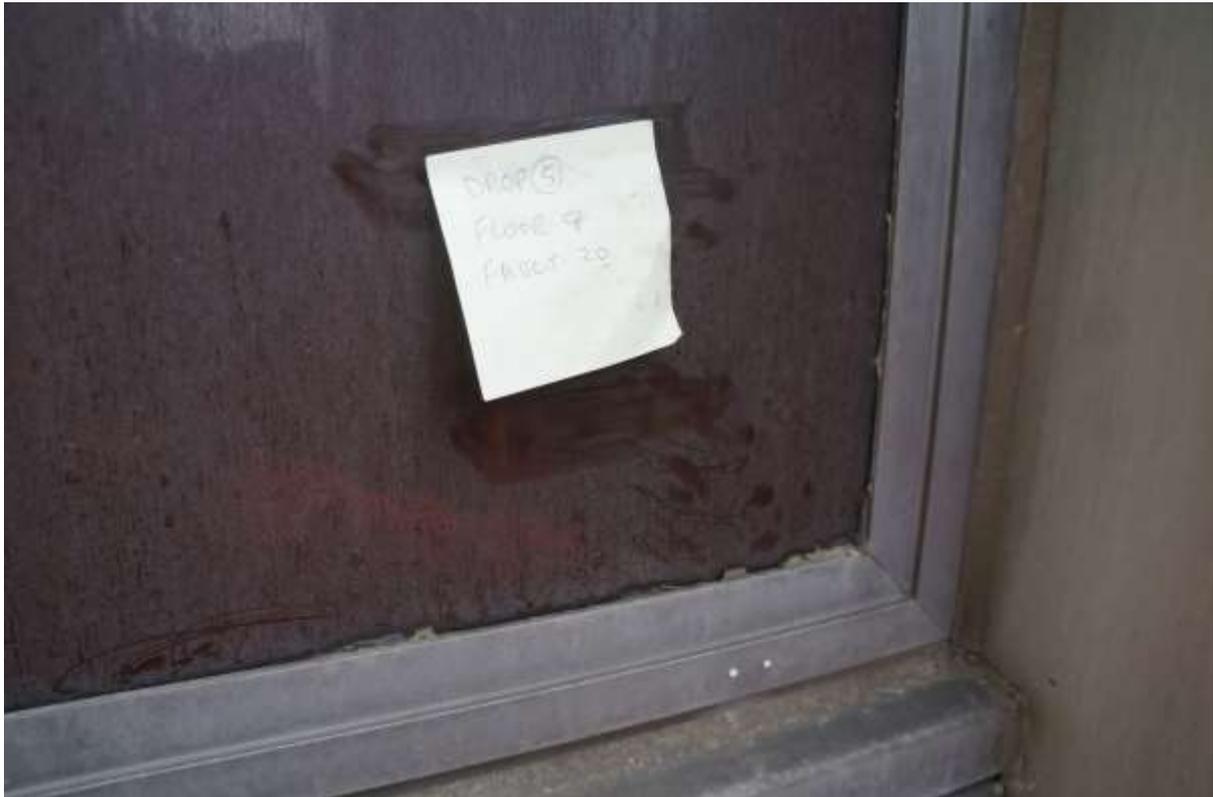
Perished butyl tape to spandrel

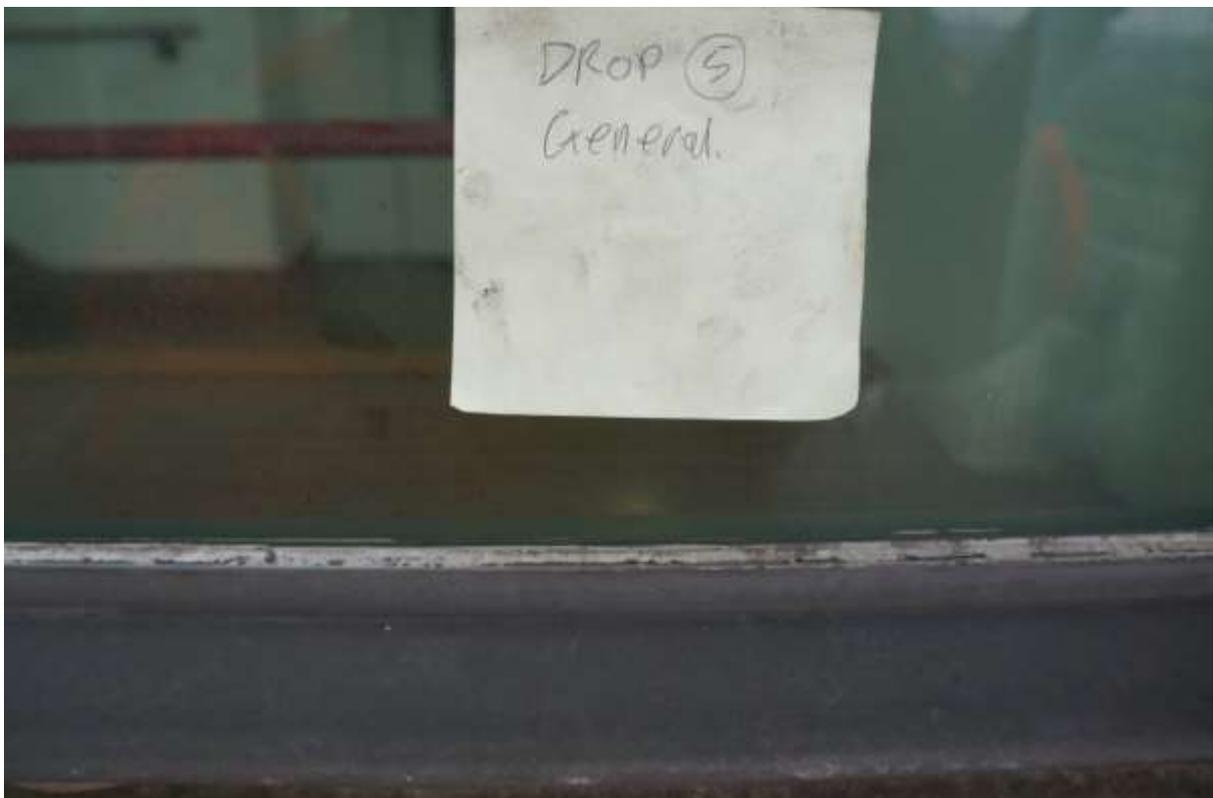
Perished butyl tape to vision unit
