FIRE SAFETY RISK ASSESSMENT EUSTON TOWER

Document Version: ETFRA2015

Fire Safety Report for:

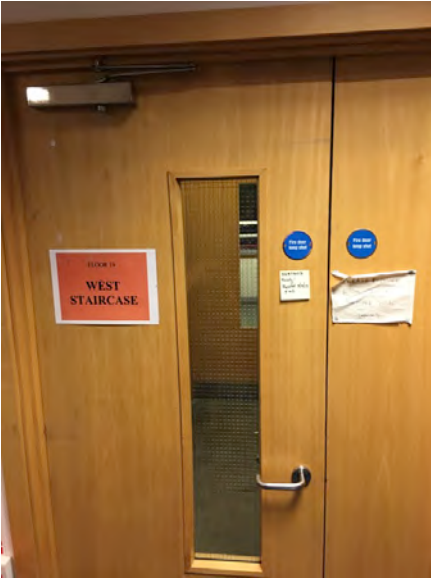
<p>Escape door not opening. Defect had been submitted and alternative escapes were available.</p>	<p>Rubbish blocking means of escape.</p>

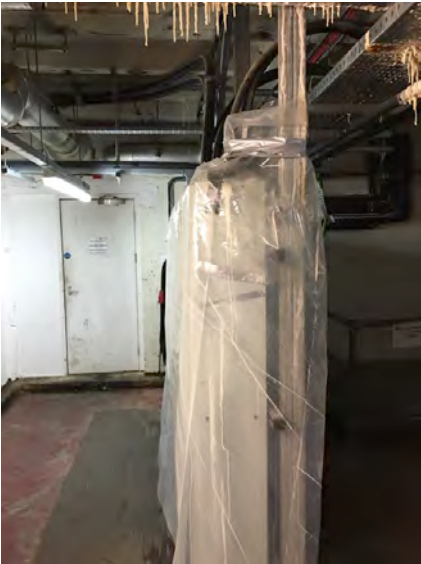
<p>Some water ingress into electrics.</p>	<p>Extinguisher should be fixed on a bracket.</p>

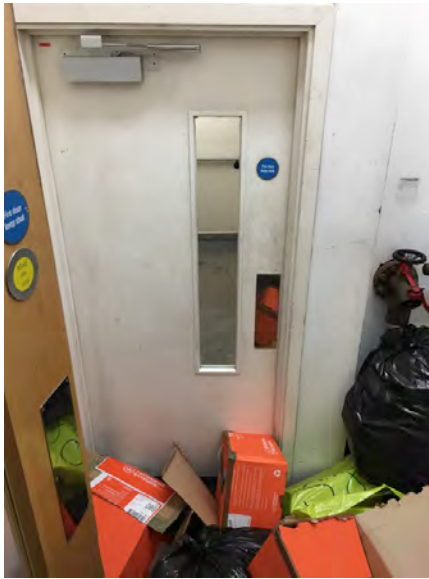
Rubbish blocking means of escape

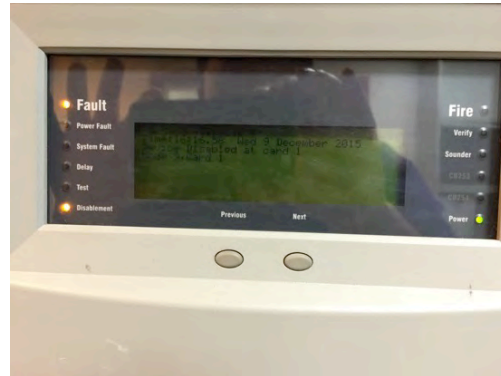
The Fire Alarm panel was showing 3 faults. These should be investigated and repaired as soon as practicable. It is important that anytime a detector is at fault or becomes disabled the building management is informed so that can carry out a risk assessment to see if interim measures are required.

3 faults on the fire panel

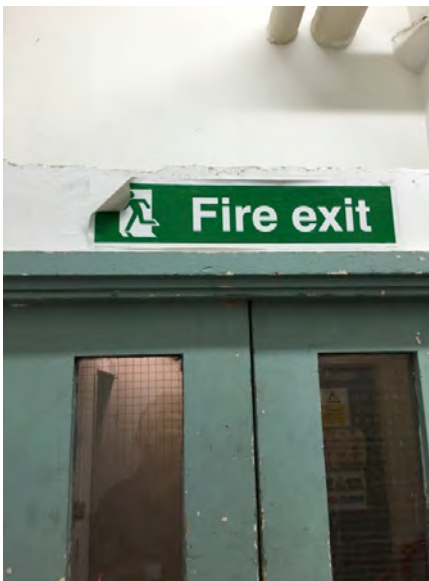
Signage in basement is peeling off the walls and needs replaced or reapplied.

Some signage is peeling away and should be repaired or replaced.

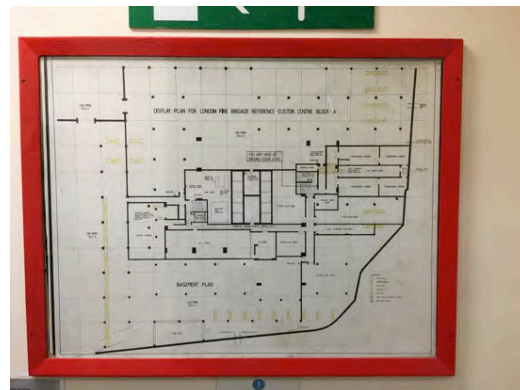
LFB plan should be updated.

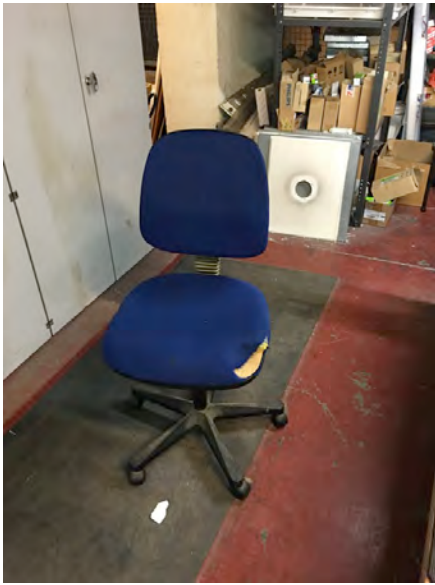
Furniture with torn fabric should be repaired or replaced.

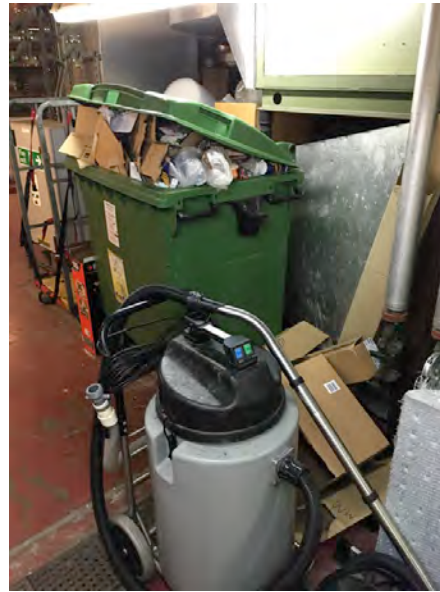
There is a significant amount of storage in the 12th floor plant rooms. Other plant rooms are kept sterile. It is recommended that all combustible materials in the 12th floor plant room should be removed and plant rooms kept clear of combustibles.

Combustibles in plant room.

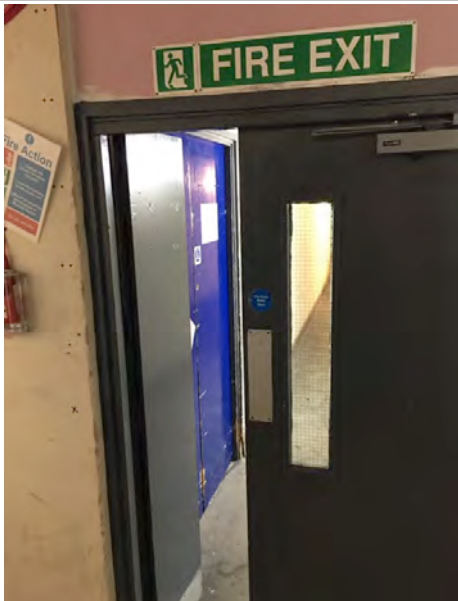
A self closer should be added to half leaf of door.

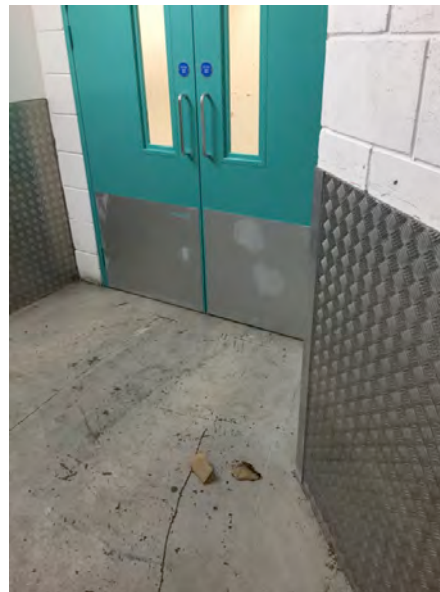
Consider fitting hold open devices to prevent doors in basement being wedged.

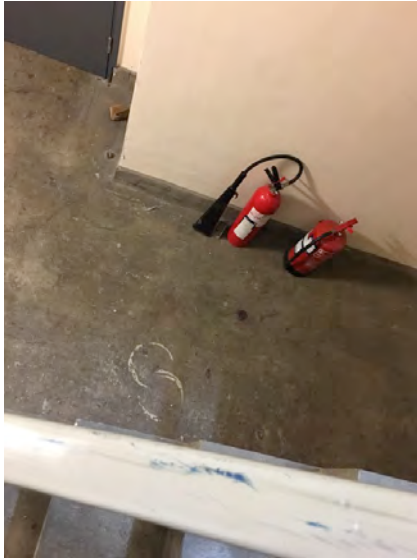
Fit extinguishers to brackets.

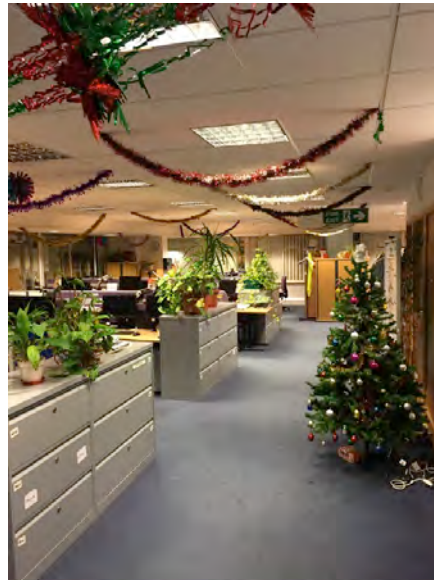
Due to the time of year this assessment has been undertaken there are Christmas decorations including Christmas lights on display. On a sample the lights haven't been PAT tested. Ensure Christmas lights are PAT tested and sockets are not overloaded. The following recommendations are made:

Christmas lights should be PAT tested and decorations should be kept away from lights

- Check Christmas lights conform to the British Standard
- Decorations can burn easily. Make sure they are kept away from lights and heaters
- Switch off Christmas lights at the end of the day
- Don't overload sockets.

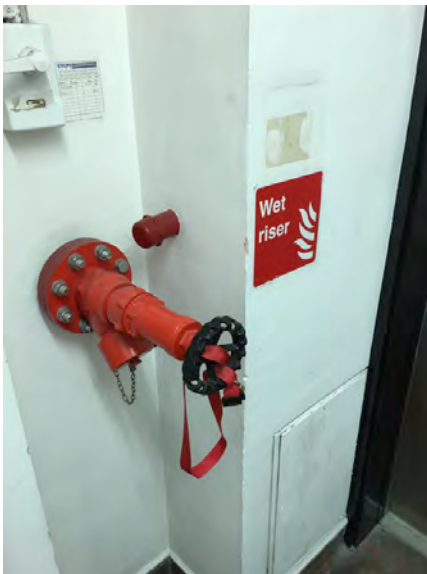
Straps need installed correctly

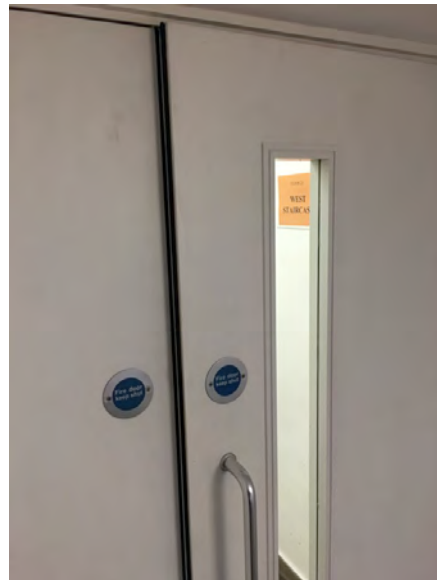
There are a number of self closers in the building which need replaced as they are not able to fully close the fire doors. Regular maintenance checks will identify these doors and the self closers should be repaired or replaced.

Some doors not closing fully due to faulty self closers

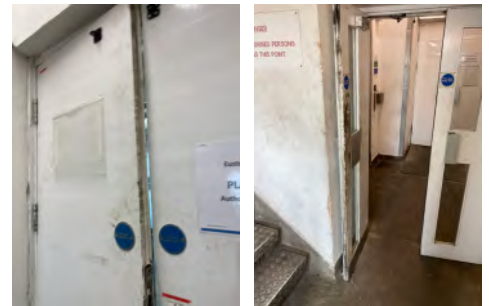
Task 2

Ref	443688
Source Version	1
Category	Escape Routes & Fire Spread
Sub Category	Fire Doors
Action Required	A number of fire doors are not closing fully. Review all fire doors and repair as required. These are due for maintenance within the coming weeks. Stairwell fire doors should be prioritised for first inspection.
Priority	High
Status	Identified
Due Date	8 October 2020

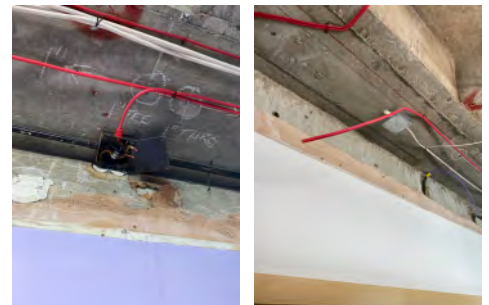
Task 4

Ref	443694
Source Version	1
Category	Detection & Warning
Sub Category	Control Equipment
Action Required	Confirm status and impact of fire alarm system on 16th floor where cables have been cut off and left and junction boxes are open and not secured correctly.
Priority	High
Status	Identified
Due Date	8 October 2020

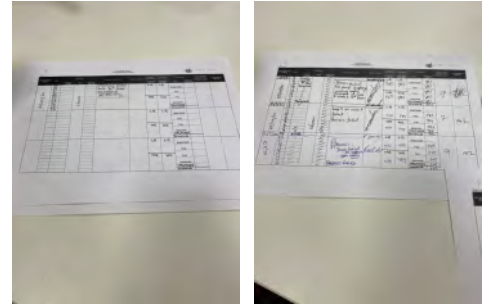
Task 16

Ref	443700
Source Version	1
Category	Fire Management
Sub Category	Record Keeping
Action Required	Fire alarm weekly: review procedure to ensure all faults are logged on weekly alarm records. Current records don't provide an overview of the faults from fire alarm and therefore make it difficult to manage actions and understand status of faults.
Priority	Medium
Status	Identified
Due Date	2 December 2020

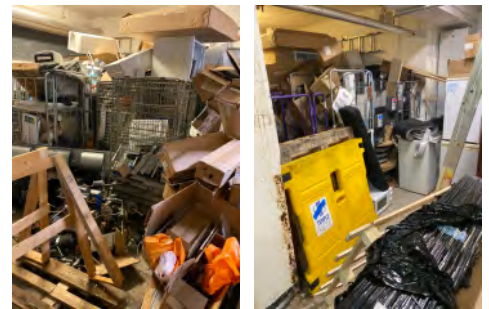
Task 17

Ref	443699
Source Version	1
Category	Fire Prevention
Sub Category	Housekeeping
Action Required	The storage of combustibles in the following locations was excessive and should be significantly reduced: apex room
Priority	Medium
Status	Identified
Due Date	2 December 2020

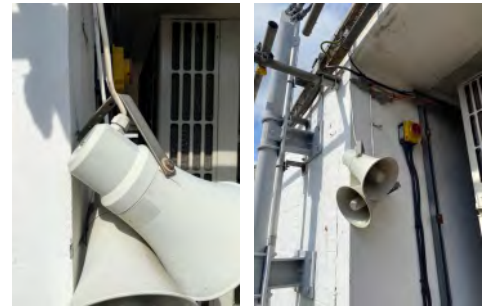
Task 22

Ref	443680
Source Version	1
Category	Detection & Warning
Sub Category	Audibility
Action Required	Two fire alarm sounders on the roof were dangling from cable and not fixed to the wall. These should be repaired and fixed to the wall.
Priority	Medium
Status	Identified
Due Date	2 December 2020

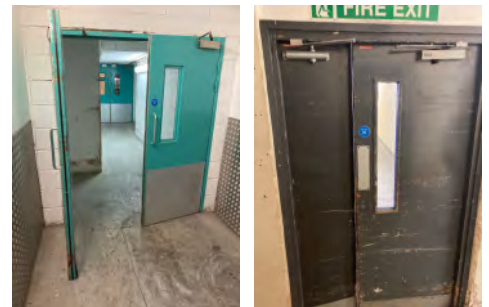
Task 23

Ref	443691
Source Version	1
Category	Escape Routes & Fire Spread
Sub Category	Fire Doors
Action Required	Fire doors in basement need repaired and replaced. Fire doors are damaged, hinges twisted and don't close fully. All basement doors need reviewed and repaired/replaced. These are high use doors and should be designed to take this into account.
Priority	Medium
Status	Identified
Due Date	2 December 2020

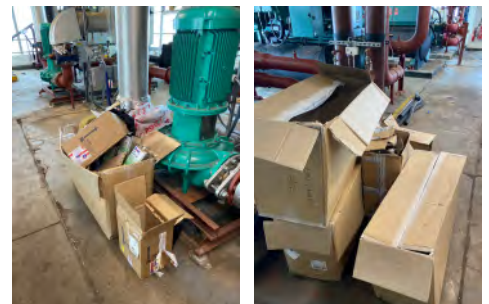
Task 24

Ref	443690
Source Version	1
Category	Fire Prevention
Sub Category	Housekeeping
Action Required	The storage of combustibles in the following locations was excessive and should be significantly reduced: Plant room 34th floor.
Priority	Medium
Status	Identified
Due Date	2 December 2020
