Initial PFP Evaluation Report for Euston Tower:

Commentary on the Investigation of an Existing Spray Fire Resistive Material
Applied to Concrete Structural Elements

PFPS-TR-2037-2

26th March 2021

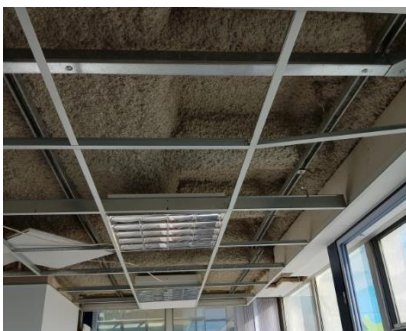
Figure 1: Soffit of Level 5 slab showing sprayed material on ribbed slab applied around ceiling and services supports (image courtesy of 190925 ARUP Invasive Survey Report)

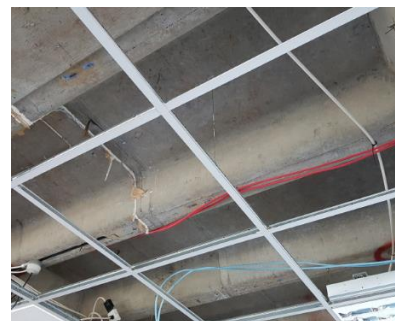
Figure 2: Soffit of Level 17 slab as-struck concrete ribs with some cast-in channels and some surface-fixed services (image courtesy of 190925 ARUP Invasive Survey Report)

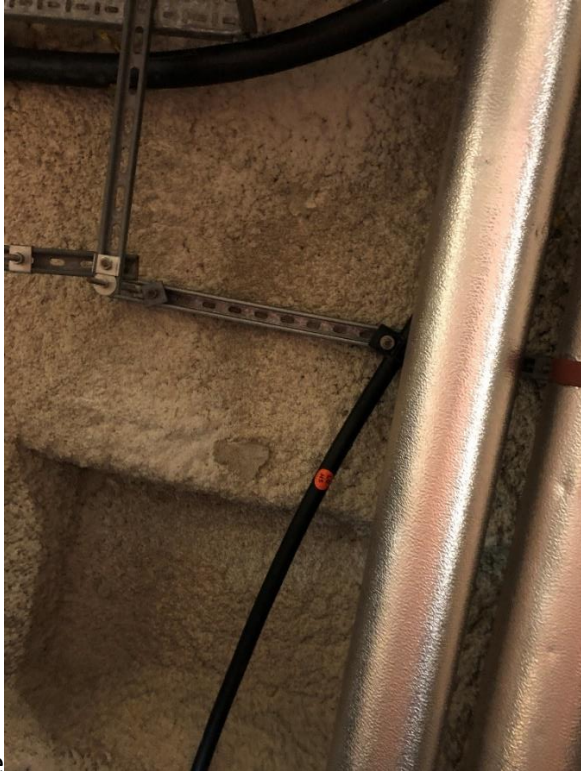
Figure 4: Minor patch repair

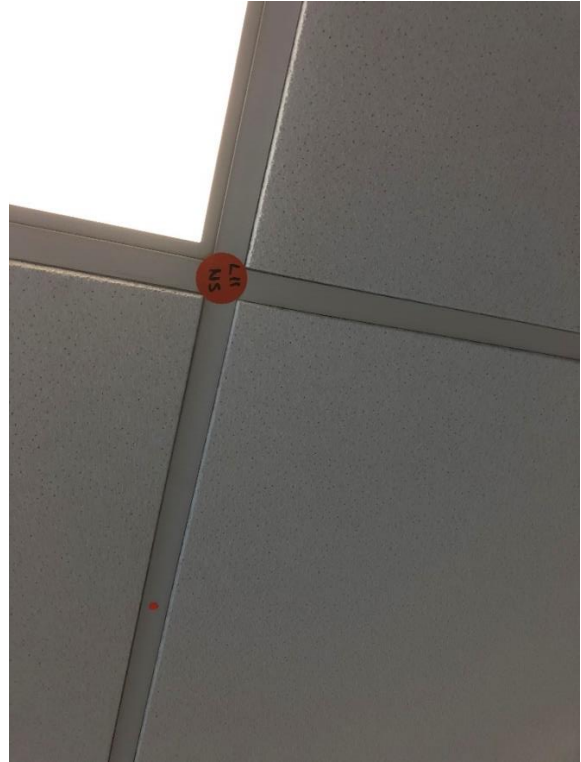
Figure 5: Adhesive label identifying the inspective location (L11 NS)

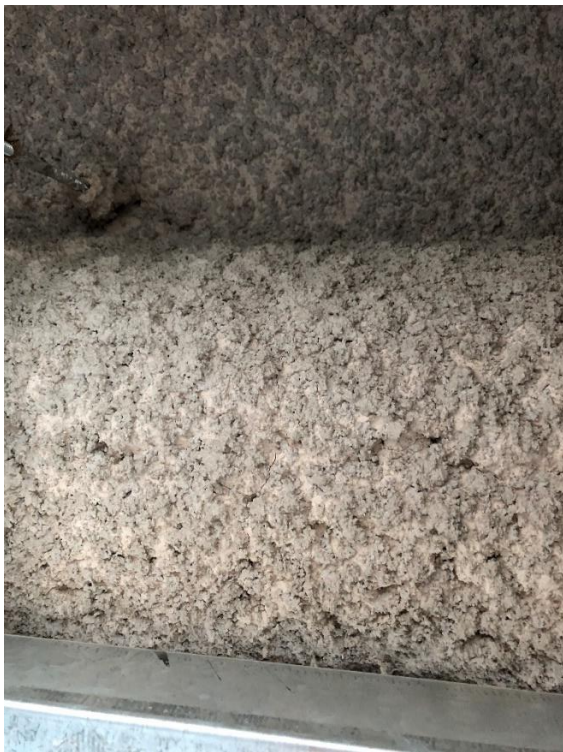
Figure 6: Heavy texture appearance

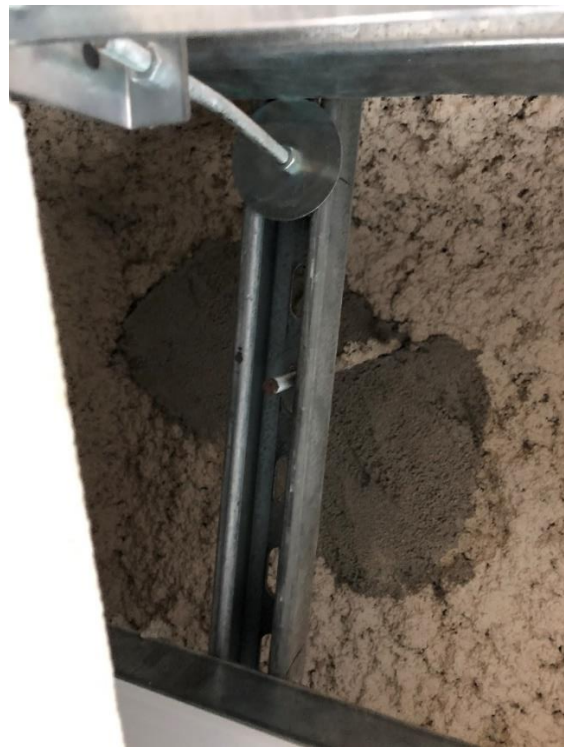
Figure 7: Small patch repair

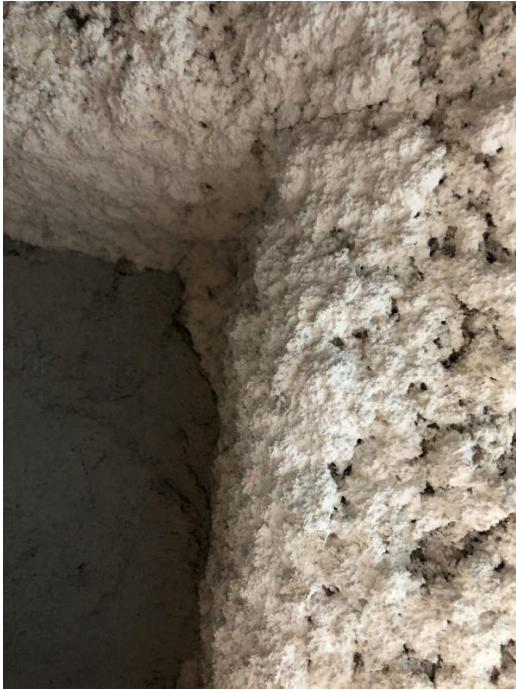
Figure 8: Large patch repair

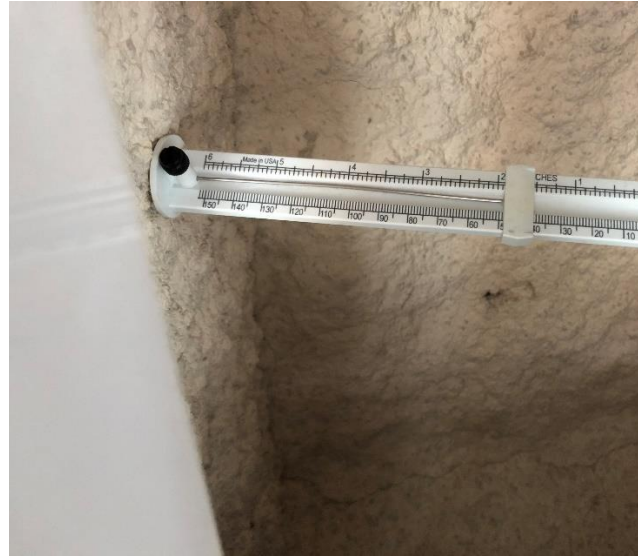
Figure 9: Needle gauge coating thickness measurement to slab rib

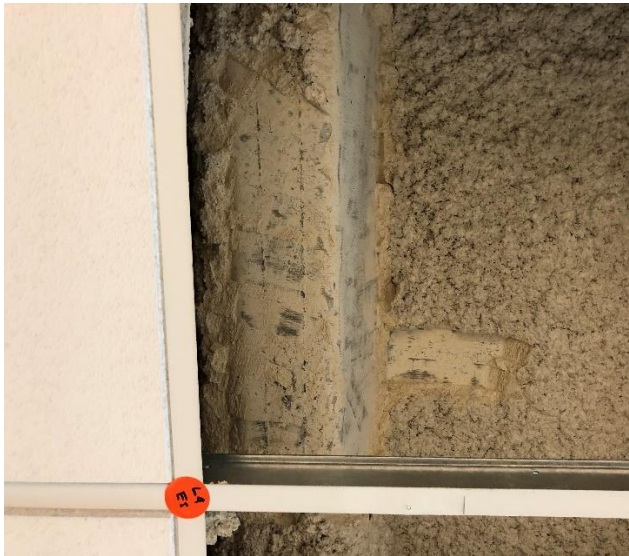
Figure 10: Level 4 East spur – large area of SFRM removed for CVI by others as part of the structural investigation

The survey results presented in Table 6 found one anomaly level 1 (severe or immediate) where McGee (see reference in Table 1) had carried out “*insulation breakout as part of Euston Tower site investigations*”. For this area, the manufacturer of the product should be able to provide a standard repair procedure which a recognised specialist contractor will incorporate into a method statement.

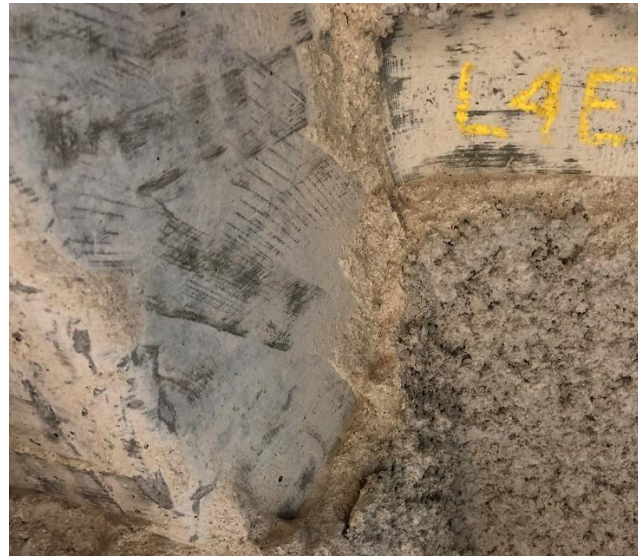
Figure 11: Level 4 East spur showing the cohesive failure of the SFRM on removal with mechanical tools – indicating good adhesion

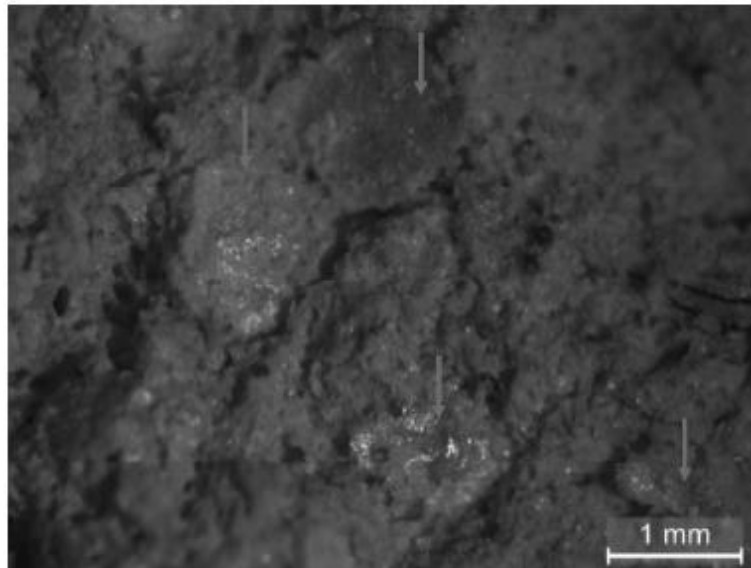
The sample 1 consists mainly of a grey colored matrix. In the matrix beige pearlescent plate like grains are embedded (some marked with a red arrow). The layers are easily pulled apart with a scalpel. It looks like a mica. These grains have a round shape.

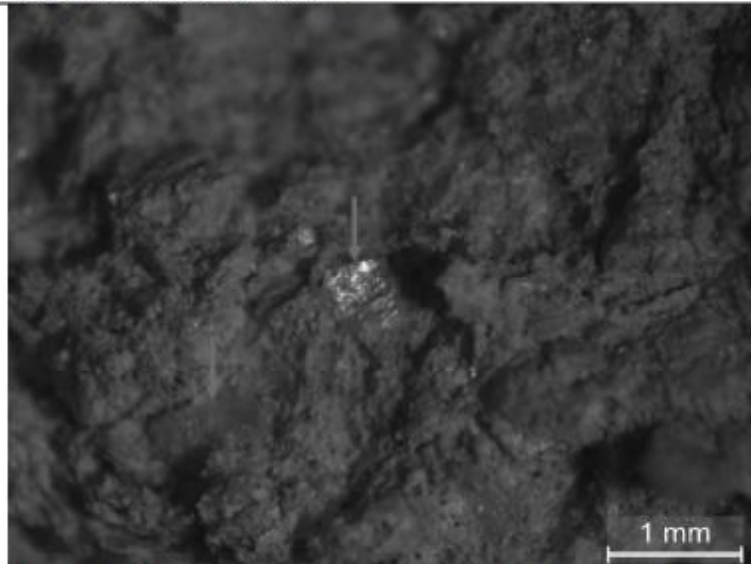
The sample 3 consists mainly of a grey colored matrix. In the matrix beige pearlescent plate like grains are embedded (some marked with a red arrow). The layers are easily pulled apart with a scalpel. It looks like a mica. These grains have a angular shape.

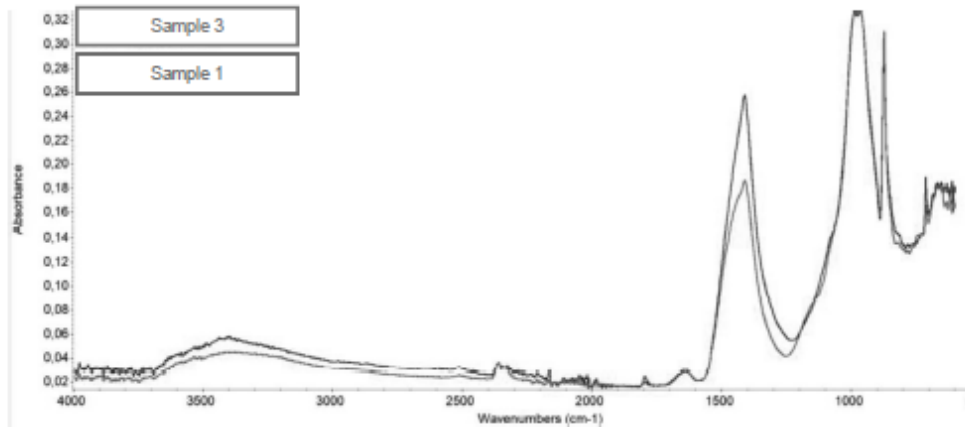
Image: ATR-FTIR spectrum of the two samples

The ATR/FTIR spectrum of the two samples are identical. The two samples consist of a Portland based cement. The reference spectrum of Portland cement is not depicted. In general quantities in lower concentrations than 10 % of unknow components cannot be detected with ATR/FTIR.
