ASBESTOS REINSPECTION REPORT

Site: RPE Euston Tower
Address: Regents Place Estate, London, NW1 3HF
Client: British land
Survey Date: 18 July 2022 to 19 July 2022
Surveyor: Andrew Johnson
Issue Number: 1

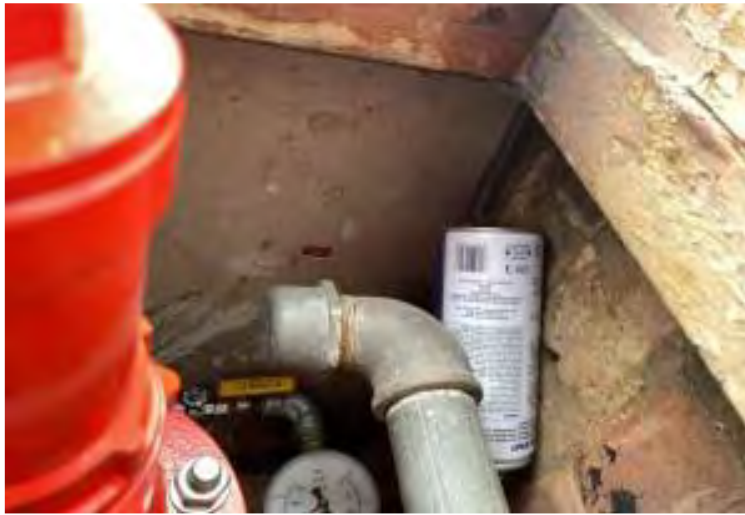
Sample Number:	F971/S005		
Building:	Euston Tower	Floor:	Main roof
Room Name/Number:	RF.01	Material/Amount:	Insulating Board 1 m2
Sample Description:	East wet riser soffit panel

Product Type:	Insulating Board	Total Risk Score:	7
Condition:	Some Minor Damage	Risk Category:	Medium
Surface Treatment:	Unsealed		
Asbestos Types:	Amosite	Action:	Manage
Comments:	Periodic inspections should be carried out in accordance with Regulation 4 of the Control of Asbestos Regulations 2012. Do not disturb this ACM. Ensure all employees, contractors & tenants who may come into contact with this ACM are made aware.

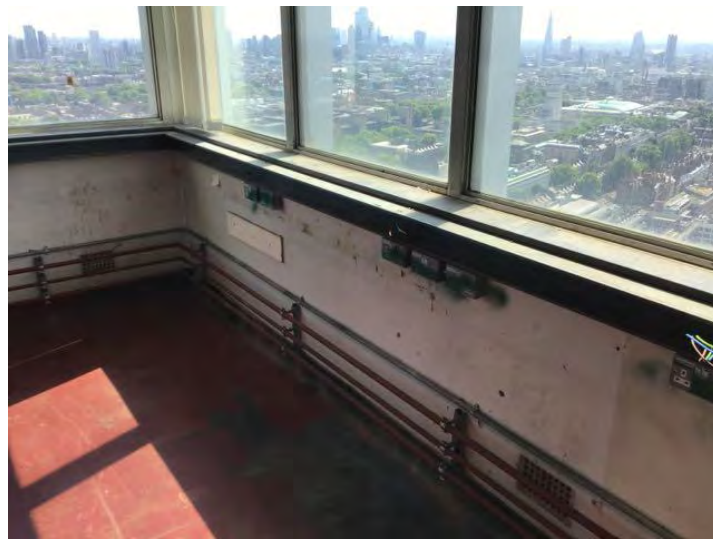
Sample Number:	AS F971/S019 F971/VR512		
Building:	Euston Tower	Floor:	35 th Floor
Room Name/Number:	35.08 workshop	Material/Amount:	Cement Product 16 lin m
Sample Description:	Window Sills

Product Type:	Cement Product	Total Risk Score:	4
Condition:	Some Minor Damage	Risk Category:	Very Low
Surface Treatment:	Sealed		
Asbestos Types:	Chrysotile	Action:	Manage
Comments:	Periodic inspections should be carried out in accordance with Regulation 4 of the Control of Asbestos Regulations 2012. Do not disturb this ACM. Ensure all employees, contractors & tenants who may come into contact with this ACM are made aware.

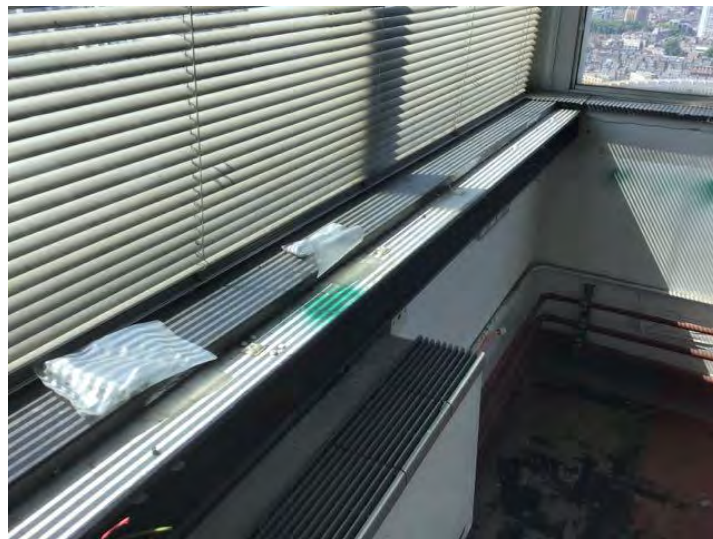
Sample Number:	AS F971/S019 F971/VR513		
Building:	Euston Tower	Floor:	35 th Floor
Room Name/Number:	35.09 Engineers Office	Material/Amount:	Cement Product 7 lin m
Sample Description:	Window Sills

Product Type:	Cement Product	Total Risk Score:	4
Condition:	Some Minor Damage	Risk Category:	Very Low
Surface Treatment:	Sealed		
Asbestos Types:	Chrysotile	Action:	Manage
Comments:	Periodic inspections should be carried out in accordance with Regulation 4 of the Control of Asbestos Regulations 2012. Do not disturb this ACM. Ensure all employees, contractors & tenants who may come into contact with this ACM are made aware.

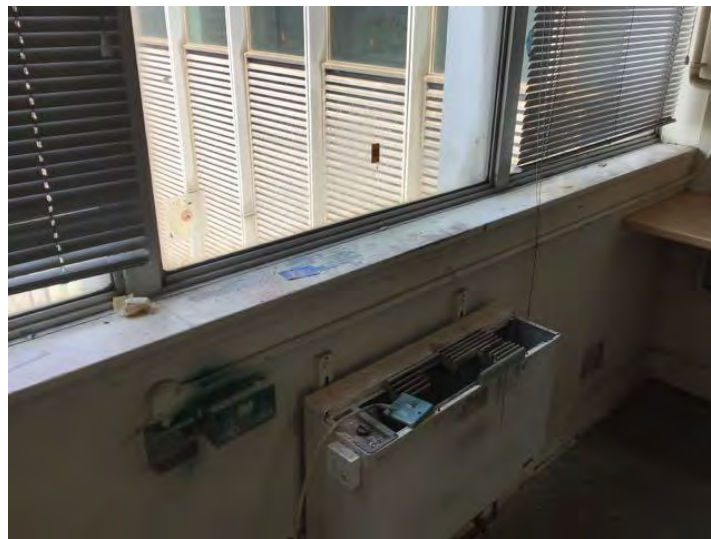
Sample Number:	AS F971/S019 F971/VR514		
Building:	Euston Tower	Floor:	35 th Floor
Room Name/Number:	35.10 Kitchen	Material/Amount:	Cement Product 3 lin m
Sample Description:	Window Sills

Product Type:	Cement Product	Total Risk Score:	4
Condition:	Some Minor Damage	Risk Category:	Very Low
Surface Treatment:	Sealed		
Asbestos Types:	Chrysotile	Action:	Manage
Comments:	Periodic inspections should be carried out in accordance with Regulation 4 of the Control of Asbestos Regulations 2012. Do not disturb this ACM. Ensure all employees, contractors & tenants who may come into contact with this ACM are made aware.

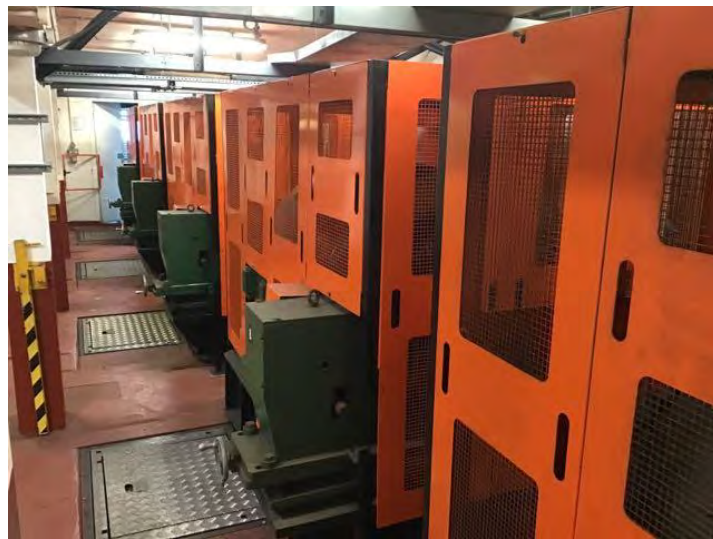
Sample Number:	F971/VR513		
Building:	Euston Tower	Floor:	35 th Floor
Room Name/Number:	35.11 High Rise Lift Motor Room	Material/Amount:	Friction Material 5 no
Sample Description:	Brake Linings to Lift Motors

Product Type:	Friction Material	Total Risk Score:	4
Condition:	Some Minor Damage	Risk Category:	Very Low
Surface Treatment:	Sealed		
Asbestos Types:	Chrysotile	Action:	Manage
Comments:	Periodic inspections should be carried out in accordance with Regulation 4 of the Control of Asbestos Regulations 2012. Do not disturb this ACM. Ensure all employees, contractors & tenants who may come into contact with this ACM are made aware.

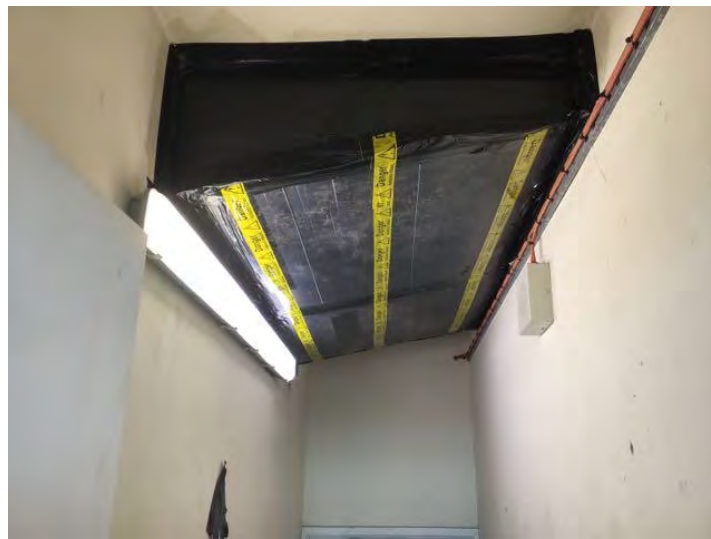
Sample Number:	F971/S023		
Building:	Euston Tower	Floor:	35 th Floor
Room Name/Number:	35.12 Lobby	Material/Amount:	Cement Product 3 m ²
Sample Description:	Durasteel Boxing

Product Type:	Cement Product	Total Risk Score:	4
Condition:	Some Minor Damage	Risk Category:	Very Low
Surface Treatment:	Sealed		
Asbestos Types:	Chrysotile	Action:	Manage
Comments:	Periodic inspections should be carried out in accordance with Regulation 4 of the Control of Asbestos Regulations 2012. Do not disturb this ACM. Ensure all employees, contractors & tenants who may come into contact with this ACM are made aware.

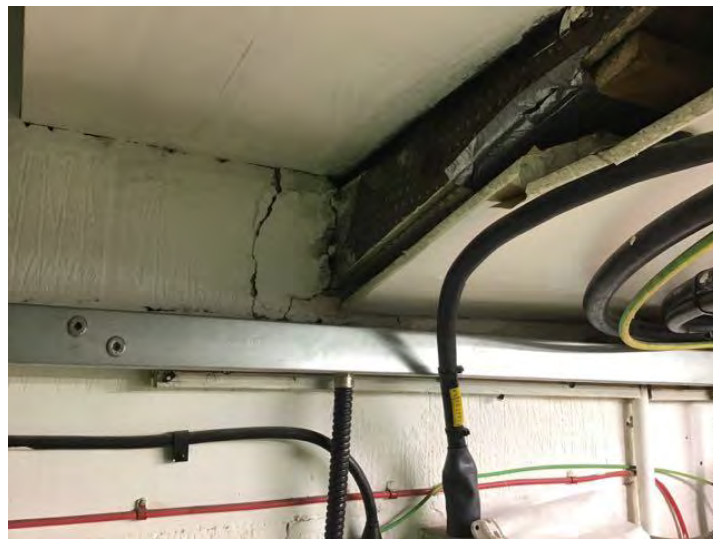
Sample Number:	F971/S023 F971/VR516		
Building:	Euston Tower	Floor:	35 th Floor
Room Name/Number:	35.13 West Goods Lift Motor Room	Material/Amount:	Cement Product 1 m ²
Sample Description:	Durasteel Boxing

Product Type:	Cement Product	Total Risk Score:	4
Condition:	Some Minor Damage	Risk Category:	Very Low
Surface Treatment:	Sealed		
Asbestos Types:	Chrysotile	Action:	Manage

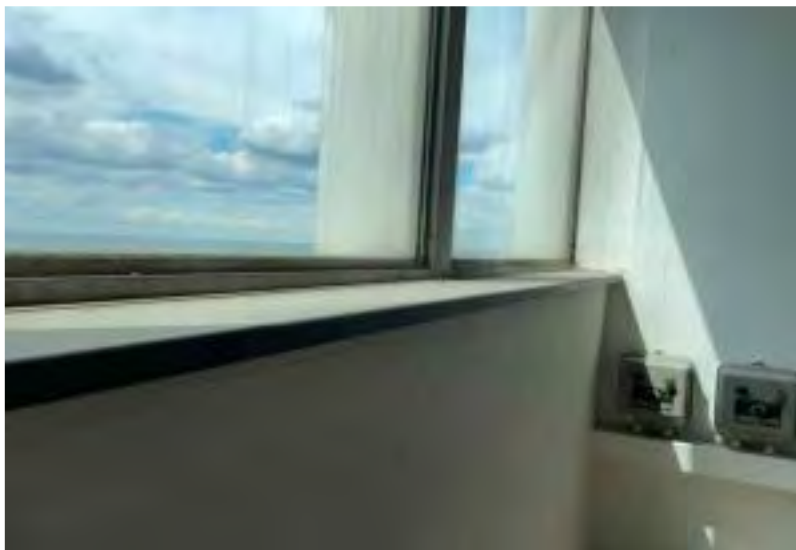
Sample Number:	F971/S019		
Building:	Euston Tower	Floor:	35 th Floor
Room Name/Number:	35.04 Control Room	Material/Amount:	Cement Product NQ
Sample Description:	Window Sills

Product Type:	Cement Product	Total Risk Score:	4
Condition:	Some Minor Damage	Risk Category:	Very Low
Surface Treatment:	Sealed		
Asbestos Types:	Chrysotile	Action:	Manage
Comments:	Periodic inspections should be carried out in accordance with Regulation 4 of the Control of Asbestos Regulations 2012. Do not disturb this ACM. Ensure all employees, contractors & tenants who may come into contact with this ACM are made aware.

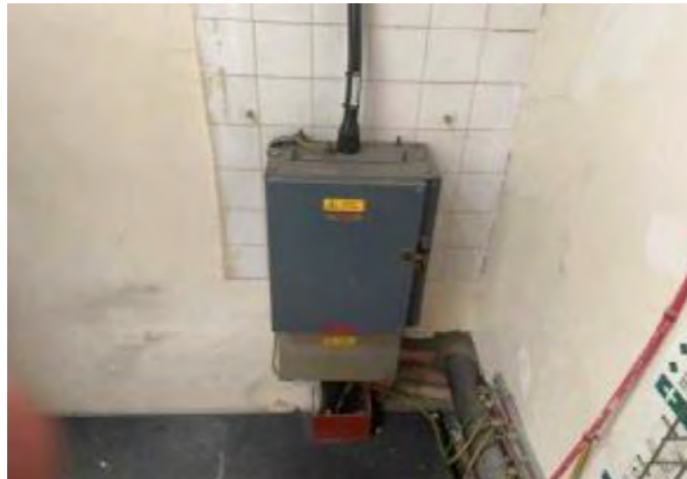
Sample Number:	F971/VR505		
Building:	Euston Tower	Floor:	36 th Floor
Room Name/Number:	36.06 UPS Room	Material/Amount:	Woven Material 1 no
Sample Description:	Within Electric Box

Product Type:	Woven Material	Total Risk Score:	5
Condition:	Some Minor Damage	Risk Category:	Low
Surface Treatment:	Sealed		
Asbestos Types:	Chrysotile	Action:	Manage
Comments:	As confirmed with the client/representative, this area was locked, and keys were not available at the time of the survey.

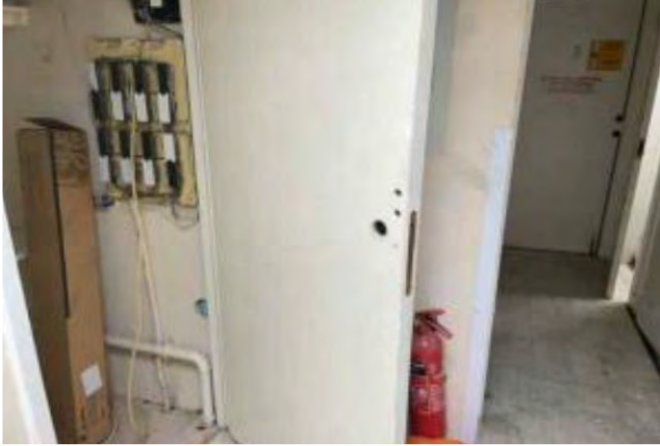
Sample Number:	F971/S002		
Building:	Euston Tower	Floor:	36 th Floor
Room Name/Number:	36.09 Comms Room	Material/Amount:	Insulating Board 1 no
Sample Description:	Door Lining

Material Assessment			
Product Type:	Insulating Board	Total Risk Score:	6
Condition:	Some Minor Damage	Risk Category:	Low
Surface Treatment:	Sealed		
Asbestos Types:	Amosite	Action:	Manage
Comments:	As confirmed with the client/representative, this area was locked, and keys were not available at the time of the survey.

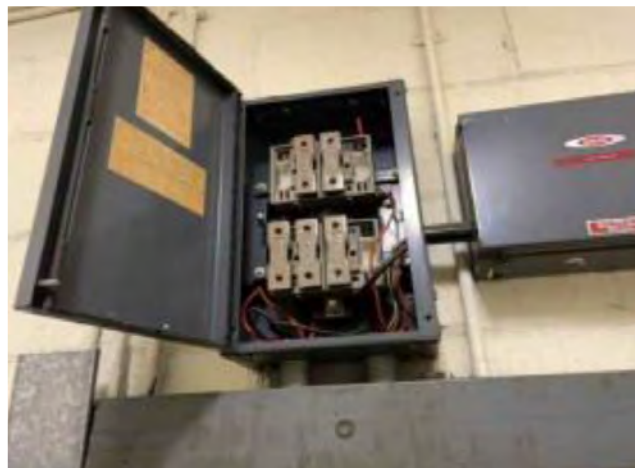
Sample Number:	F971/VR517		
Building:	Euston Tower	Floor:	36 th Floor
Room Name/Number:	36.13 Battery Room	Material/Amount:	Woven Material 2 no
Sample Description:	Within Electric Boxes

Product Type:	Woven Material	Total Risk Score:	5
Condition:	Some Minor Damage	Risk Category:	Low
Surface Treatment:	Sealed		
Asbestos Types:	Chrysotile	Action:	Manage

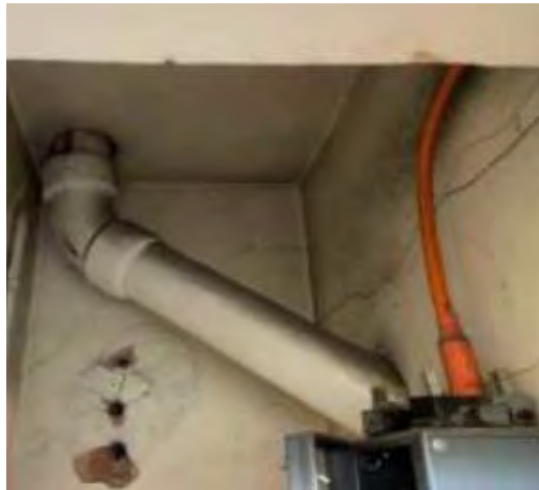
Sample Number:	AS F971/S003 F971/VR519		
Building:	Euston Tower	Floor:	36 th Floor
Room Name/Number:	36.14 Gas Cupboard	Material/Amount:	Cement Product 2 Visible lin m
Sample Description:	Flue Pipe's

Product Type:	Cement Product	Total Risk Score:	4
Condition:	Some Minor Damage	Risk Category:	Very Low
Surface Treatment:	Sealed		
Asbestos Types:	Chrysotile	Action:	Manage

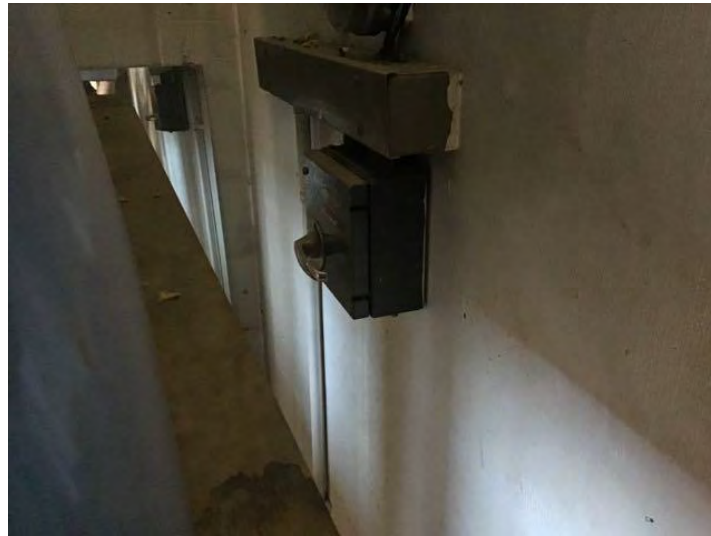
Sample Number:	F969/VR511		
Building:	Euston Tower	Floor:	24 th Floor
Room Name/Number:	24.19 - Plant Room	Material/Amount:	Woven Material 1 no
Sample Description:	Within Electric Boxes

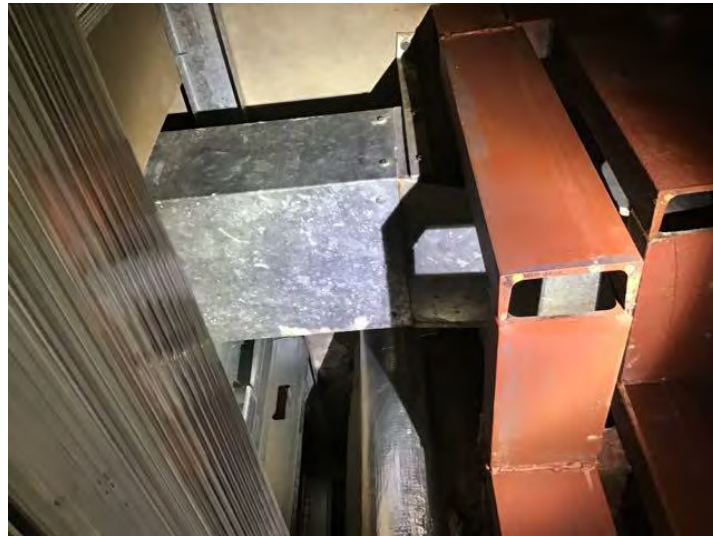
Sample Number:	AS F969/S004 F969/VR502		
Building:	Euston Tower	Floor:	Floors 2-33
Room Name/Number:	Ladies Toilets	Material/Amount:	Mastic Throughout
Sample Description:	Mastic to ductwork throughout ladies' toilets on floors 2-33

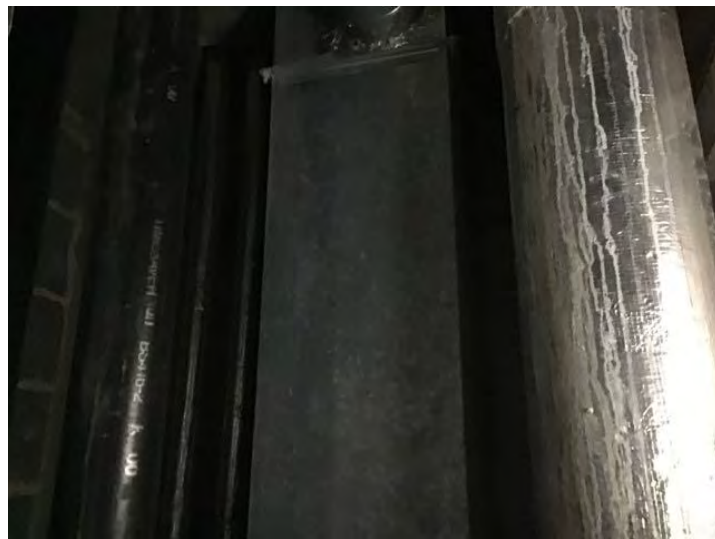
Sample Number:	F969/S004		
Building:	Euston Tower	Floor:	17 th Floor
Room Name/Number:	17.17 Ladies Toilet	Material/Amount:	Mastic Throughout
Sample Description:	Mastic to Ductwork

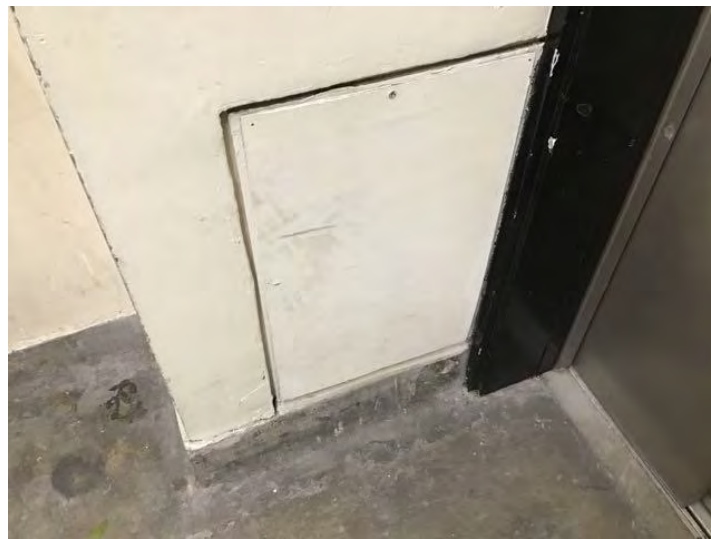
Sample Number:	F970/S009		
Building:	Euston Tower	Floor:	26 th Floor
Room Name/Number:	R.01 East Lift Lobby Riser	Material/Amount:	Cement Product 1 m ²
Sample Description:	Cement debris on floor

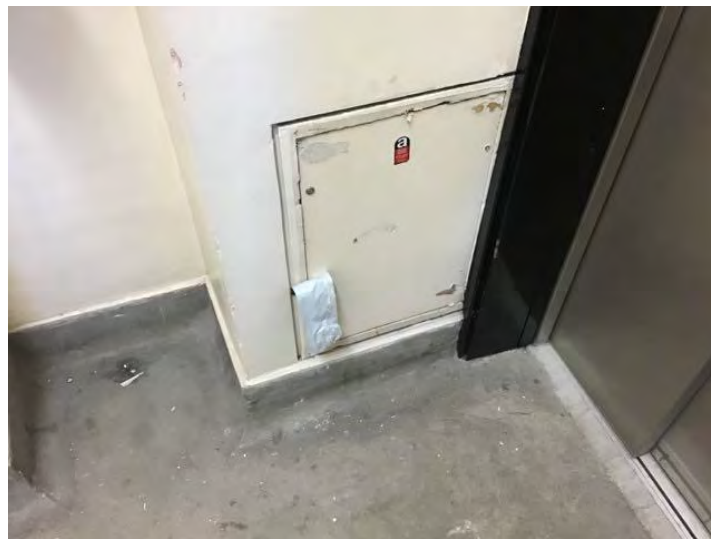
Sample Number:	F969/S012		
Building:	Euston Tower	Floor:	17 th to 24th Floors
Room Name/Number:	East Lift Lobby Riser	Material/Amount:	Insulating Board Throughout Riser
Sample Description:	Insulating board debris throughout riser

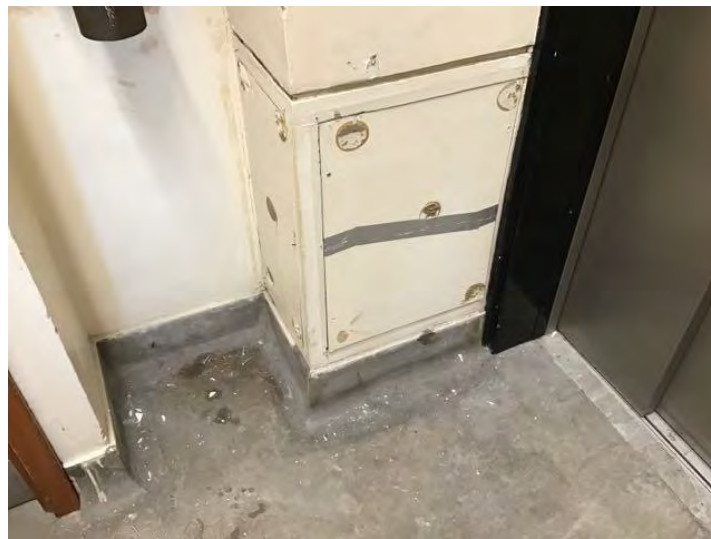
Sample Number:	F969/S010		
Building:	Euston Tower	Floor:	17 th to 24th Floors
Room Name/Number:	West Lift Lobby Riser	Material/Amount:	Insulating Board Throughout Riser
Sample Description:	Insulating board debris throughout riser

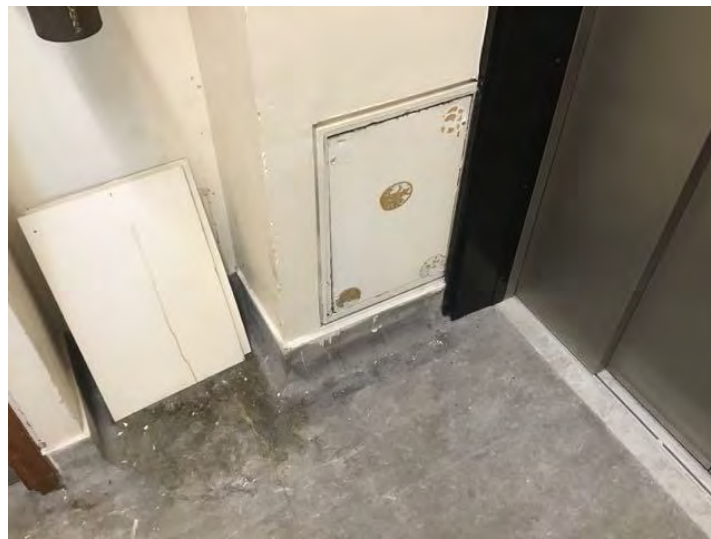
Sample Number:	F968/S023		
Building:	Euston Tower	Floor:	9 th to 16 th Floors
Room Name/Number:	West Lift Lobby Riser	Material/Amount:	Insulating Board Throughout Riser
Sample Description:	Insulating board debris throughout riser

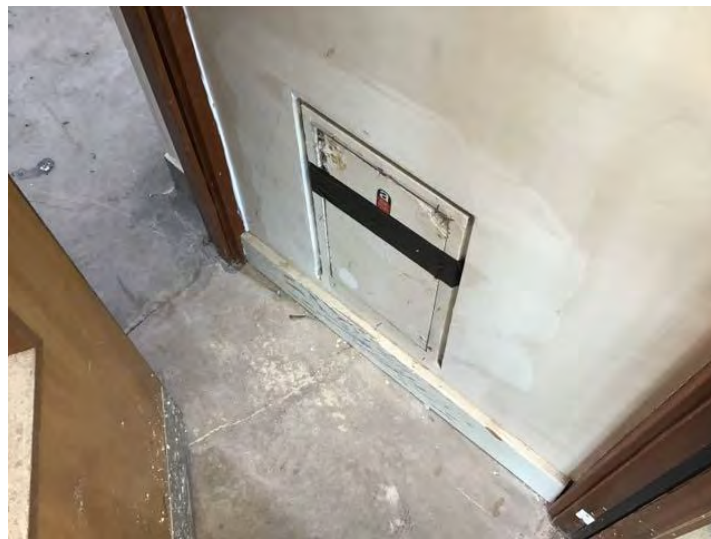
Sample Number:	F969/S011		
Building:	Euston Tower	Floor:	17 th to 24 th Floors
Room Name/Number:	South Lobby Riser	Material/Amount:	Insulating Board Throughout Riser
Sample Description:	Insulating board debris throughout riser

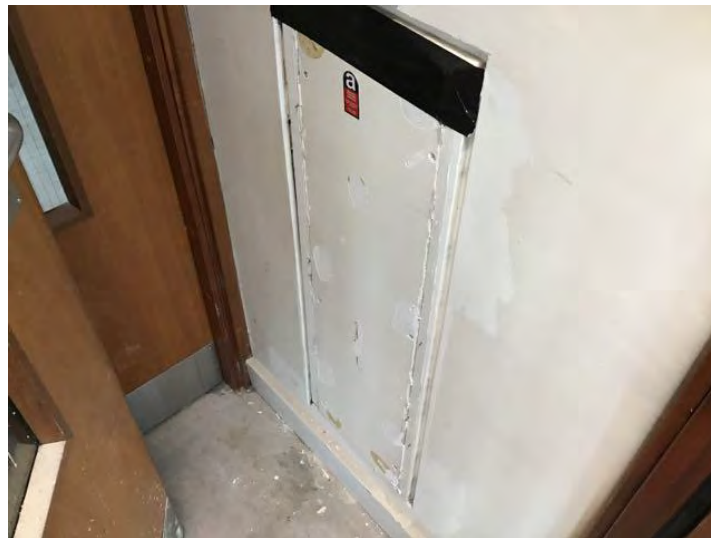
Sample Number:			
Building:	Euston Tower	Floor:	9 th to 16 th Floors
Room Name/Number:	South Lobby Riser	Material/Amount:	Insulating Board Throughout Riser
Sample Description:	Insulating board debris throughout riser

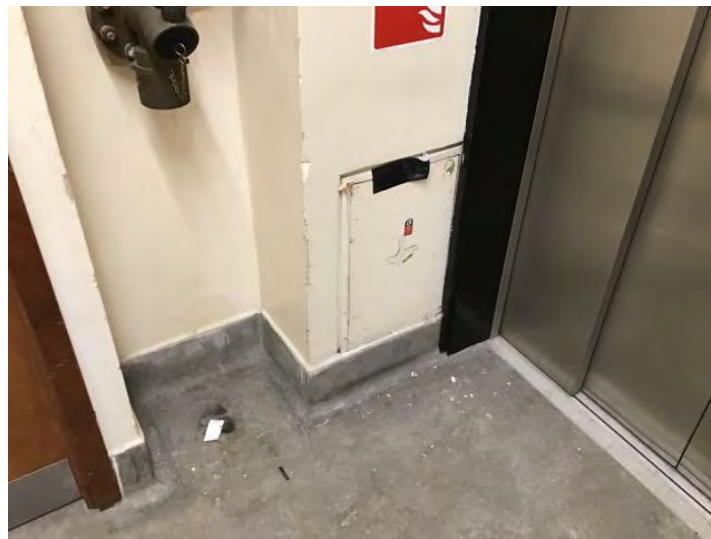
Euston Tower, 9 th to 16 th Floors, East Lift Lobby Riser	F968/S022	Insulating Board	Insulating board debris throughout Riser	Throughout Riser	High Damage/Debris	Easy	Amosite	Previously Sampled	Medium	Remove
Euston Tower, 17 th to 24 th Floors, East Lift Lobby Riser	F969/S012	Insulating Board	Insulating board debris throughout Riser	Throughout Riser	High Damage/Debris	Easy	Amosite	Previously Sampled	Medium	Remove
Euston Tower, 25 th to 33 rd Floors, East Lift Lobby Riser	G044/VR503	Insulating Board	Insulating board debris throughout Riser	Throughout Riser	High Damage/Debris	Easy	Amosite	Previously Sampled	Medium	Remove
Euston Tower, 1 st to 8 th Floors, West Lift Lobby Riser	G044/VR507	Insulating Board	Insulating board debris throughout Riser	Throughout Riser	High Damage/Debris	Easy	Amosite	Previously Sampled	Medium	Remove
Euston Tower, 9 th to 16 th Floors, West Lift Lobby Riser	F968/S023	Insulating Board	Insulating board debris throughout Riser	Throughout Riser	High Damage/Debris	Easy	Amosite	Previously Sampled	Medium	Remove

Sample Number:	F968/S022		
Building:	Euston Tower	Floor:	9 th to 16 th Floors
Room Name/Number:	East Lift Lobby Riser	Material/Amount:	Insulating Board Throughout Riser
Sample Description:	Insulating board debris throughout riser

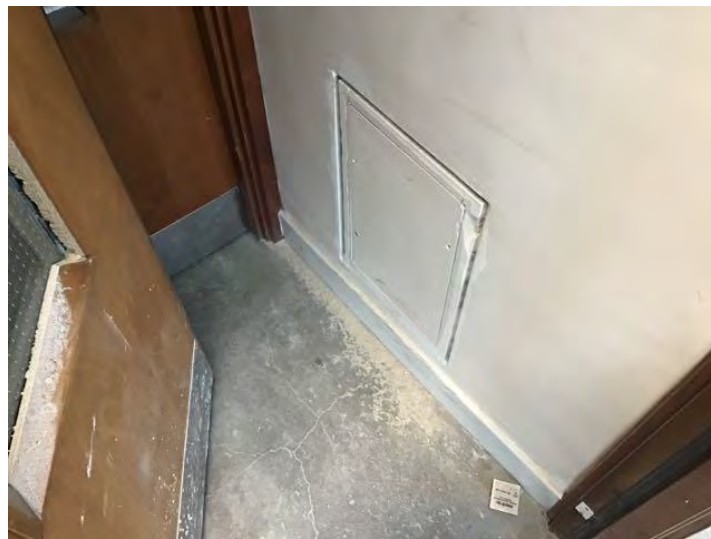
Sample Number:	F969/S013		
Building:	Euston Tower	Floor:	17 th to 24 th Floors
Room Name/Number:	North Lobby Riser	Material/Amount:	Insulating Board Throughout Riser
Sample Description:	Insulating board debris throughout riser

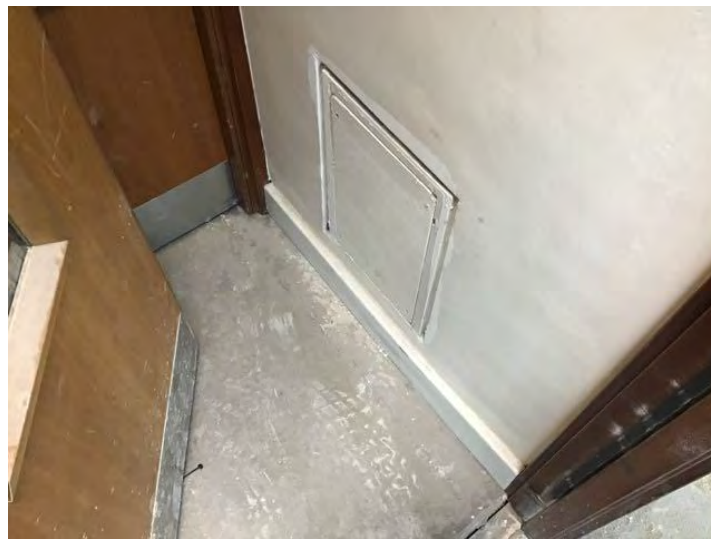
Sample Number:	F968/S024		
Building:	Euston Tower	Floor:	9 th to 16 th Floors
Room Name/Number:	North Lobby Riser	Material/Amount:	Insulating Board Throughout Riser
Sample Description:	Insulating board debris throughout riser

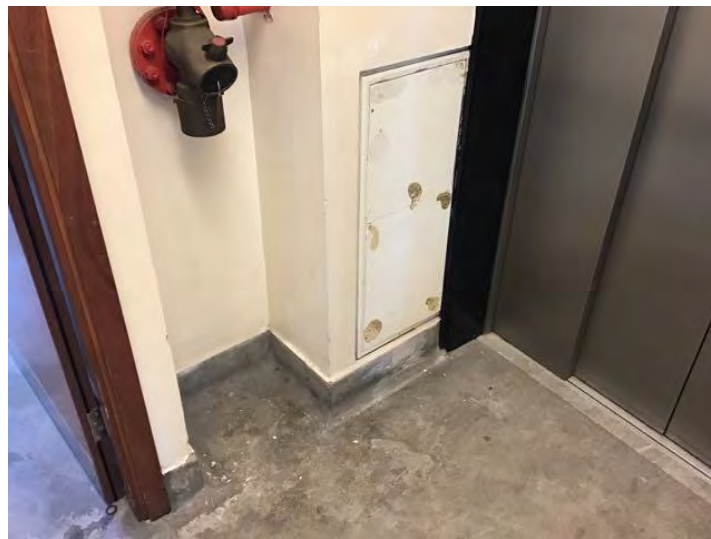
Sample Number:	G044/VR507		
Building:	Euston Tower	Floor:	1 st to 8 th Floors
Room Name/Number:	West Lift Lobby Riser	Material/Amount:	Insulating Board Throughout Riser
Sample Description:	Insulating board debris throughout riser

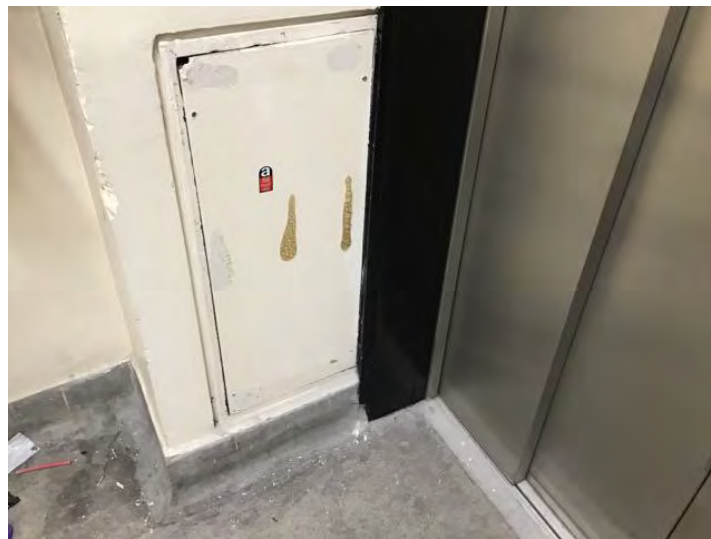
Sample Number:	G044/VR501		
Building:	Euston Tower	Floor:	25 th to 33 rd Floors
Room Name/Number:	West Lift Lobby Riser	Material/Amount:	Insulating Board Throughout Riser
Sample Description:	Insulating board debris throughout riser

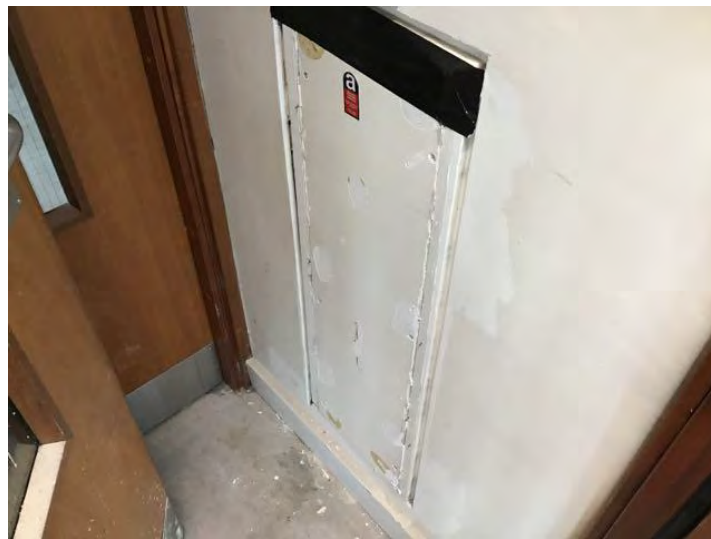
Sample Number:	G044/VR502		
Building:	Euston Tower	Floor:	25 th to 33 rd Floors
Room Name/Number:	South Lobby Riser	Material/Amount:	Insulating Board Throughout Riser
Sample Description:	Insulating board debris throughout riser

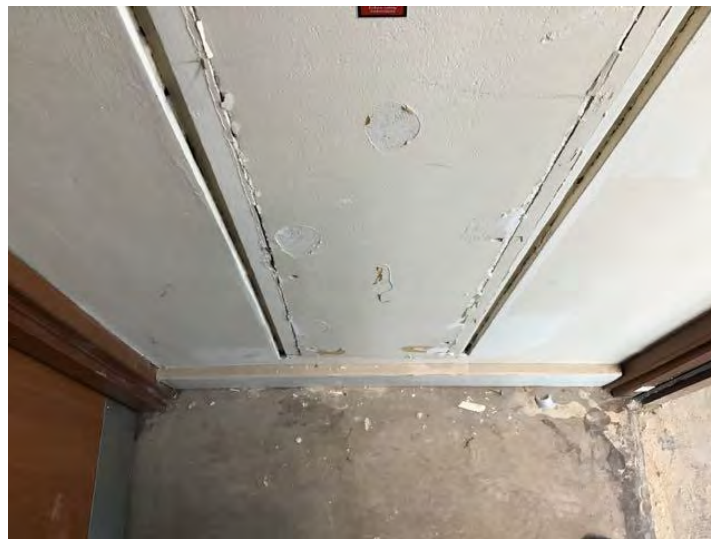
Sample Number:	G044/VR508		
Building:	Euston Tower	Floor:	2 nd to 8 th Floors
Room Name/Number:	South Lobby Riser	Material/Amount:	Insulating Board Throughout Riser
Sample Description:	Insulating board debris throughout riser

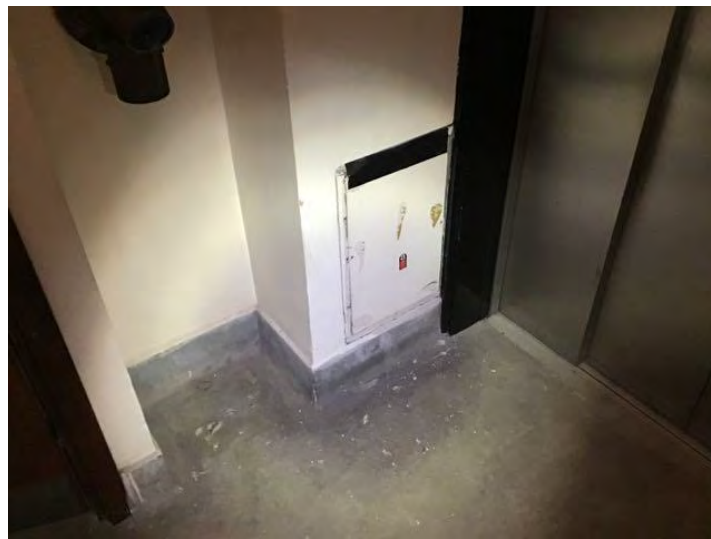
Sample Number:	G044/VR503		
Building:	Euston Tower	Floor:	25 th to 33 rd Floors
Room Name/Number:	East Lift Lobby Riser	Material/Amount:	Insulating Board Throughout Riser
Sample Description:	Insulating board debris throughout riser

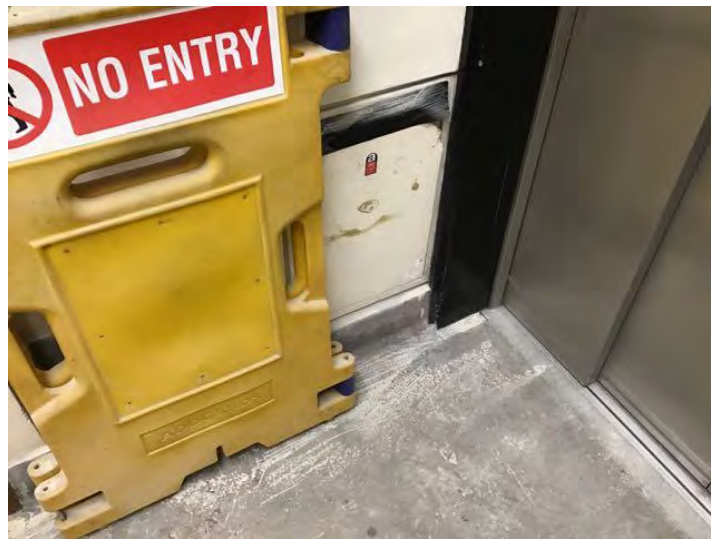
Sample Number:	G044/VR505		
Building:	Euston Tower	Floor:	1 st to 8 th Floors
Room Name/Number:	East Lift Lobby Riser	Material/Amount:	Insulating Board Throughout Riser
Sample Description:	Insulating board debris throughout riser

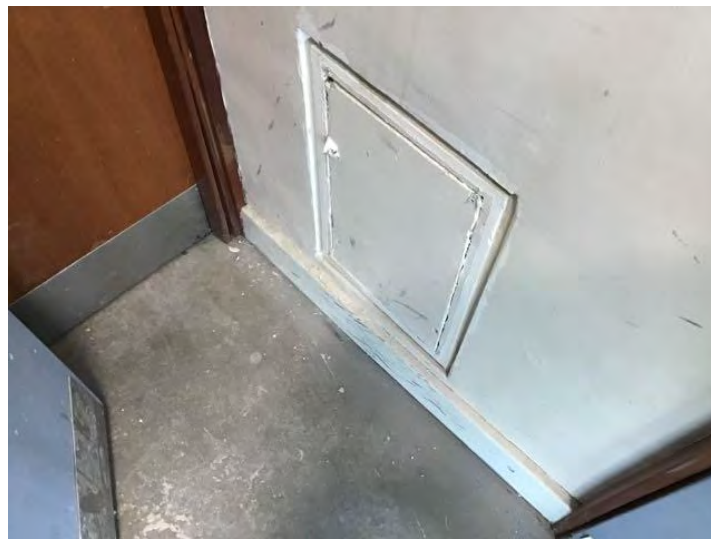
Sample Number:	G044/VR504		
Building:	Euston Tower	Floor:	25 th to 33 rd Floors
Room Name/Number:	North Lobby Riser	Material/Amount:	Insulating Board Throughout Riser
Sample Description:	Insulating board debris throughout riser

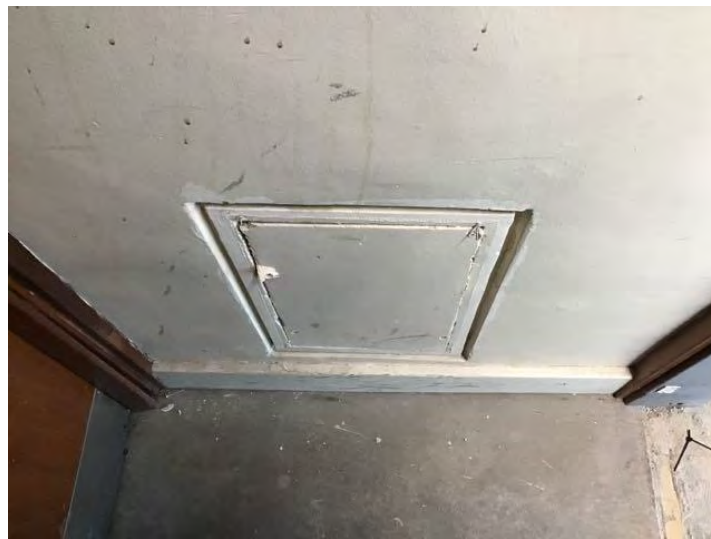
Sample Number:	G044/VR506		
Building:	Euston Tower	Floor:	2 nd to 8 th Floors
Room Name/Number:	North Lobby Riser	Material/Amount:	Insulating Board Throughout Riser
Sample Description:	Insulating board debris throughout riser

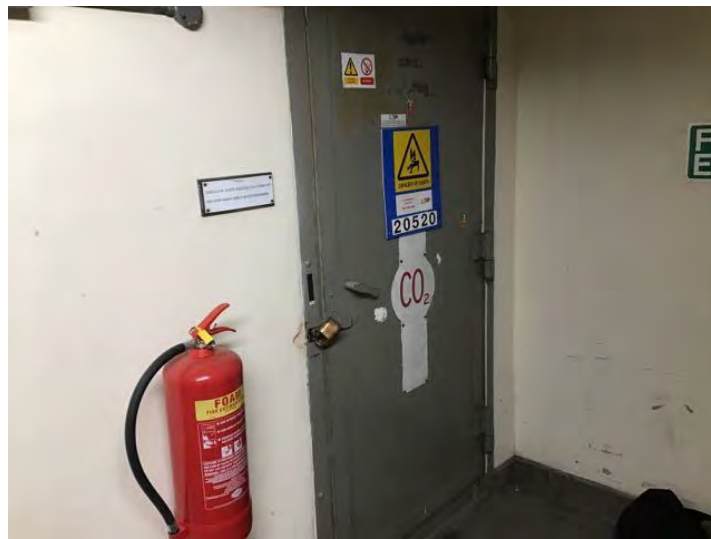
Sample Number:	AS F971/S037 F971/VR527		
Building:	Euston Tower	Floor:	Basement
Room Name/Number:	B.02 Corridor	Material/Amount:	Cement Product 1 no
Sample Description:	Durasteel Door

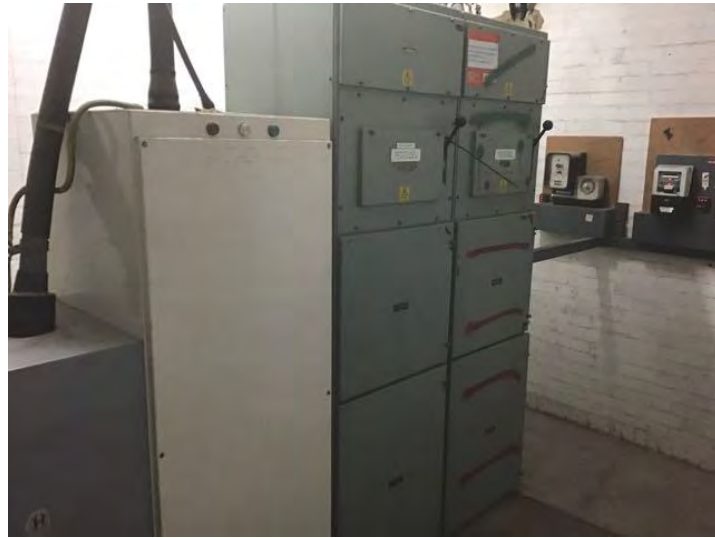
Sample Number:	F971/VR529		
Building:	Euston Tower	Floor:	Basement
Room Name/Number:	B.04 Electric Intake	Material/Amount:	Woven Material 1 no
Sample Description:	Within Electric Boxes

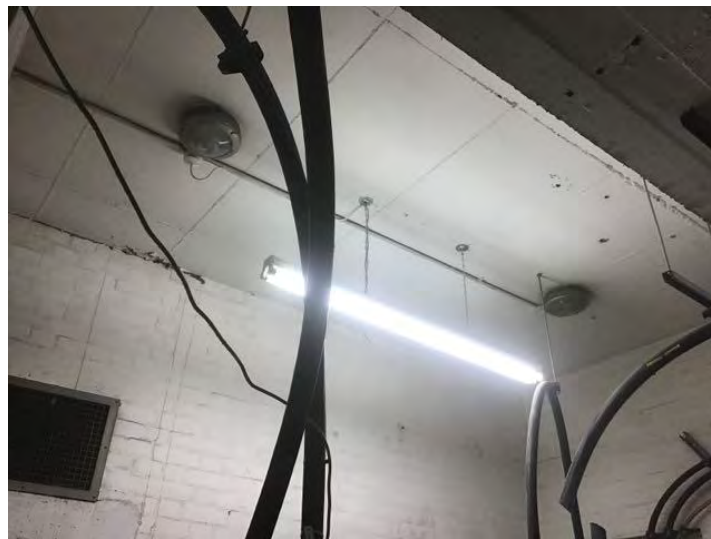
Sample Number:	AS F971/S042/ F971/VR528		
Building:	Euston Tower	Floor:	Basement
Room Name/Number:	B.04 Electric Intake	Material/Amount:	Putty 2 no
Sample Description:	Putty to Emergency Lighting Unit to Soffit

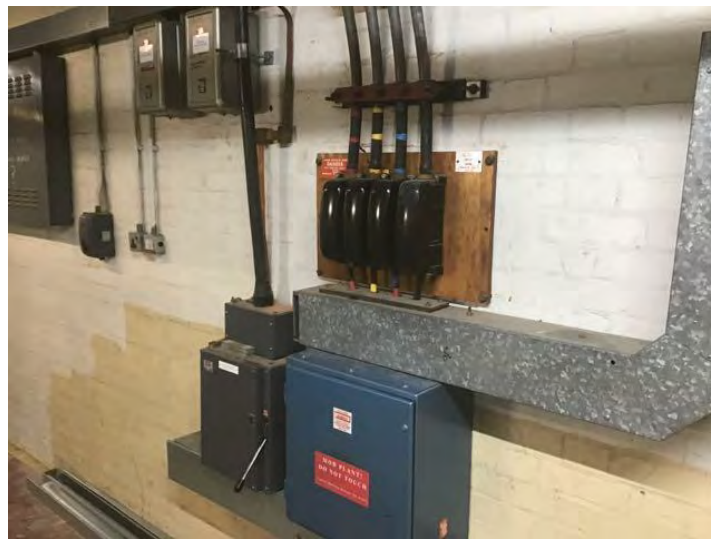
Euston Tower, Basement, B.05 Main Switch Room	F971/VR531	Woven Material	Within Electric Boxes	4 no	Some Minor Damage	Medium	Chrysotile	Previously Sampled	Low	Manage
Euston Tower, Basement, B.05 Main Switch Room	F971/VR530	Thermoplastic	Bakelite Covers	4 no	Some Minor Damage	Medium	Chrysotile	Previously Sampled	Very Low	Manage
Euston Tower, Basement, B.06 Store Room	F971/VR532	Bituminous Product	Damp Proof Course to Below Lightwell	10 lin m	Some Minor Damage	Difficult	Chrysotile	Previously Sampled	Very Low	Manage
Euston Tower, Basement, B.06 Store Room	F971/VR537	Putty	Putty to Emergency Lighting Unit to Soffit	1 no	Some Minor Damage	Difficult	Chrysotile	Previously Sampled	Very Low	Manage
Euston Tower, Basement, B.13 Pump Room	AS F971/S037 F971/VR533	Cement Product	Durasteel Fire Door	2 no	Some Minor Damage	Easy	Chrysotile	Previously Sampled	Very Low	Manage
Euston Tower, Basement, B.13 Pump Room	F971/VR542	Woven Material	Within Electric Boxes	4 no	Some Minor Damage	Difficult	Chrysotile	Previously Sampled	Low	Manage

Sample Number:	F971/VR531		
Building:	Euston Tower	Floor:	Basement
Room Name/Number:	B.05 Main Switch Room	Material/Amount:	Woven Material 4 no
Sample Description:	Within Electric Boxes

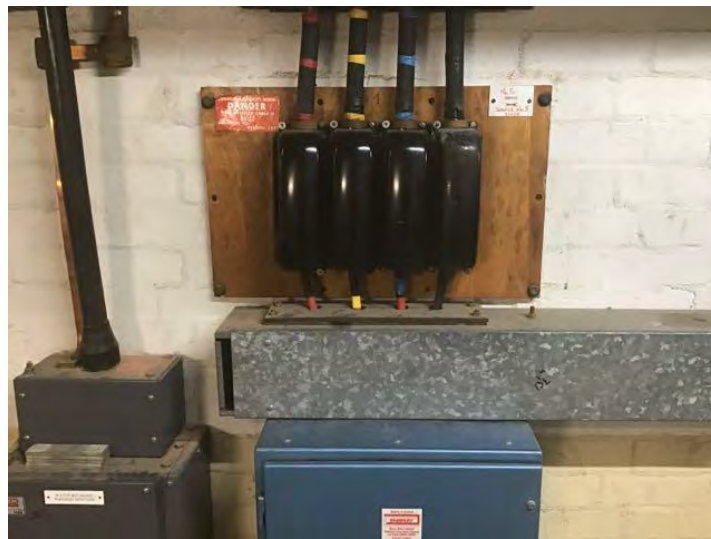
Sample Number:	F971/VR530		
Building:	Euston Tower	Floor:	Basement
Room Name/Number:	B.05 Main Switch Room	Material/Amount:	Thermoplastic 4 no
Sample Description:	Bakelite Covers

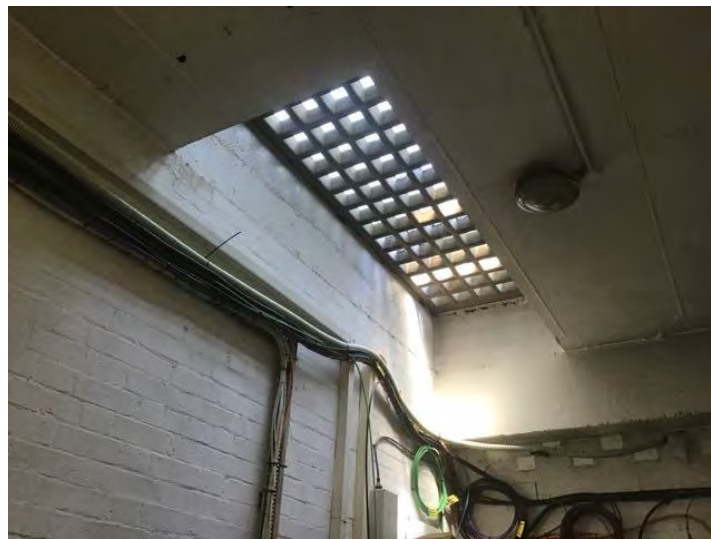
Sample Number:	F971/VR532		
Building:	Euston Tower	Floor:	Basement
Room Name/Number:	B.06 Store Room	Material/Amount:	Bituminous Product 10 lin m
Sample Description:	Damp Proof Course to Below Lightwell

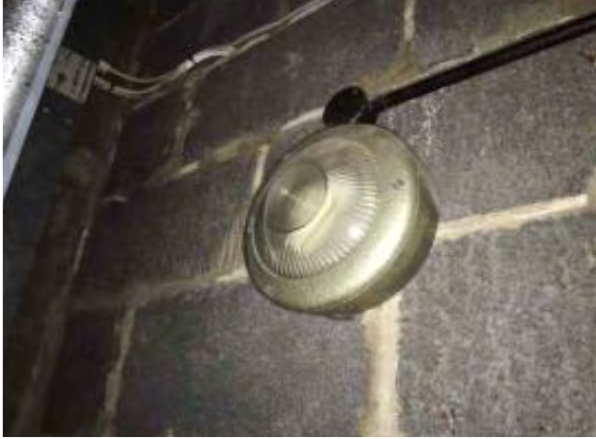
Material Assessment			
Product Type:	Putty	Total Risk Score:	3
Condition:	Some Minor Damage	Risk Category:	Very Low
Surface Treatment:	Composite/Self Sealed		
Asbestos Types:	Chrysotile	Action:	Manage
Comments:	As confirmed with the client/representative, this area was locked, and keys were not available at the time of the survey.

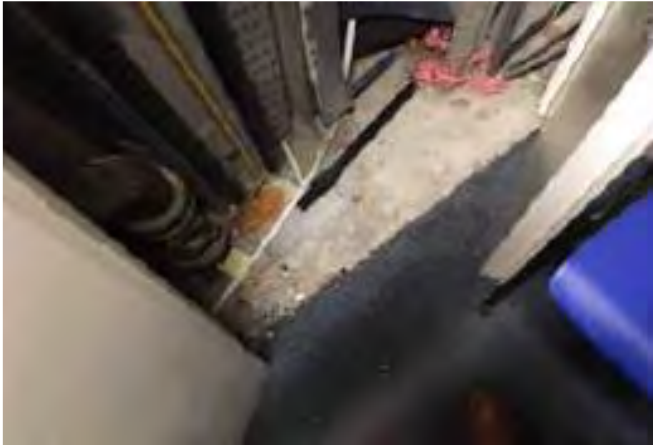
Material Assessment			
Product Type:	Insulating Board	Total Risk Score:	9
Condition:	High Damage/Debris	Risk Category:	Medium
Surface Treatment:	Unsealed AIB/Sealed Lagging		
Asbestos Types:	Amosite	Action:	Remove
Comments:	<p>As confirmed with the client/representative, this area was locked, and keys were not available at the time of the survey.</p> <p>Remove this ACM using a licensed asbestos contractor.</p> <p>Until then, do not disturb. Ensure all employees, contractors & tenants who may come into contact with this ACM are made aware.</p>

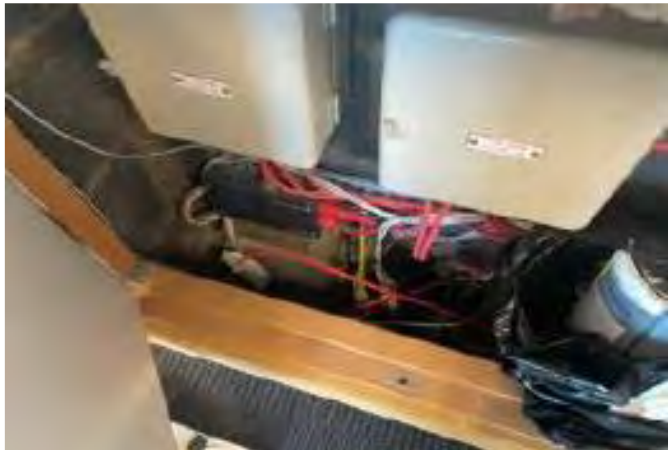
Material Assessment			
Product Type:		Total Risk Score:	7
Condition:	High Damage/Debris	Risk Category:	Medium
Surface Treatment:	Unsealed AIB/Sealed Lagging		
Asbestos Types:	Amosite	Action:	Remove
Comments:	<p>Remove this ACM using a licensed asbestos contractor.</p> <p>Until then, do not disturb. Ensure all employees, contractors & tenants who may come into contact with this ACM are made aware.</p>
