Dilapidation Report

Site: **Euston Tower**
 Address: **Regents Place, Euston Road, London**
 Date: **02/11/2021**
 Engineer(s): **Sam Noakes, Ben Spink**

We have been asked to carry out investigation works into the current state of the system and rectify faults where possible. The System is a 10 panel Gent Sentri/SMS network in a 38-storey building which is being stripped back to shell & core with no occupied areas except for the retail units on the ground floor –all of which have their own systems.

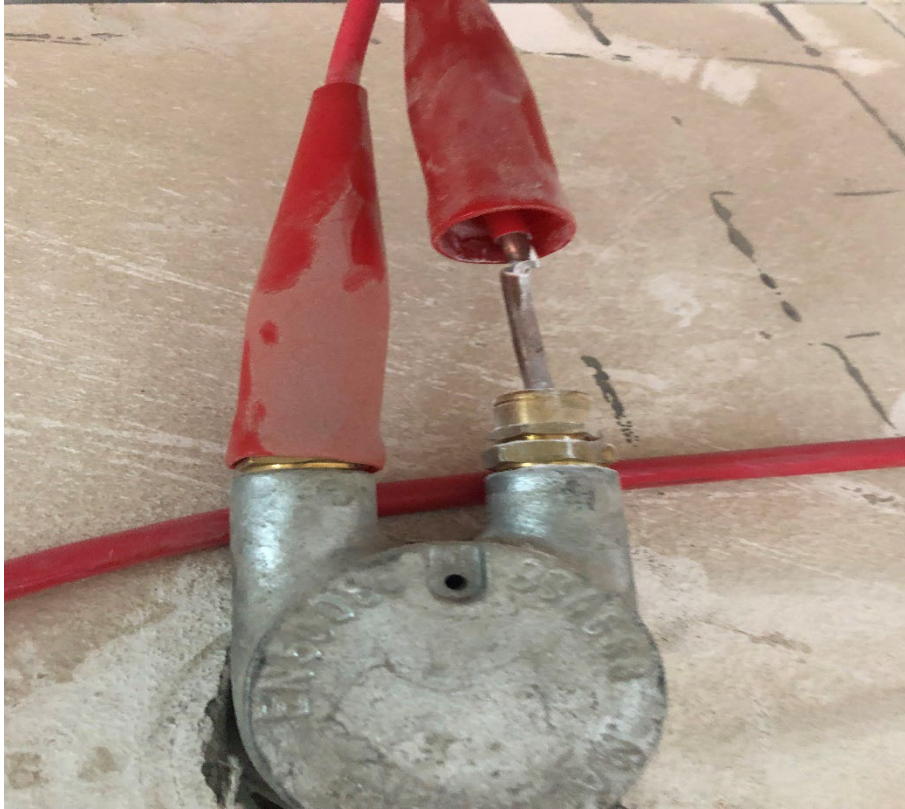
Damaged pyro causing short circuit on level 32

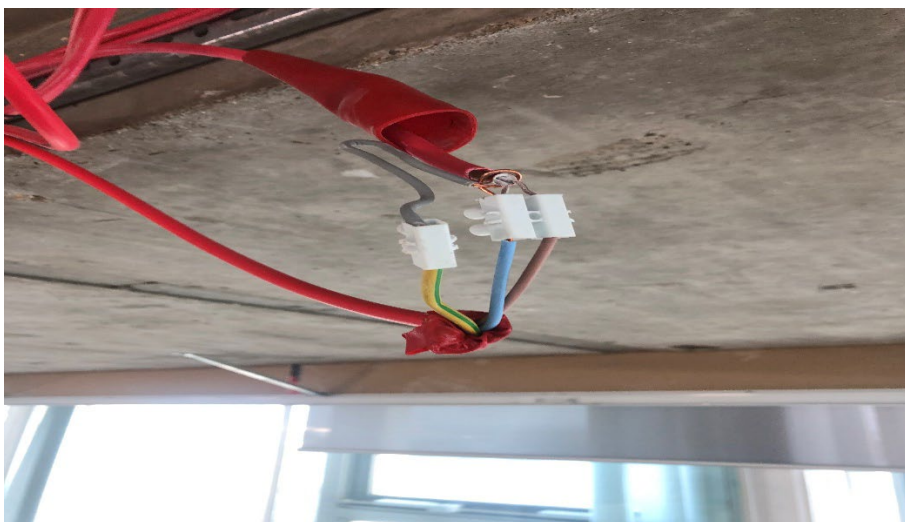
Pyro joint causing short circuit due to earth link touching both pairs

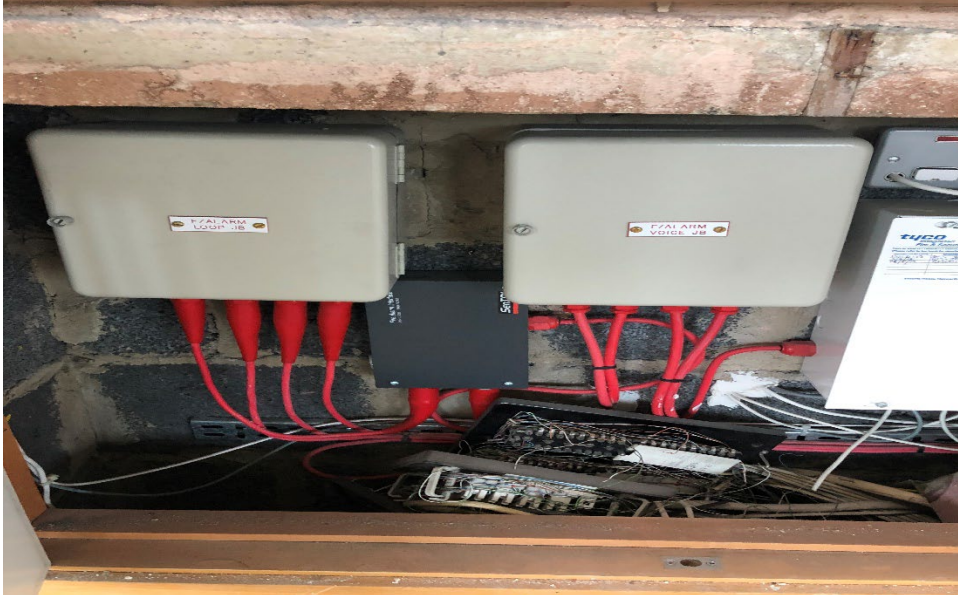
Joint boxes for both VA/FA located in risers from levels 21 – 34, loops could be strip back to these risers.

We propose a strip out of all existing fire alarm and PA/VA systems back to the south core comms riser (as per levels 21 upwards). Once all cabling has been stripped back to the core, we then re cable using FP200 gold a minimal system consisting of devices leading to fire exits, covering of risers and flue like structures.

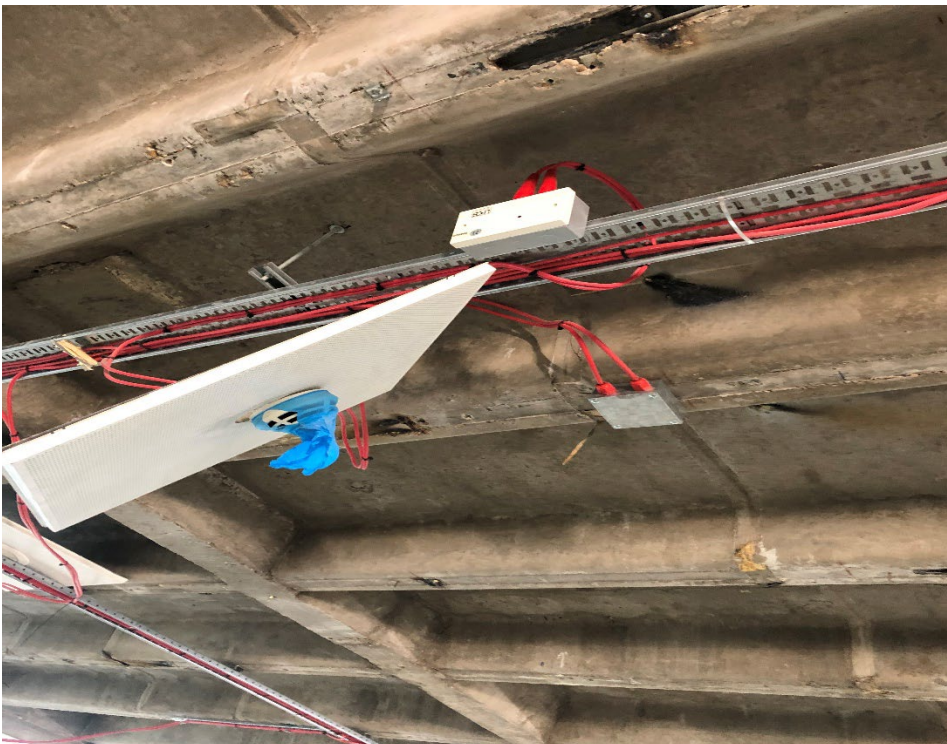
Multiple joint boxes and old zone isolators across all floors.

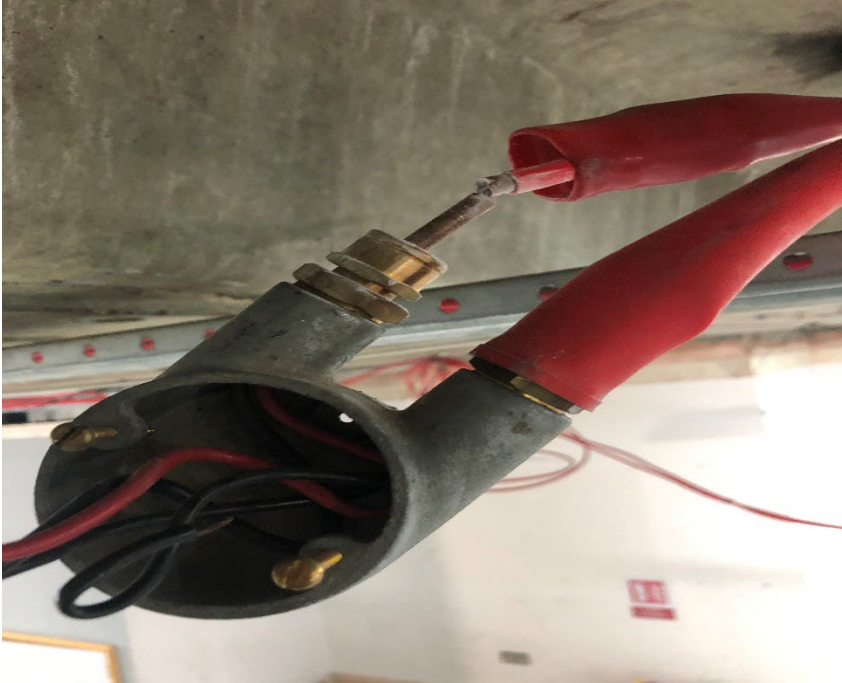
Pyro cable damaged causing short circuit on loop, Level 28

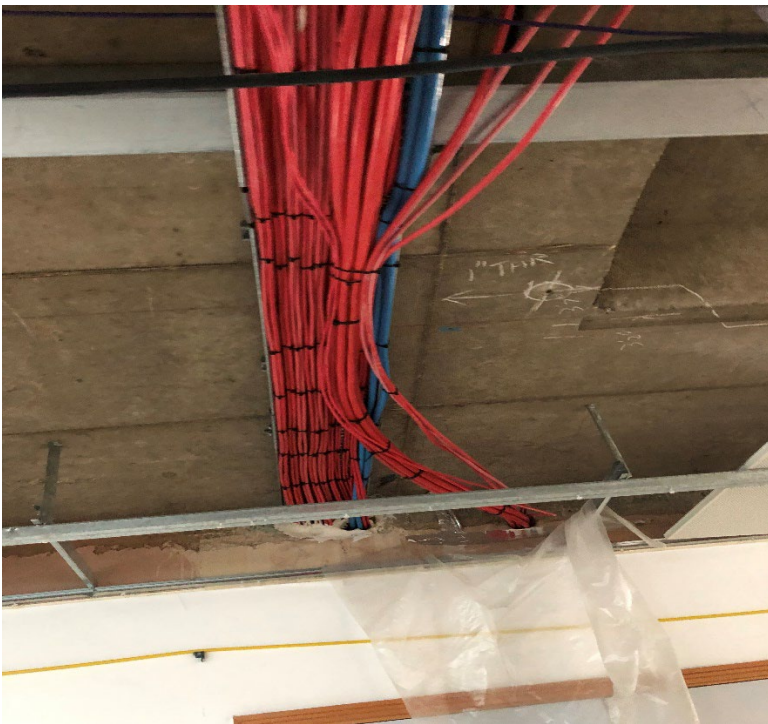
Level 24 multiple cables running through the floor to old VA rack now being used as a joint box

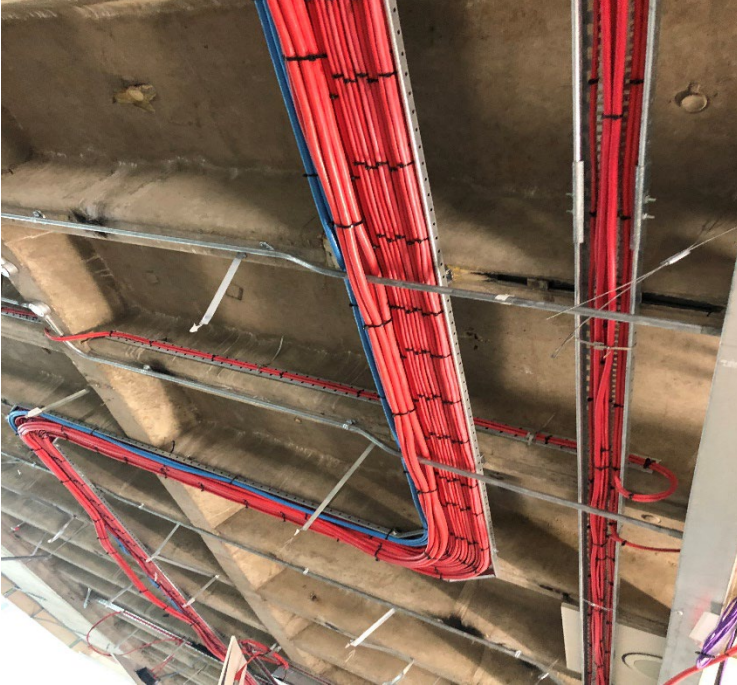
Level 24 multiple cables running through the floor to old VA rack now being used as a joint box

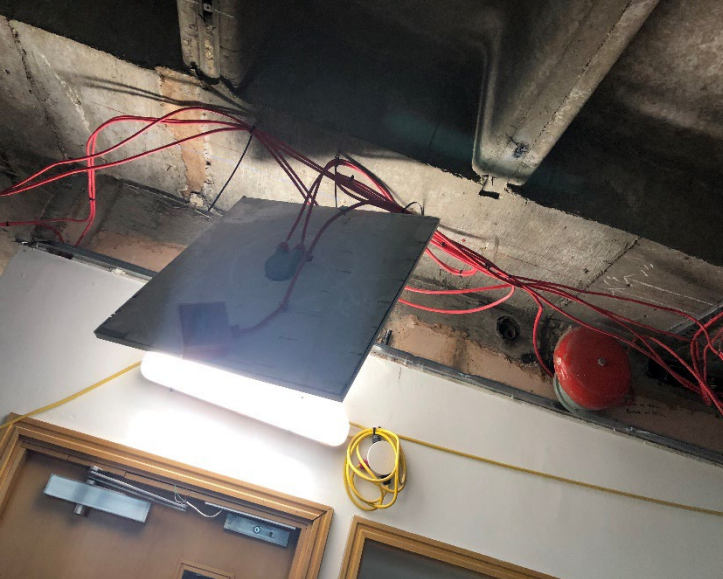
Old Cabling / mcp from previous system.

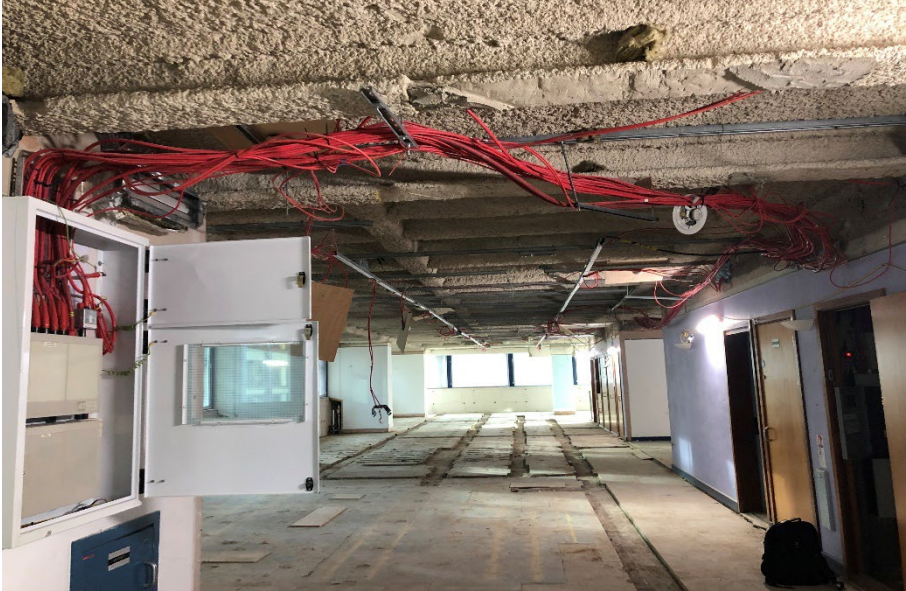
Level 3 – Old FA system panel used as JB to feed loops for new gent system / panel in adj riser.

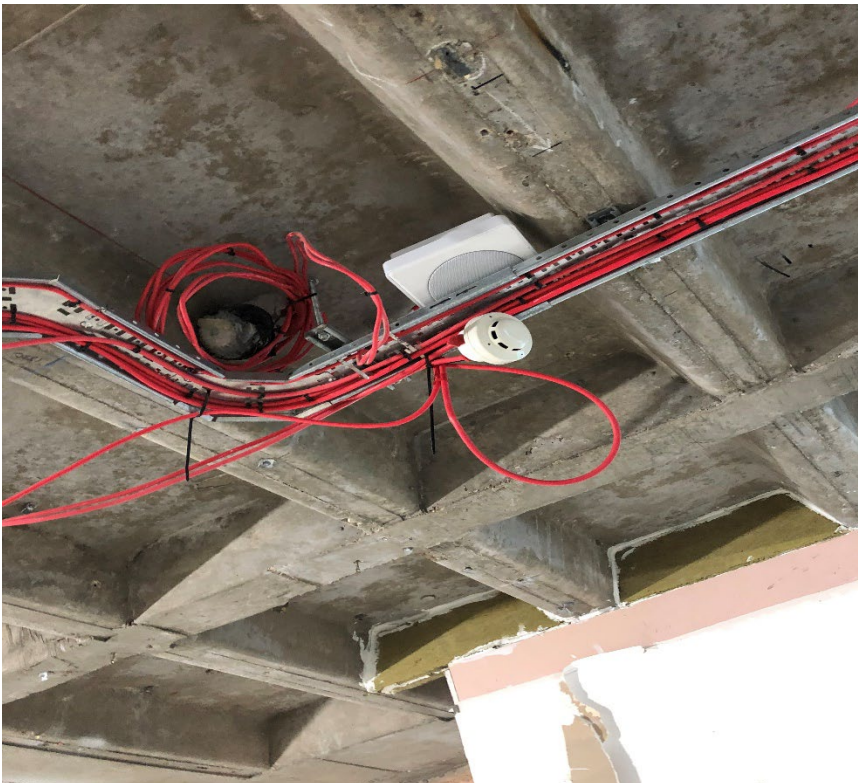
Old Cabling / Smoke from previous system.

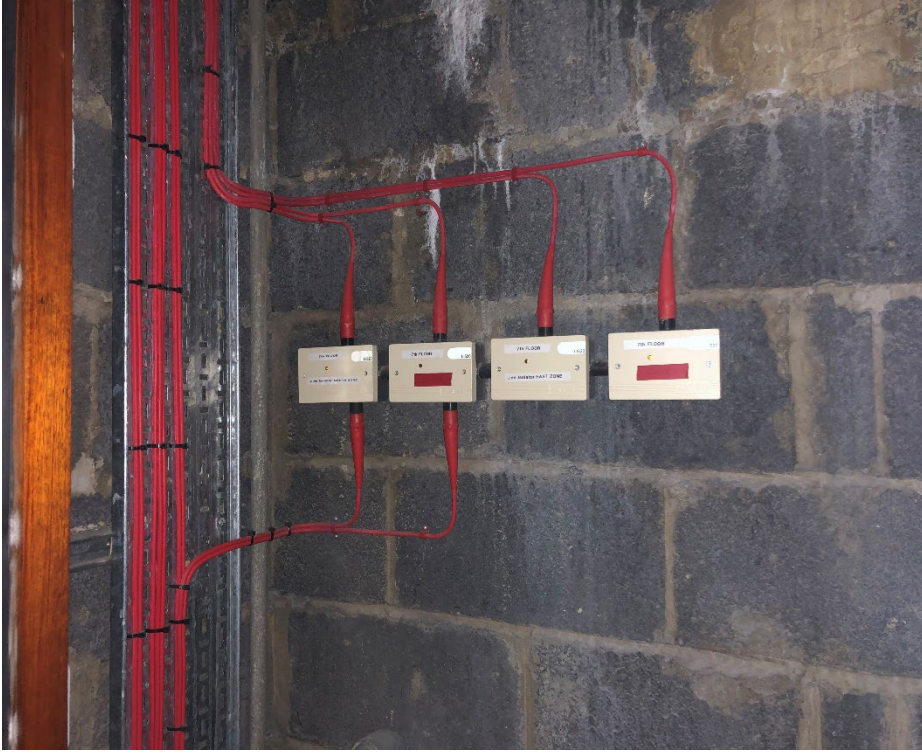
Isolators from old risers installed on most floors as using as feed wiring for the loops on each floor.
