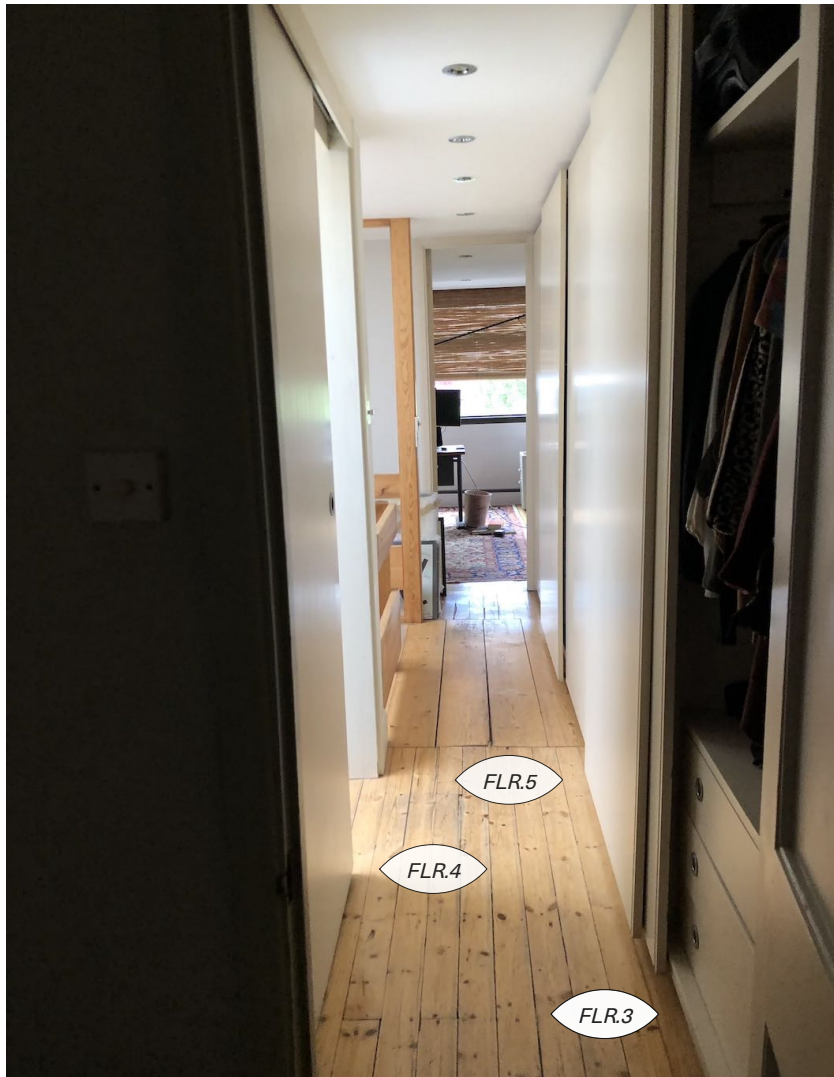
View of the existing Second Floor timber floor viewed from the Rear Elevation Bedroom.

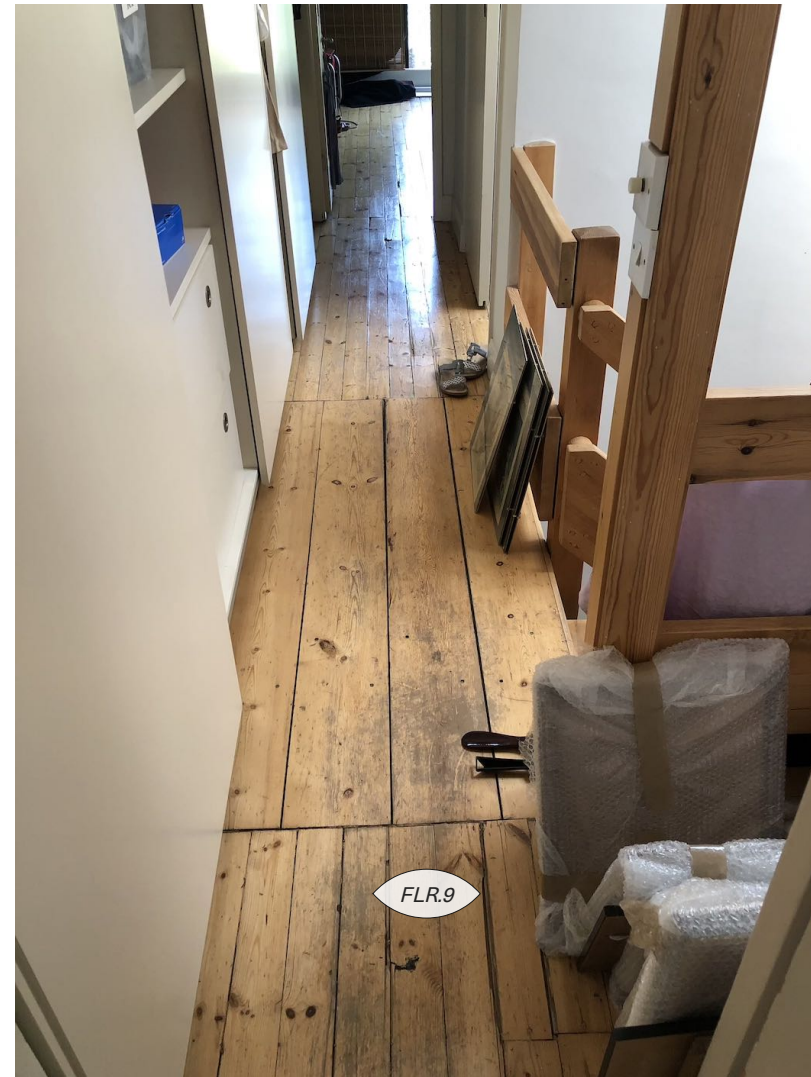
View of the existing Second Floor timber floor viewed from the Front Elevation Study Room.

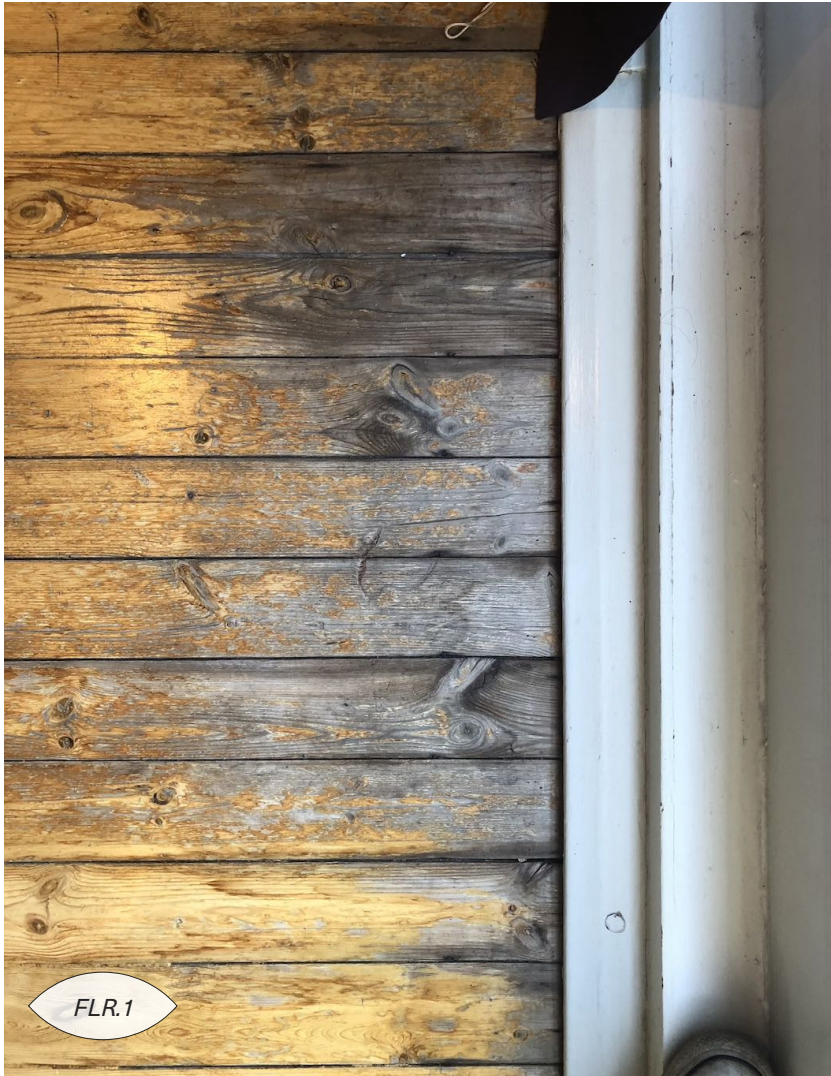
View of the existing condition to the second floor threshold area to balcony - water damage

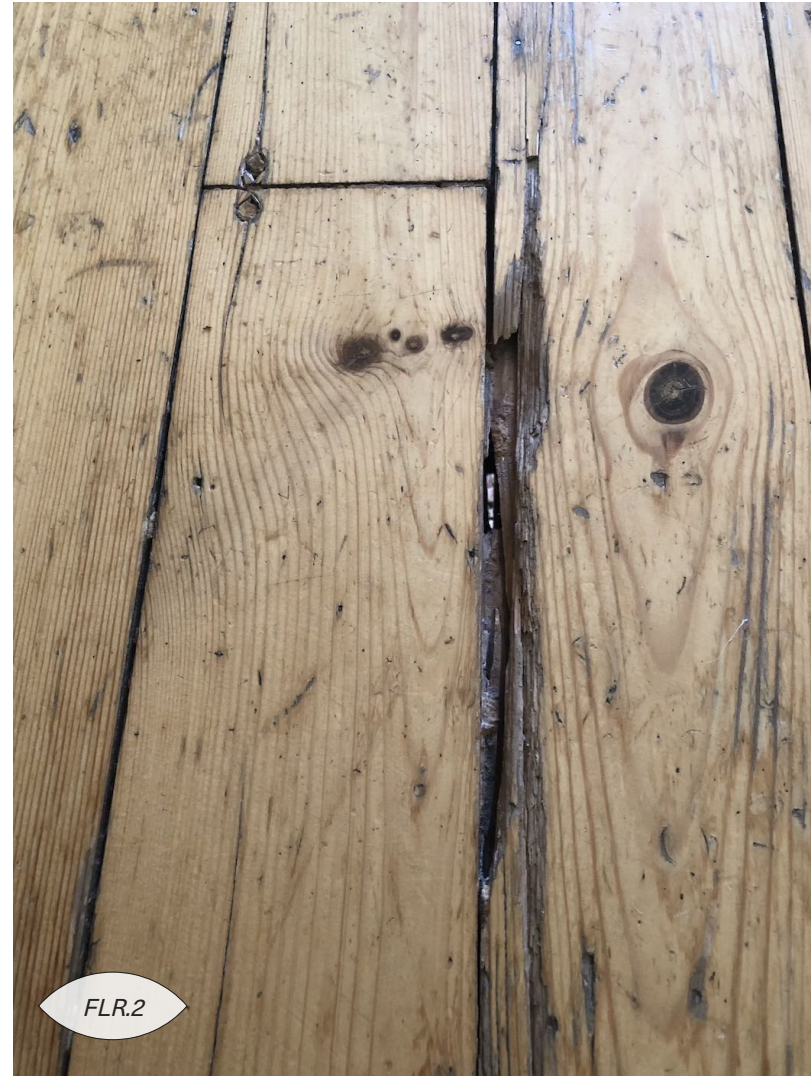
View of the existing Second Floor timber floor viewed the bedroom - visible hole through

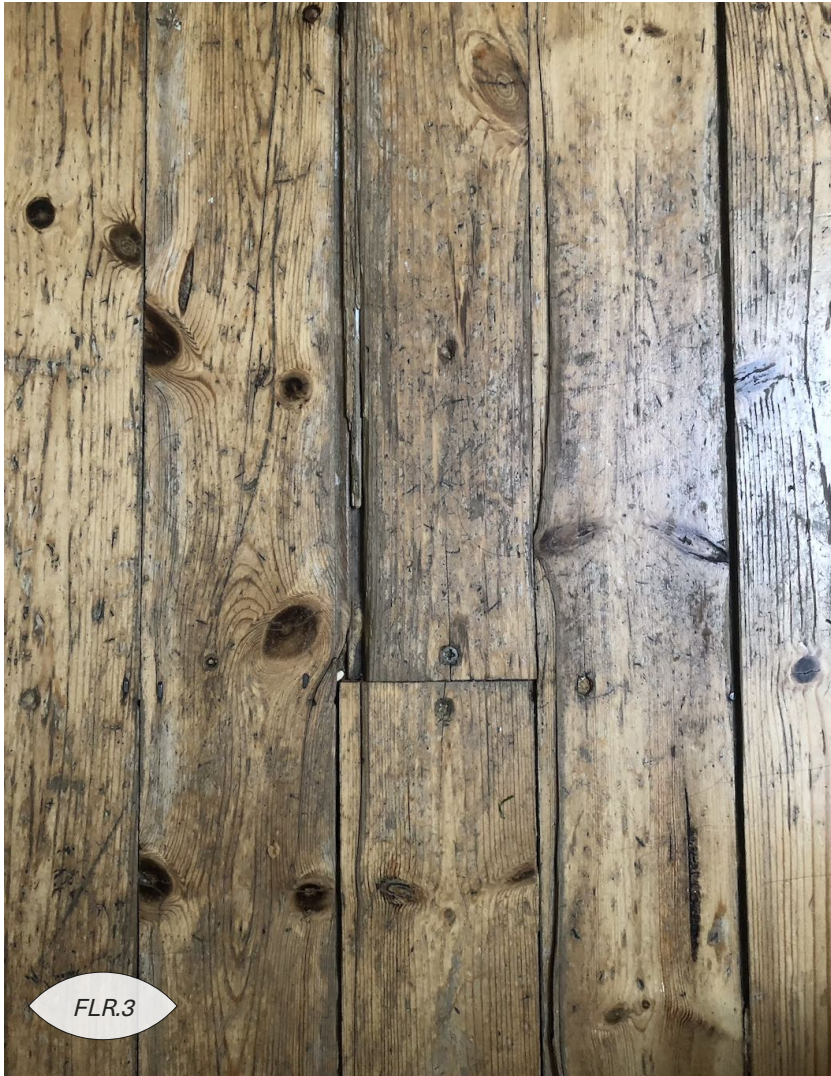
View of the existing condition to the second floor hallway

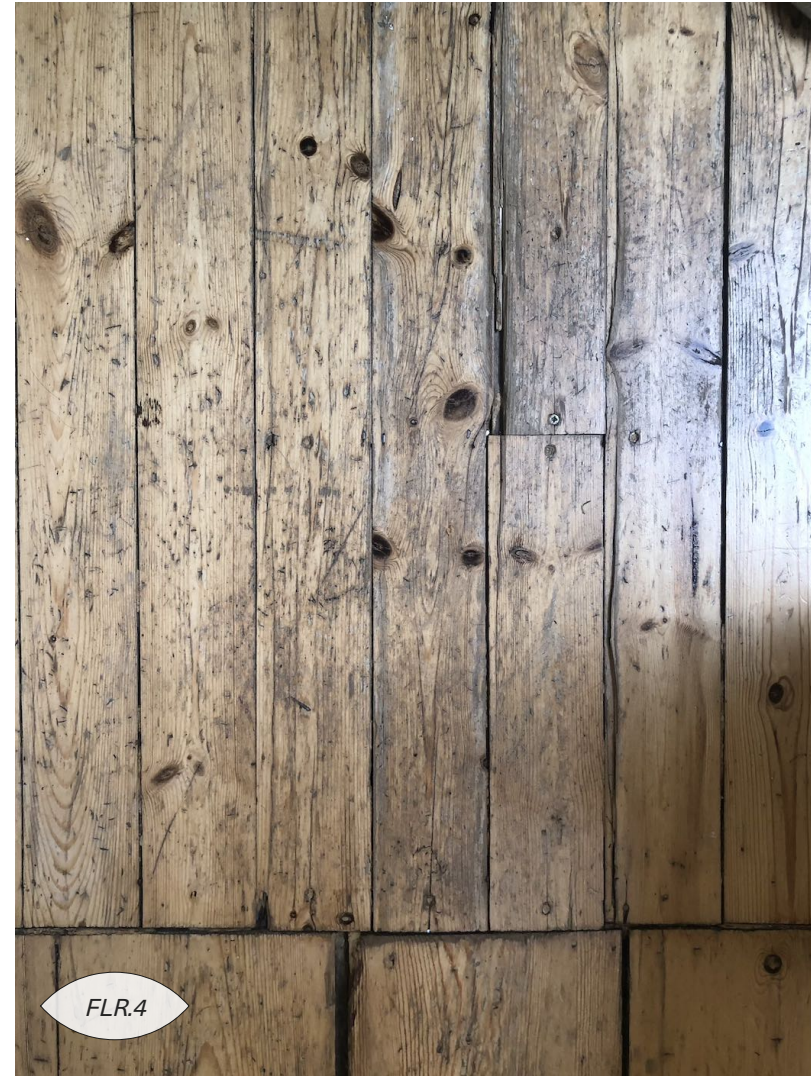
View of the existing Second Floor timber floor hallway adjacent to landing

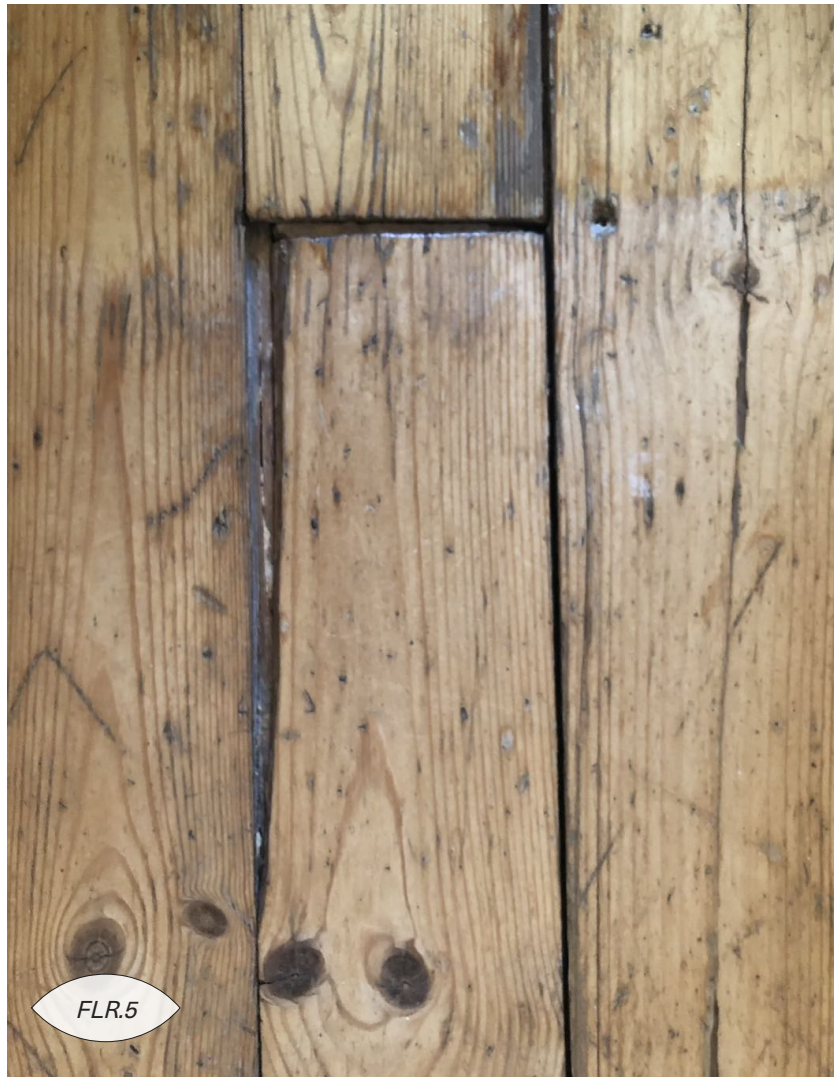
View of the existing condition to the second floor hallway

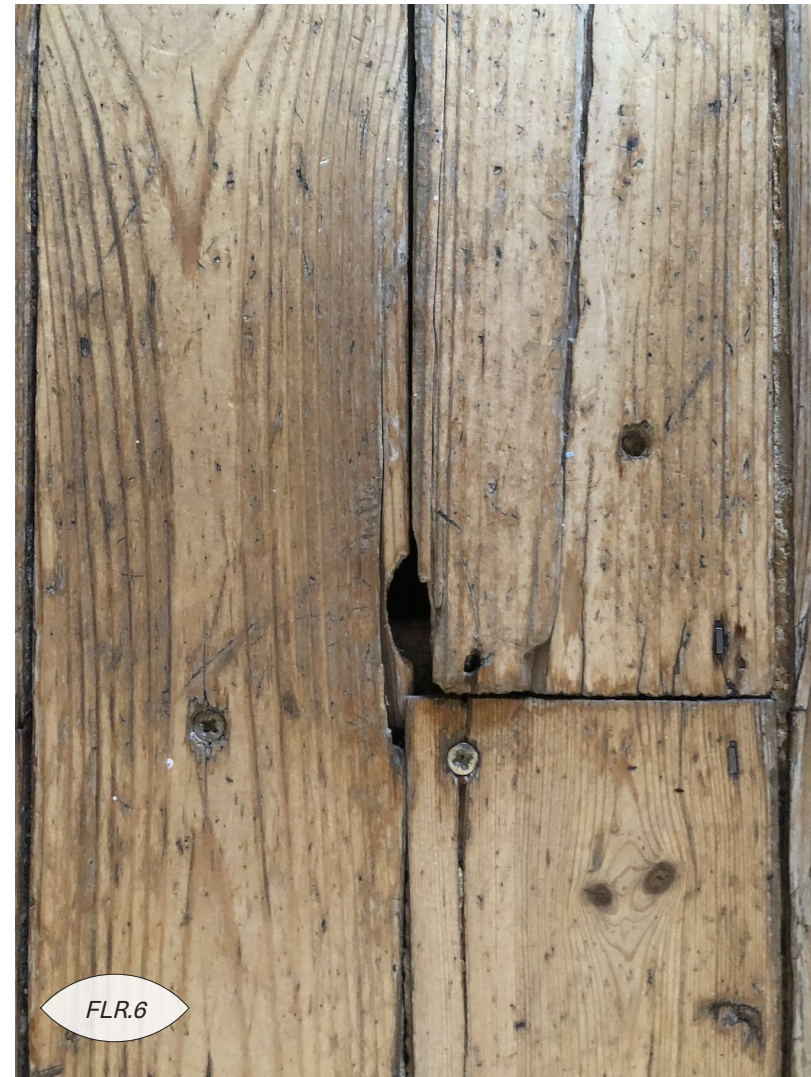
View of the existing Second Floor timber floor hallway adjacent to landing

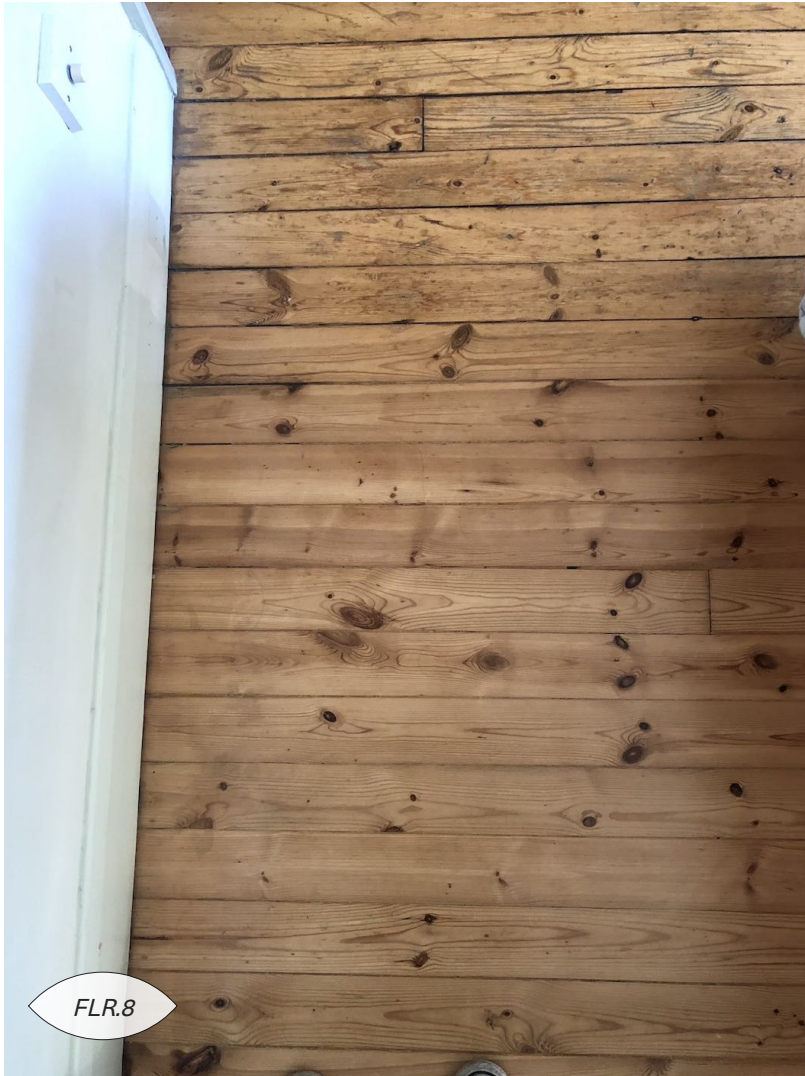
Area of previously replaced flooring to the bedroom (lower half of image)

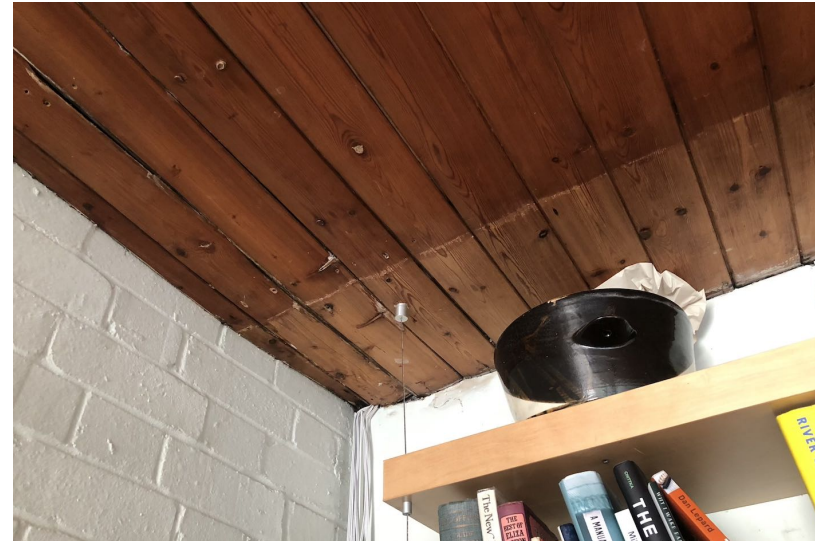
View of the existing First Floor ceiling - water damaged areas from the bathroom above

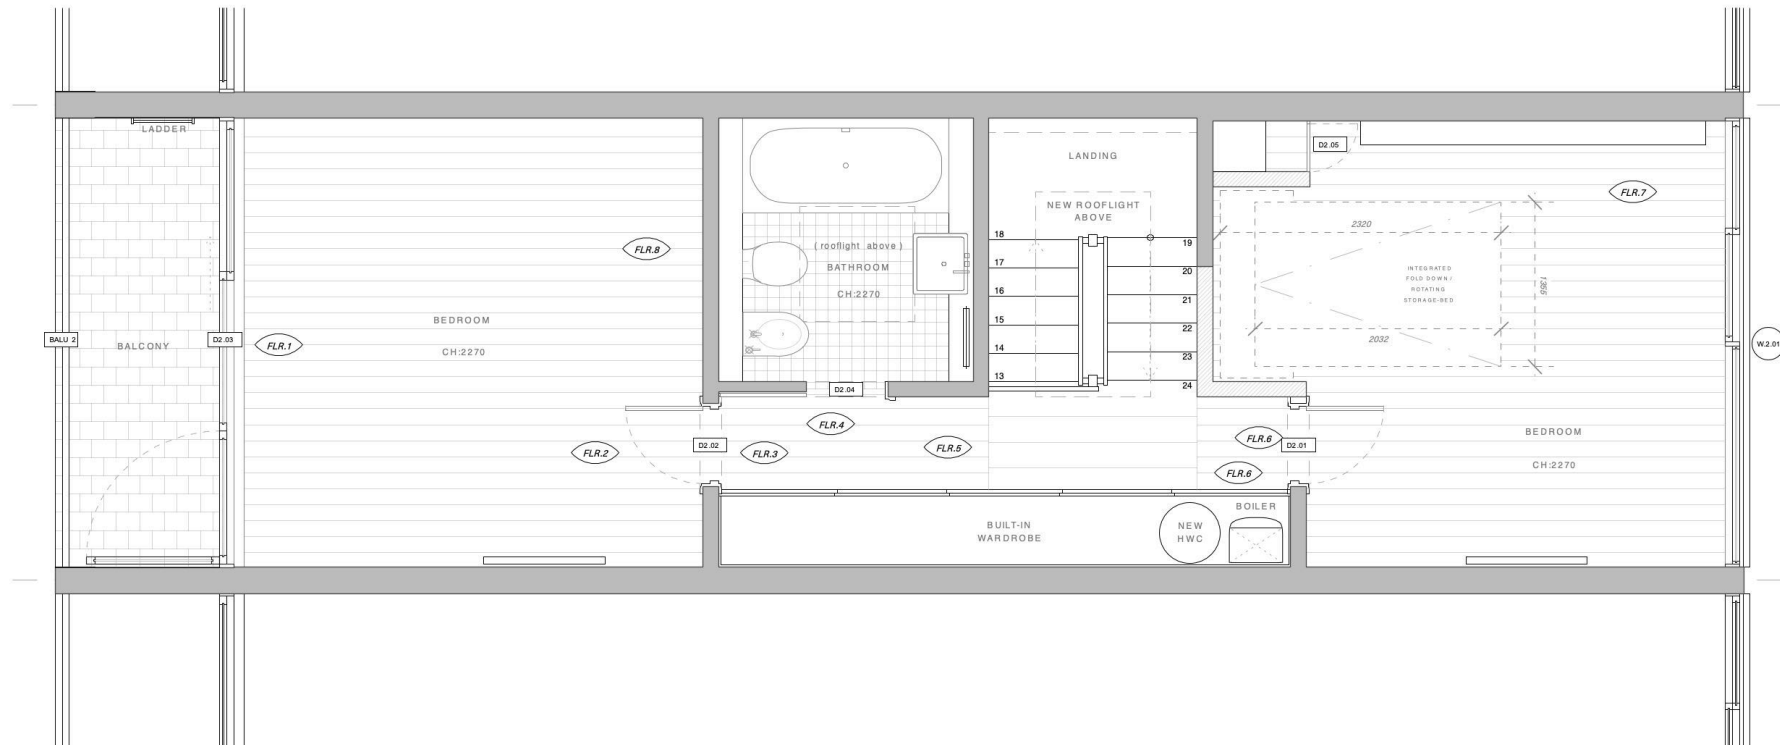
Reference Plan for Floor Condition Photos on previous pages: Please note **FLR.7** indicates an area of flooring with significant movement. A video record of this flooring defect is available.
