1. Case Details Insured Gilling Court Address Flat 26 & Common Areas, Gilling Court, Belsize Court, Hampstead, NW3 4UY Client Subsidence Management Services Contact Stephan Barnes Claim No. ES Ref Consultant Andrew Cayley Contact No.

Gilling Court, Belsize Grove, London, NW3 4UY

ITP/BH1 Foundation Detail and Borehole Log

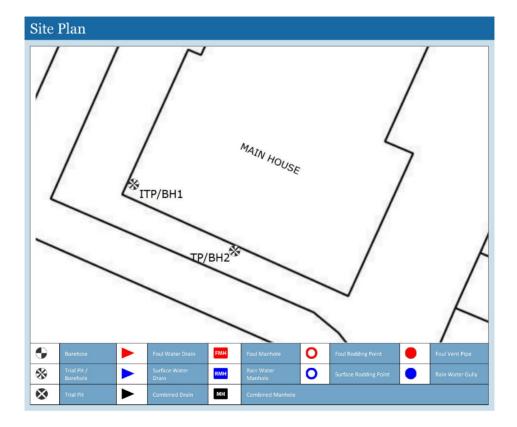
House wall foundation comprised of brick wall to 300mm bgl, bearing on stepped brickwork to 500mm bgl with a total projection of 100mm from the elevation. In turn, bearing on concrete to 900mm bgl with a total projection of 300mm from the elevation. Underside of foundation (USF) was exposed to 100mm back from the face of the foundation and probed 350mm back from the face of the foundation.

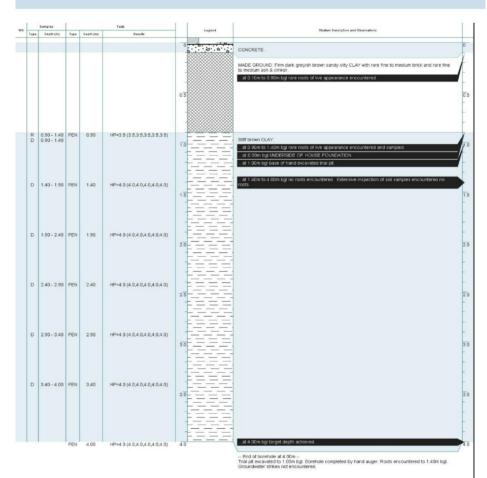
TP/BH2 Foundation Detail and Borehole Log

House foundation comprised of brick wall to 150mm bgl, bearing on stepped brickwork to 300mm bgl with a total projection of 120mm from the elevation. In turn, bearing on concrete to 900mm bgl with a total

projection of 200mm from the elevation. Underside of foundation (USF) was exposed to 100mm back from the face of the foundation and probed 300mm back from the face of the foundation.

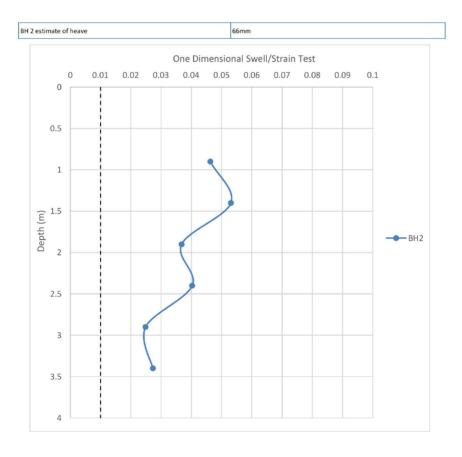
Summary of Oedometer Testing for BH2

Lab Ref Depth (m) Strain Heave (mm) Remarks 0.9 0.0463 20.8 13.3 1.9 0.0368 9.2 10 2.4 0.0403 10.1 0.0249 0.0273
