Site Investigation Report

Job Information	
Client	[Redacted]
Client ref	[Redacted]
Visit date	31/10/2022
Report date	03/11/2022

Auger were commissioned by Questgates to undertake a site investigation and CCTV inspection of the underground drainage within the area of concern (AOC) at the property.

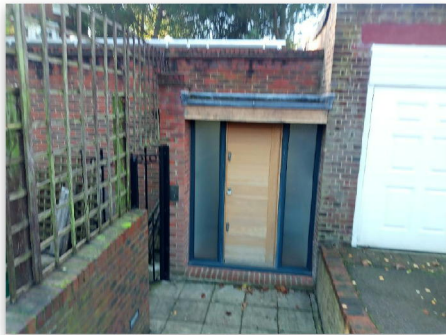
Fig 2.1: Trial Hole 2 Location

TH2 was completed in the proposed location and revealed the footing. Soil and root samples were taken. Within TH2 we also took readings from the garage wall, these measurements can be shown in trial hole log 2b below

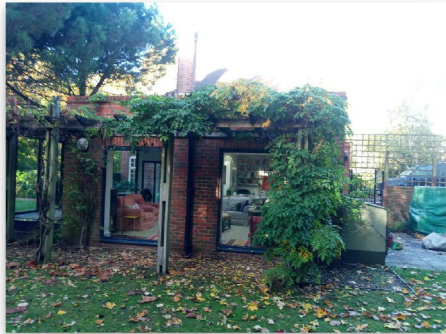
Fig 3.1: Trial Hole 3 Location

TH3 was completed in the proposed location and revealed the footing. Soil and root samples were taken.

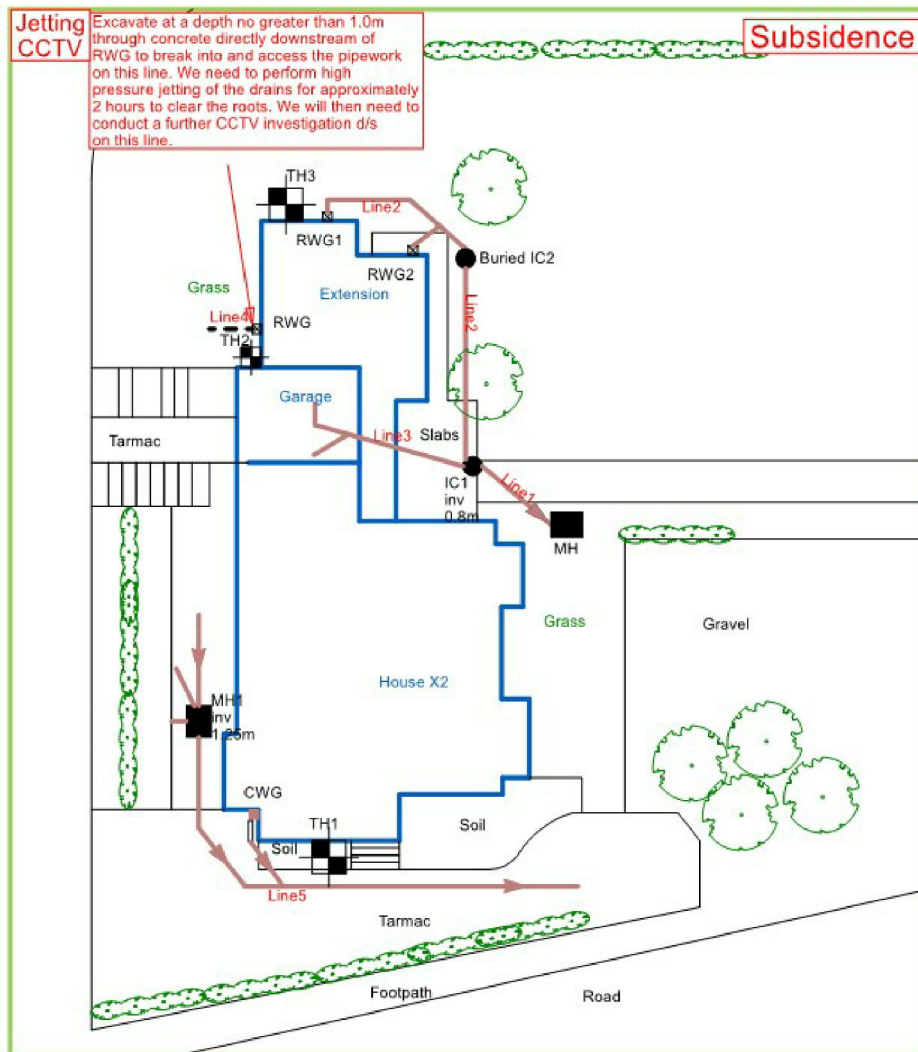
We were unable to survey line 4 properly due to severe root ingress within the pipework.

We were unable to complete a full CCTV survey of line 4 due to an unknown blockage in the pipework.

Recommendations	
Refer Back to Client	<p>It is recommended that the following further investigation works are carried out to confirm the condition of all pipework at the property:</p> <p>Line 4 Excavate at a depth no greater than 1.0m through concrete directly downstream of RWG to break into and access the pipework on this line. We need to perform high pressure jetting of the drains for approximately 2 hours to clear the roots. We will then need to conduct a further CCTV investigation downstream on this line.</p> <p>Please note The further CCTV investigation may reveal additional defects to the drainage system. This will be reported whilst on-site and could potentially cause an increase in repair costs and provide further inconvenience to the customer/occupants.</p> <p>We will now refer the claim back to the client in order to progress the claim.</p>
	<p><i>Once repairs have been undertaken the customer should ensure the drainage system is periodically inspected in the future for any deterioration and kept free flowing / free of blockages. Any damage noted during future inspections should be repaired immediately in accordance with current Building Regulations.</i></p> <p><i>With any repair process, complications and unforeseen circumstances can arise. These scenarios will be reported whilst on-site and could potentially cause an increase in repair costs and inconvenience.</i></p> <p><i>If any of the above lining recommendations fail then excavation and replacement of the pipework would be required. This would severely increase the cost of repairs and would provide greater inconvenience to the residents.</i></p> <p><i>Recommendations have been made to reline or patch reline sections of the drainage system at the property. This process combines a number of chemicals in a resin, which then harden in a fibreglass matting to create a new section of drain within the original. The reaction creates a strong smell which can linger for up to 72 hours once works are completed - this is not harmful. It is recommended that any areas where smells are experienced are kept well ventilated until the odour subsides.</i></p>

Excavate at a depth no greater than 1.0m through concrete directly downstream of RWG to break into and access the pipework on this line. We need to perform high pressure jetting of the drains for approximately 2 hours to clear the roots. We will then need to conduct a further CCTV investigation d/s on this line.

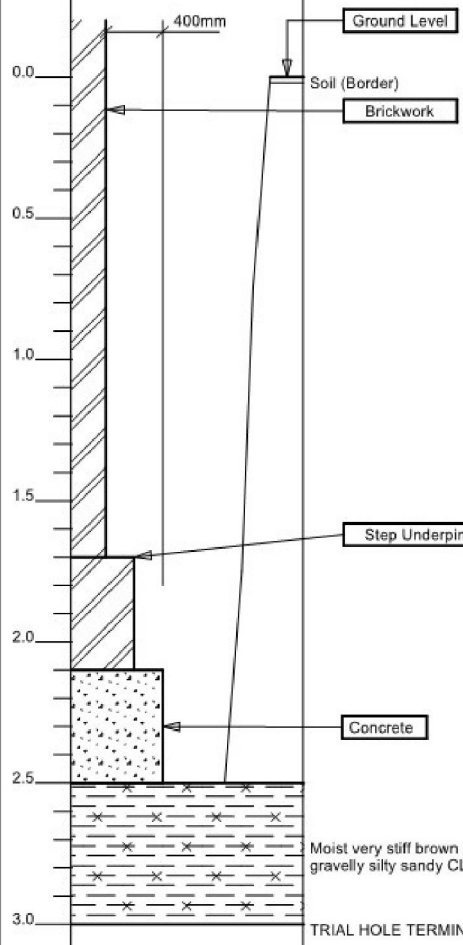
Trial Hole Log No.1

TH1 was completed in the proposed location and reached the required depth, soil and root samples were taken. The footing was determined by probing to a depth below 1m, if deemed necessary we can return with two men to dig a larger hole and fully expose the footing.

Ground Level				
		Soil (Border)				
0.5		Brickwork				
1.0						
1.5		Step Underpinned				
2.0						
2.5		Concrete	82kpa		Soil @ 2.5m	Root @ 2.5m
3.0		Moist very stiff brown slightly fine gravelly silty sandy CLAY				
		TRIAL HOLE TERMINATED	88kpa		Soil @ 3m

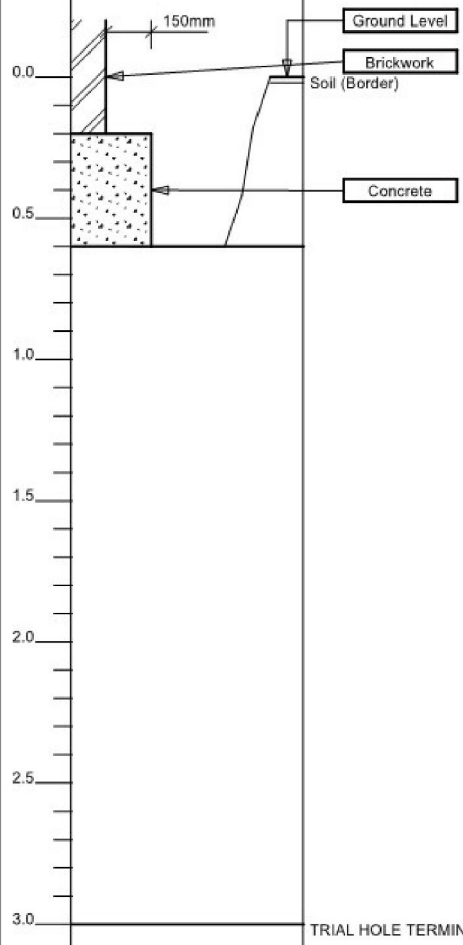
Trial Hole Log No.2b

Ground Level				
		Brickwork				
		Soil (Border)				
0.5		Concrete				
1.0						
1.5						
2.0						
2.5						
3.0		TRIAL HOLE TERMINATED
