Surveying Services

TYPE: PRELIMINARY REPORT
CLAIM: Domestic Subsidence

POLICY No: [REDACTED]
INSURER Ref: [REDACTED]
QG Ref: [REDACTED]
NAME & ADDRESS OF INSURED: [REDACTED]
34 Heath Drive, London, NW3 7SD
SITUATION OF LOSS: 34 Heath Drive, London, NW3 7SD
VAT STATUS OF INSURED: Not Registered
DATE OF LOSS: 15 August 2022
CIRCUMSTANCES/CAUSE: Subsidence
RESERVE: [REDACTED]

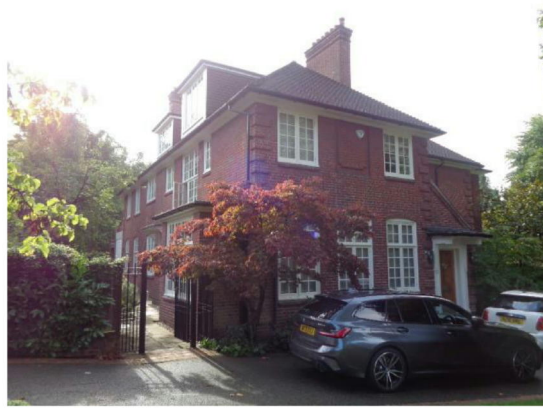
Front Elevation of Property

The risk address comprises a three storey, detached house which appears to have been originally constructed circa 1920.
