Alexandra Road Estate Heating Infrastructure

Technical Report | Feb 2020

In August 2019 Camden Council brought together a team to carry out a qualitative and quantitative review of the current heating infrastructure and evaluate which areas could be retained and re-used and which areas would require replacement and/or repair. This included a review of the heritage, visual, mechanical, technical and practical implications.

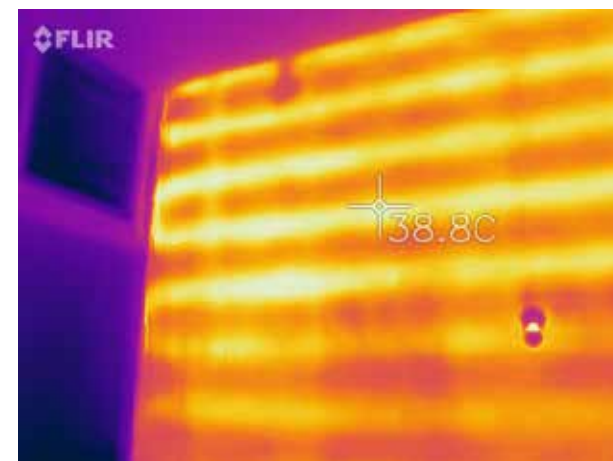
The heated walls were designed to have a surface temperature of 38°C and have been observed to still operate at this temperature. Figure 3.7 shows the recorded temperature of the wall in winter of 2019, seen through a thermal imaging camera.

Figure 3.7 - Thermal image of a heated wall coil in block A, showing a surface temperature of 38°C

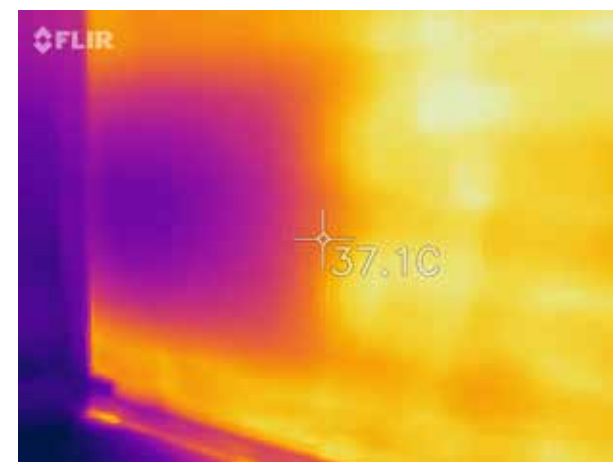
Figure 3.8 - Thermal image of a heated wall coil in block A, showing the link to the tail connections. The cold purple patch shows the unheated area between the tail legs at the top and bottom of the wall.

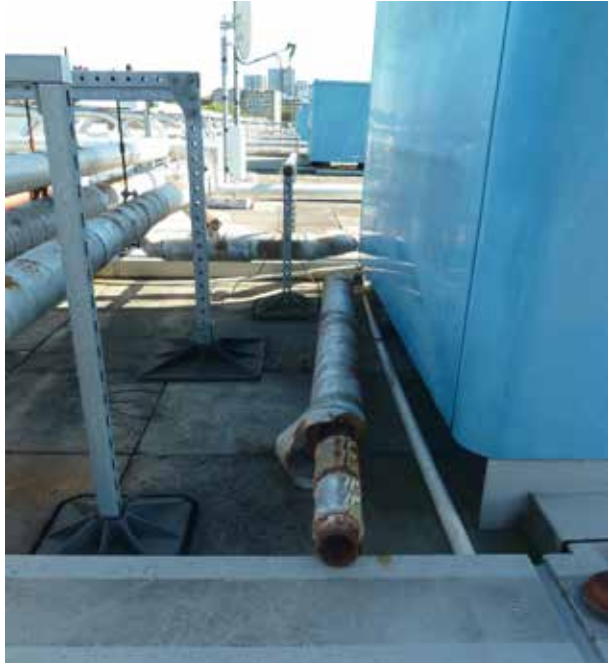
The estate distribution pipework is at the end of its working life. For many years the pipework has suffered from extreme corrosion, furring-up and leaks.

The replacement of the boilers has proved a successful intervention, however, the communal heating pipework that supplies heat across the Alexandra Road Estate is now in need of urgent replacement due to extreme corrosion and risk of catastrophic failure.

Figure 4.0 - Condition of heating pipes located on the roof of Block A

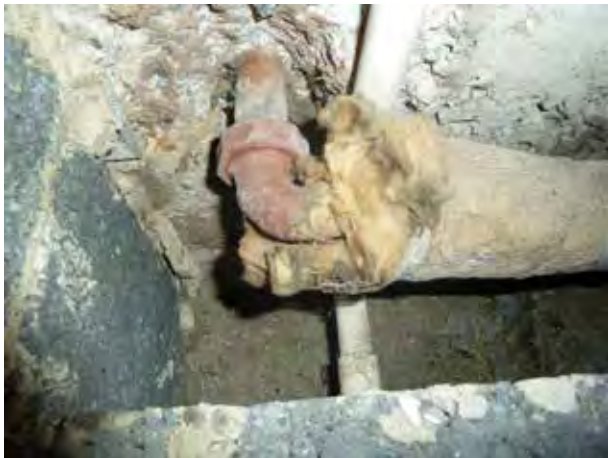
Figure 4.1 - Tail pipe

In some units the coils joint/tail between the network and the heating coils has failed. When this has occurred, the coils have typically been isolated and radiators fitted in the affected homes.

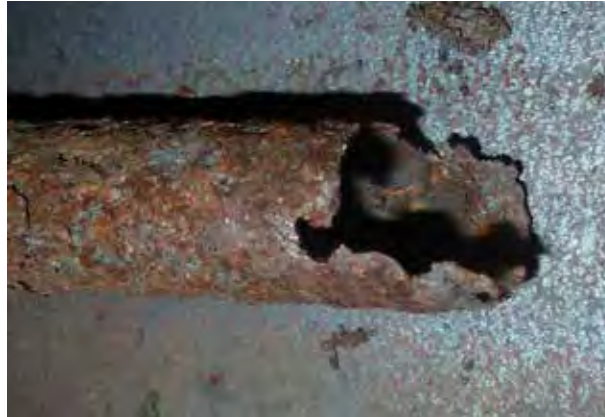
Figure 4.2 - Corroded pipework

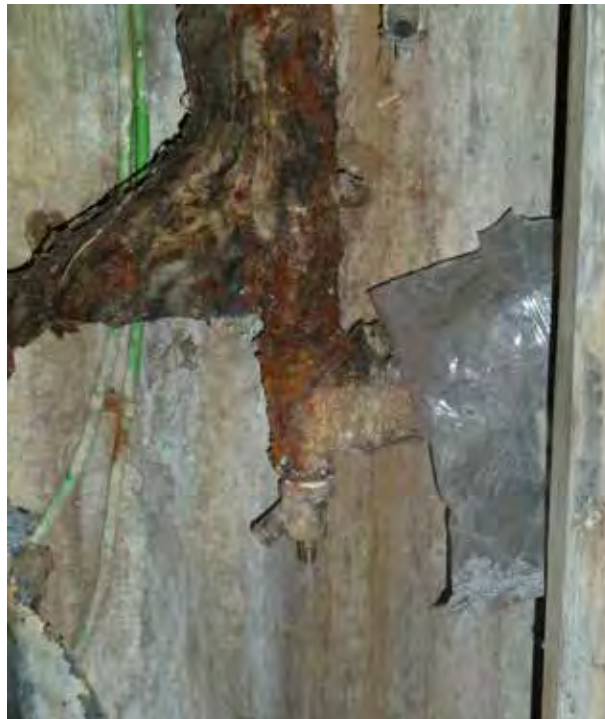
Figure 4.3 - Corroded valve

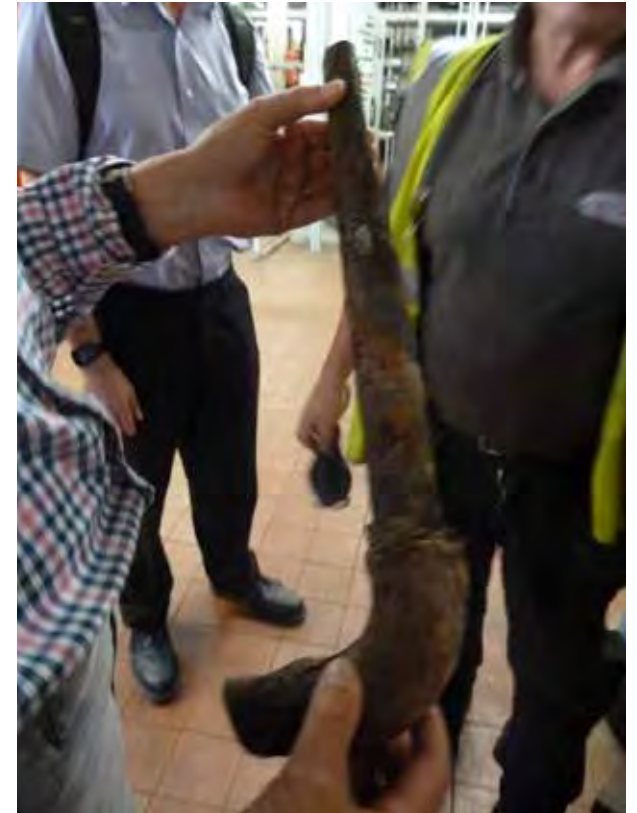
Figure 4.4 - Corroded pipework section

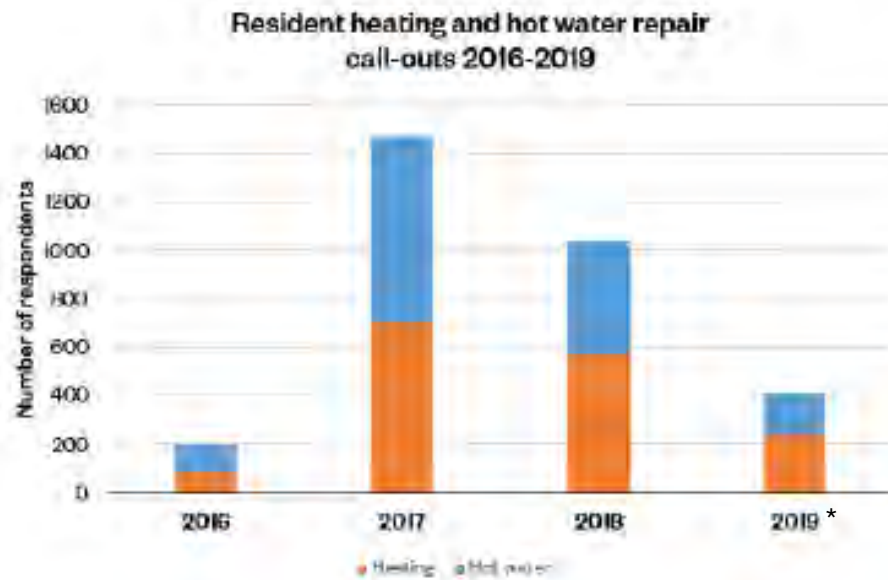
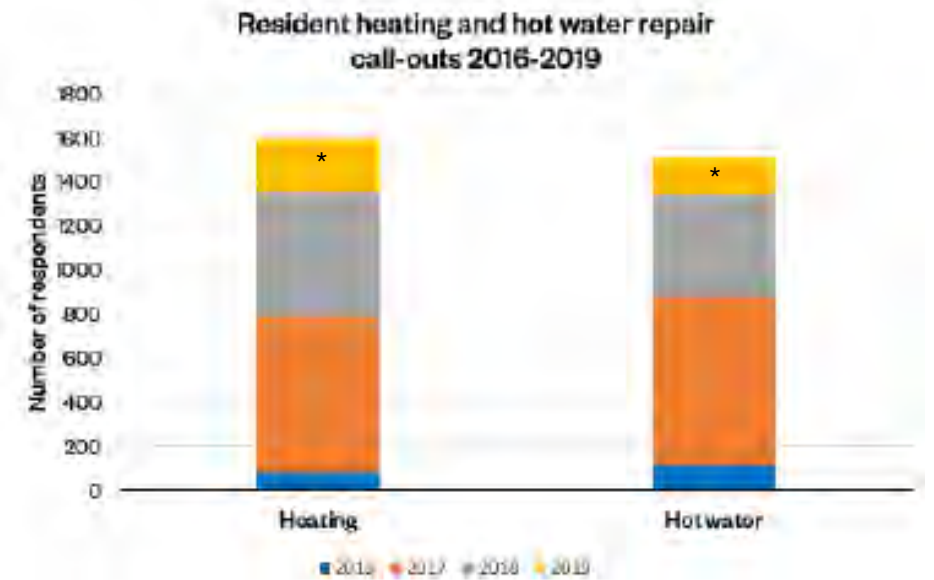
Figure 4.5 - Repair call-out graphs

In 2017 there were over 1,400 call-outs with 1,000 in 2018 across the 520 homes. This highlights the instability of the heat network to provide consistent heating and hot water for residents. It also highlights the urgency of action to reduce the number of failures on the system.

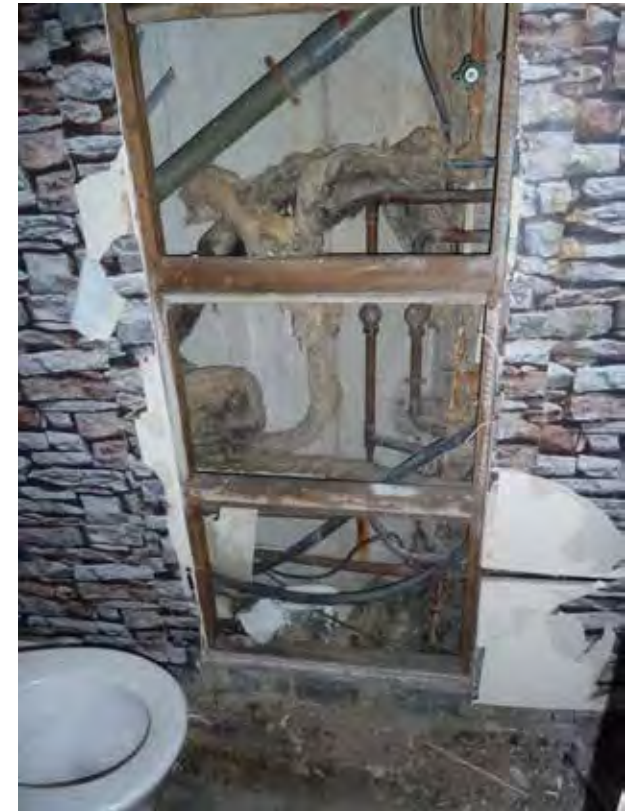
Figure 5.1 - Internal distribution - disruptive access

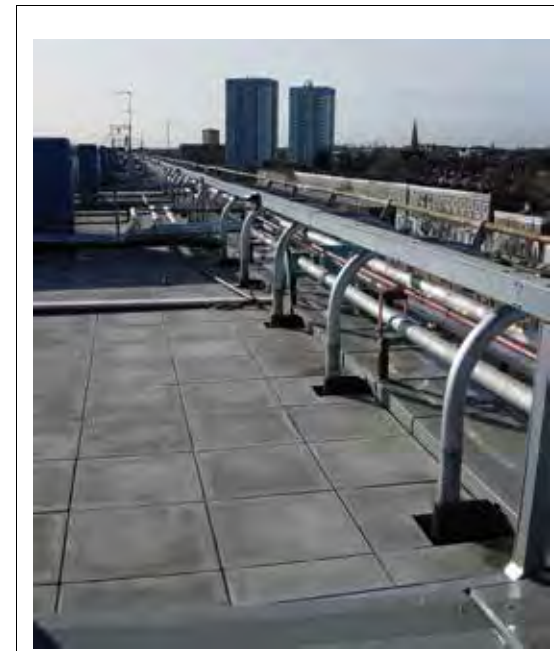
Block A - View looking West showing roof-top pipe work

In Block 'A' VT heating and primary hot water services mains exit the boiler room and run on the underside of the pedestrian bridge towards the Estate Office. They enter the Estate Office at high level then run to the rear, rise up the existing lift shaft and onto the roof of block A. The pipes then run horizontally along the roof of block A as indicated below.

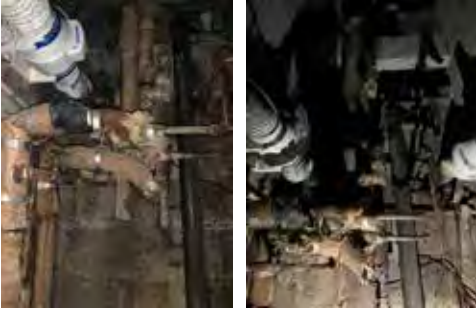
however significant presumably from external corrosion.	
1.3	<p>Inspection of riser pipework and embedded coil tails in an under stair service void supplying dwelling space heating and hot water cylinders Block B</p> <p>1.3.1 The distribution pipework ran in the garages below? Pipework and pipe fittings were generally badly corroded where visible and beneath pipe insulation. The embedded coil tails to the adjacent dwellings could be inspected as they came out of the end of the concrete wall. There is a welded socket on the end of the steel tail into with the connection pipework end is screwed. The ones we inspected had not suffered significant external corrosion possibly because they were hot in winter, not insulated and horizontal as opposed to vertical with pipework above.</p> <p>1.3.2 MF commentary on maintenance and replacement activities based on input from GEM and Camden FM team: Access was reasonable but required working at height within the duct to maintain the upper floor coils. The risers set over at high level within the upper dwelling above the kitchen cupboards to then rise in the higher dwellings within ducts adjacent to the entrance doors. Access is difficult.</p>

1.4	<p>Inspection of distribution pipework on the roof of Block A</p> <p>1.4.1 The main distribution pipework runs across the roof of Block A. It appeared the pipework has already been replaced at least once. The pipework is prefabricated with a thin wall steel water carrier, foam insulation and spiral wound galvanised steel protective cover. The pipework is hung from roof supported hoop brackets will rollers and offsets to accommodate expansion. There were sections of pipe on the roof that has been removed from the system and which had failed. These pipes have failed from corrosion thinning the pipe wall, holing or structural collapse.</p>

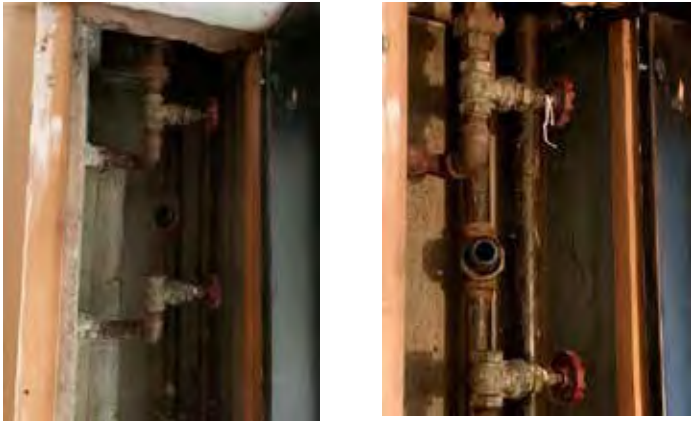
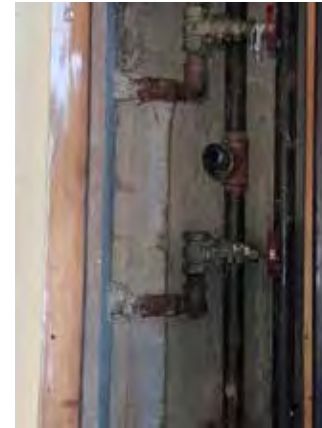
3.1 Coil 2 & 3 Test Disassembled Connections

All 3 coils held the test pressure over the 1 hour period and there were no identified water tightness leaks. It is unlikely the coil pipework had corroded to the extent that the pipework had lost its water tightness integrity.

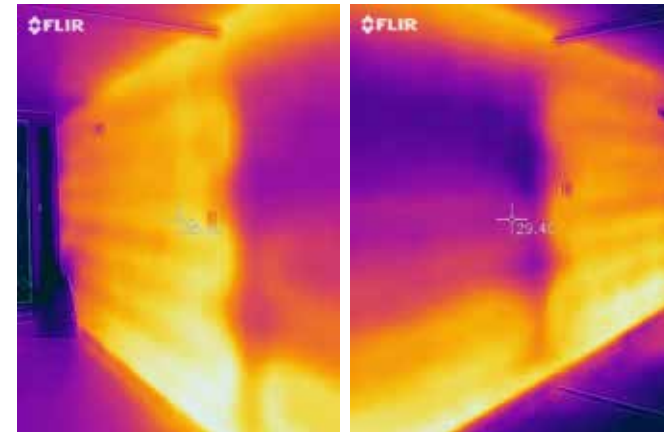
Figure 1: Heated wall in Block-A flat showing difference in coil density and surface temperature for living room and bedroom

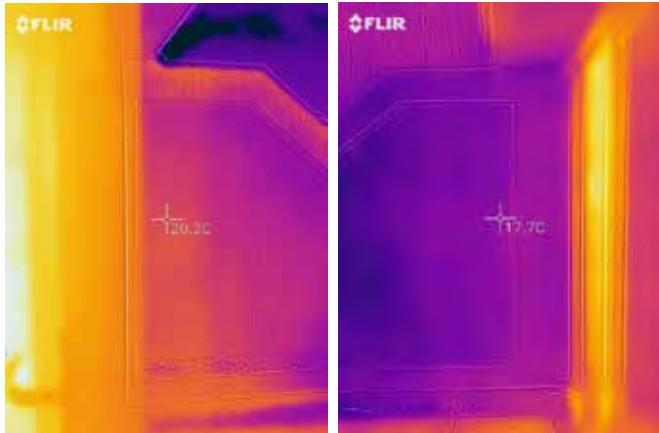
Figure 2: IR photo of external part of heated wall and external part of unheated wall

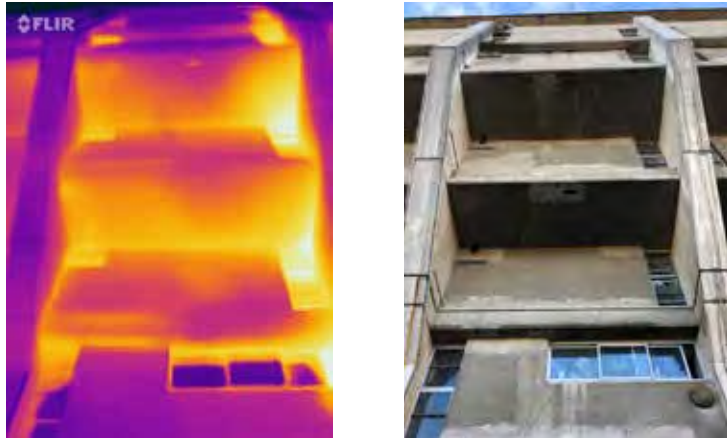
Figure 1: Rear of block A showing the heated party wall from the coils (right) and the unheated wall (left).

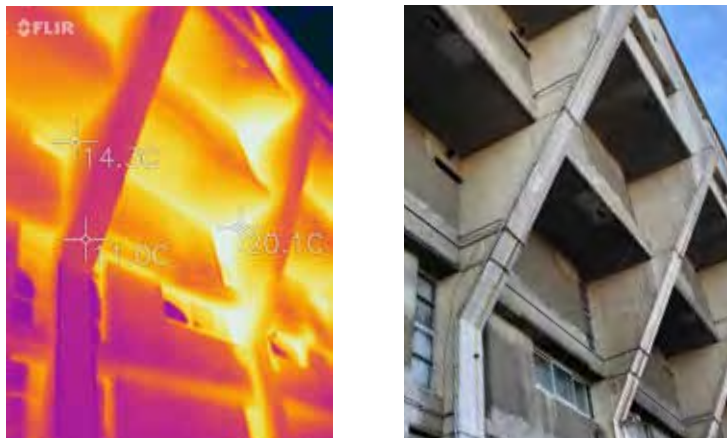
Figure 2: Rear of block A showing the heated party wall (right) and an unheated wall (left). The temperature readings from the image show that there are significant thermal bridges from the party walls. The unheated wall has a 3°C difference between the external wall (14°C) and the edge of the spine (11°C). The heated party wall (20°C) is 6°C warmer than the unheated wall (14°C).

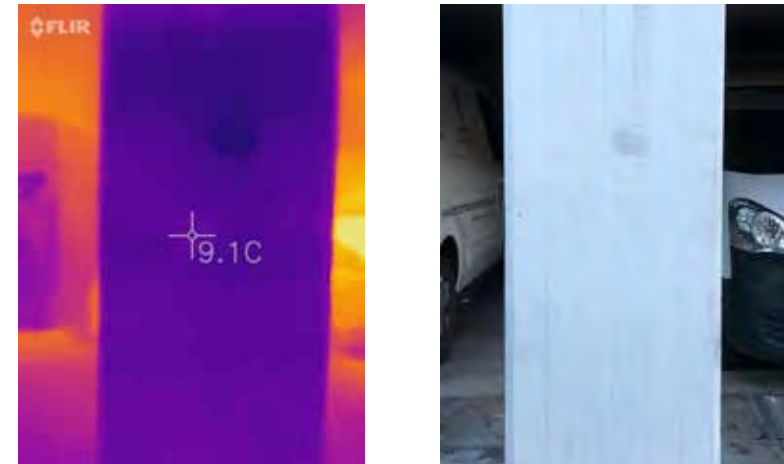
Figure 3: The base of the spine wall between the parking spaces at the ground floor of block A was measured at 9°C. This shows that the thermal bridge from the flats extends to the edge of the spines with a 2°C difference between the lower (9°C) areas and upper floors (11°C).

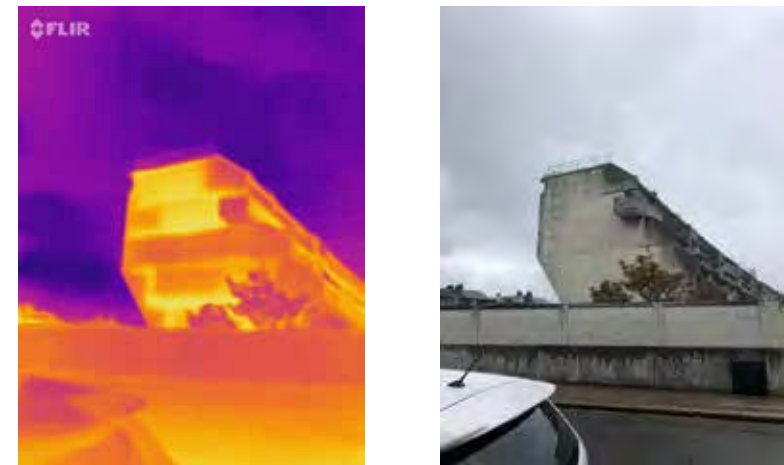
Figure 4: The western end wall of block A illustrating heat loss from the flats and significant thermal bridges at the floor and wall junctions.

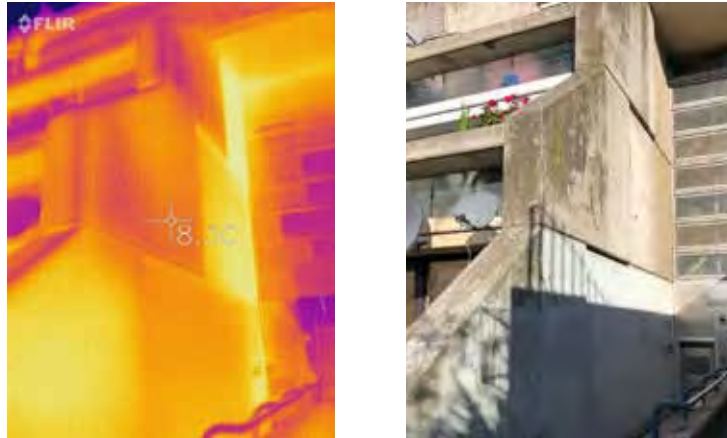
Figure 5 : Eastern end wall of block A illustrating heat loss from the flats. The thermal image was taken at 8pm to prevent the heat from the sun affecting the image. The photograph was taken the following day.

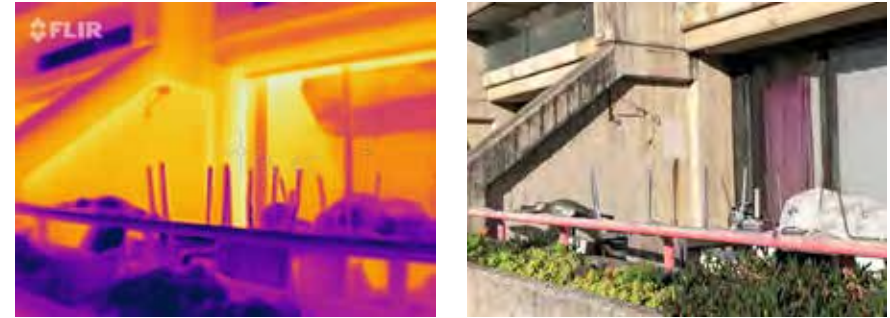
Figure 7 : Front of block A illustrating heat loss and the thermal bridge from the heated party wall. Temperature where the concrete fin meets the window wall shows 15°C. The thermal image was taken at 8pm to prevent the heat from the sun affecting the image. The photograph was taken the following day.

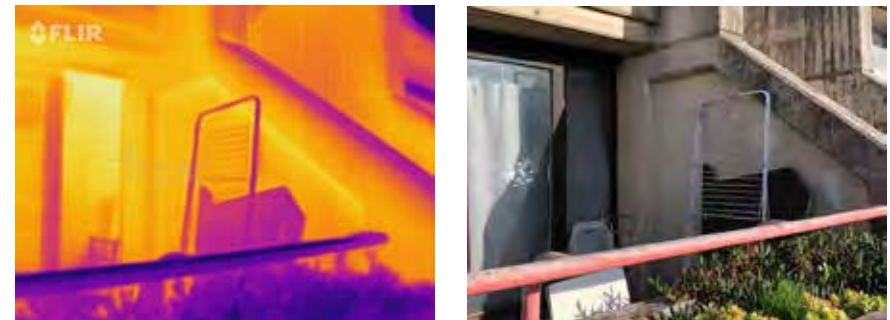
Figure 8 : Front of block A illustrating heat loss and the thermal bridge from the unheated party wall. This image shows that it was 3°C cooler on the unheated side (12°C) than the heated wall (15°C, figure 7) The thermal image was taken at 8pm to prevent the heat from the sun affecting the image. The photograph was taken the following day.

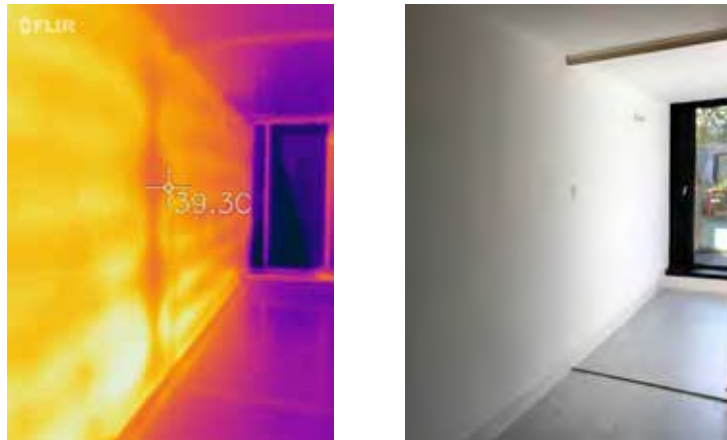
Figure 9: Internal image of a void A1 unit, showing the coil heated party wall - facing towards Rowley Way.

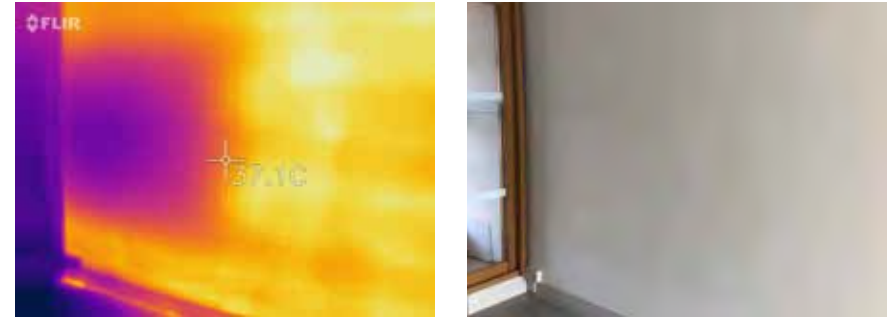
Figure 11: Internal image of the same void A1 unit, showing the coil heated party wall - facing towards the railway line. It is possible to see the route of the tail pipes at the top and bottom of the wall from the heated coil.

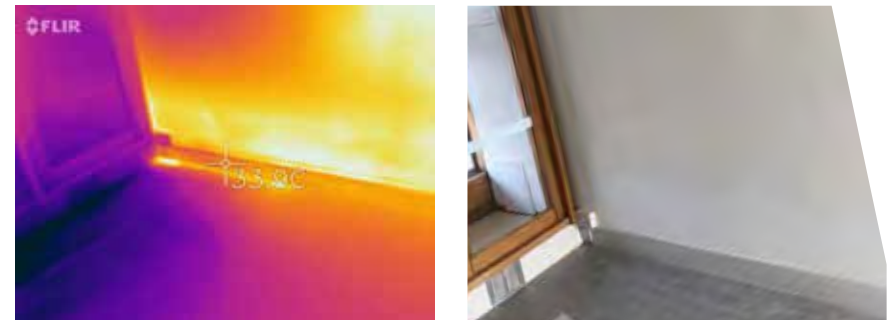
Figure 12: Similar image as figure 11 above. Assumed the heated coil tail pipe runs in the wall behind the skirting board, due to warm patch shown along base of skirting board.
