NENE VALLEY
FIRE & ACOUSTIC LTD.

FIRE STOPPING SURVEY

Site	26A Rowley Way
Address:	Camden NW8 0SQ
Customer:	Camden
Date:	18 Aug 2021

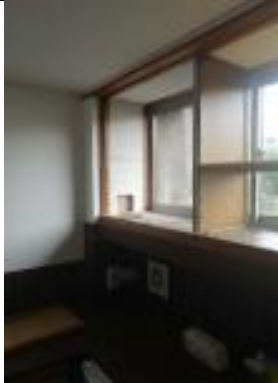
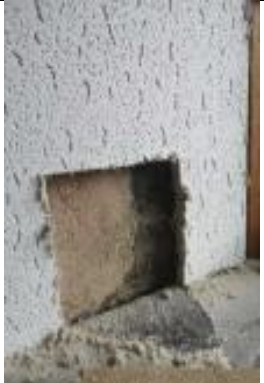
Seal Id	1		
Location	Floor 1 Kitchen

Description of works	Intrusion made within kitchen boxing. To be found solid block substrate
