Pre-Redevelopment and Pre-Demolition Audit Report

Project 200 East Development – University College School

University College School Hampstead

08/12/2023

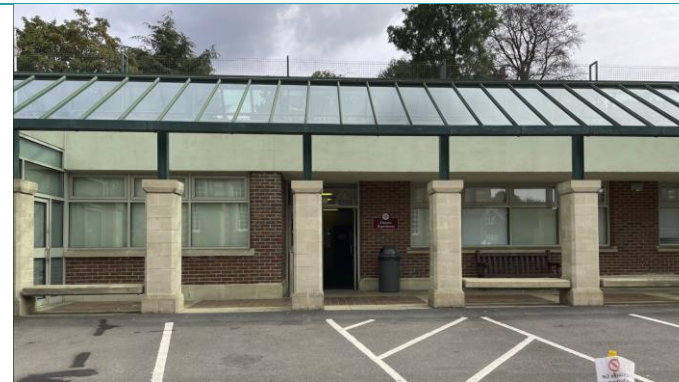
Image 4 GS Wing

Since its construction the building has been bedevilled by construction problems, in particular water ingress from the roof and from tanked retaining walls, it therefore has a history of maintenance repairs associated with lower quality standards of build.

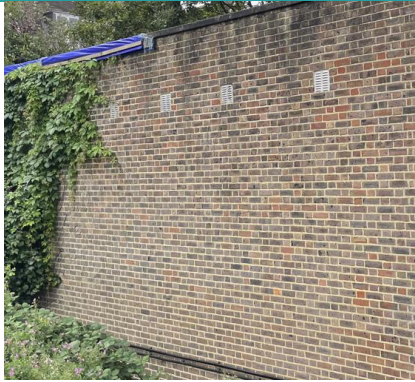
Image 9 Fives Courts - Solid Bricks

8.6 All brickwork was found to be in good condition with only minor hairline cracks noted.

The bricks found on-site that are not matching that of other buildings within the Proposed Development can be carefully removed and then reused for landscaping purpose. However, there are few barriers related to this process including bricks not matching the design of the Proposed Development due to its colour and bricks bound with cement mortar requiring cleaning and is labour intensive.

Alternatively, these bricks can be sent to a crushing plant on-site or off-site, from where the crushed aggregate can be reused for infill.

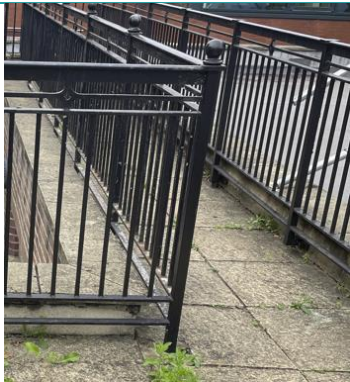
Image 18 GS Wing - Metal Railings

8.8 There are metal cast railings on the walkway at roof level. These were found in fair condition with some spans showing isolated areas of surface corrosion. Steel mesh fencing was found around the perimeter of tennis courts and was found in good condition throughout. Aluminium Windows and doors were found to be in fair condition in most areas however, the external door and windows at the rear of QS wing were noted to be in poor condition.

Alternatively, all metals can be sent off-site for recycling.

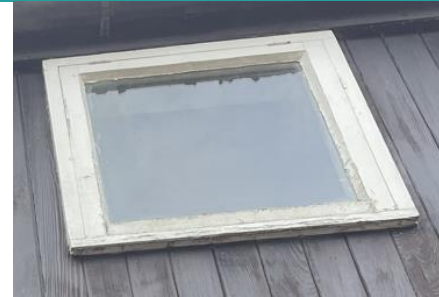
Image 31 Fives Courts - Timber from Windows

8.10 The timber cladding slats in Fives Courts were noted to be in fair condition with only minor signs of weathering. The timber framed windows in Fives Courts and Maintenance shed were end of life and in poor condition. Wooden flooring was found in the GS Wing showed some signs of wear and tear from footfall.

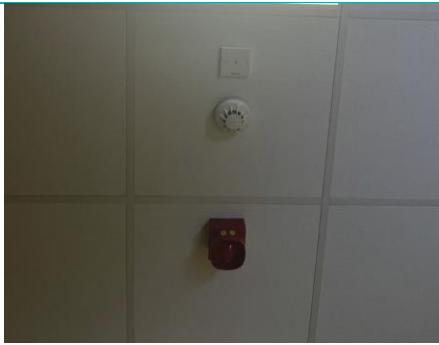
Image 44 Fives Courts - Grid Mineral Ceiling Tiles

8.12 The tiles and ceramics found on-site was noted to be in varying quality i.e., from reasonable to poor.

Due to the binding applied to the standard wall ceramic tiles, these ceramic tiles will be sent off-site for recycling. In case, the suspended grid mineral tiles do not meet the requirements of the Proposed Development, then these can be sent off-site for recycling.

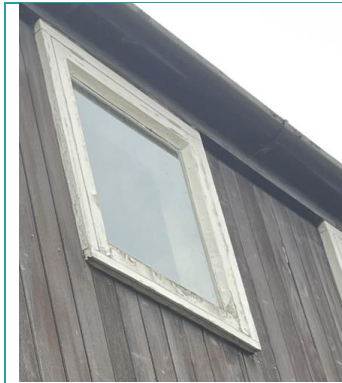
Image 49 Fives Courts - Single Glazed Window

8.16 Glass found on-site was noted to be in reasonable condition.

Due to common barriers including joint components and potential low performance, all glass will be sent off-site for recycling.
