**16 Church Row, Hampstead, London**

## Structural Assessment Report

**Ref:** 230595/K Clark

**Date:** 01 Dec 2023

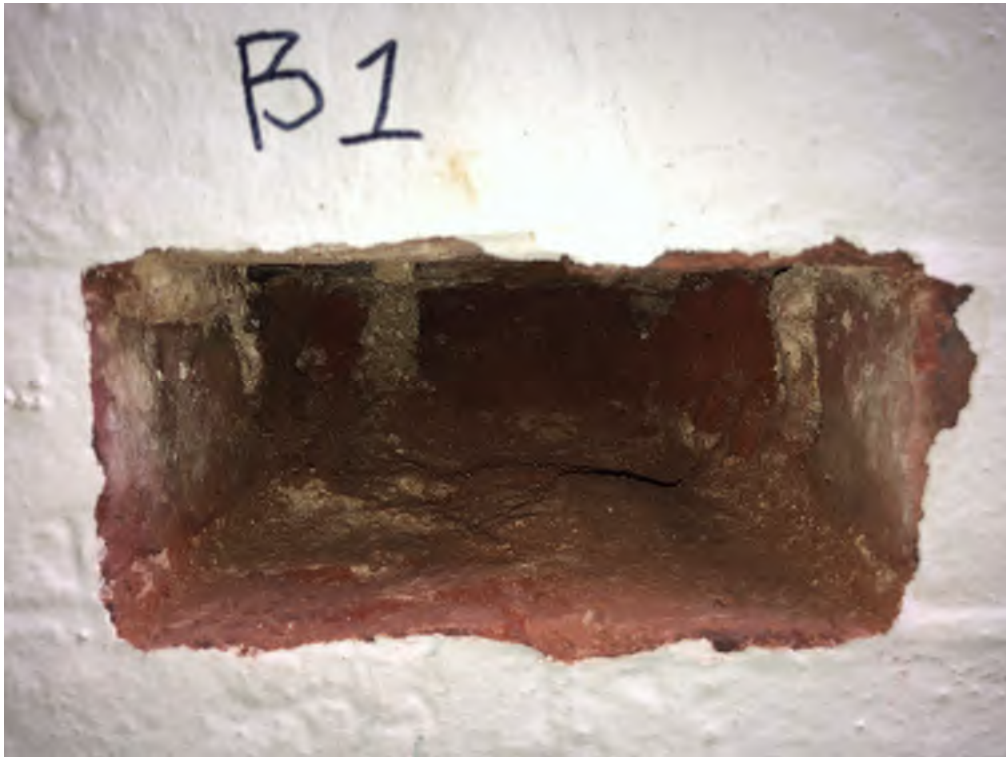
**Figure 4.1** Intrusive investigation of front elevation exterior at Basement

- 4.6 The intrusive investigation findings at the front elevation may be summarised as follows:
- At Basement level the front elevation brickwork wall was found to be in good condition where investigated with no noteworthy separation between the refronting brickwork and the original brickwork (see Figure 4.1). No cracking or other defects were revealed on locally removing the internal wall finishes (see Figure 4.2).

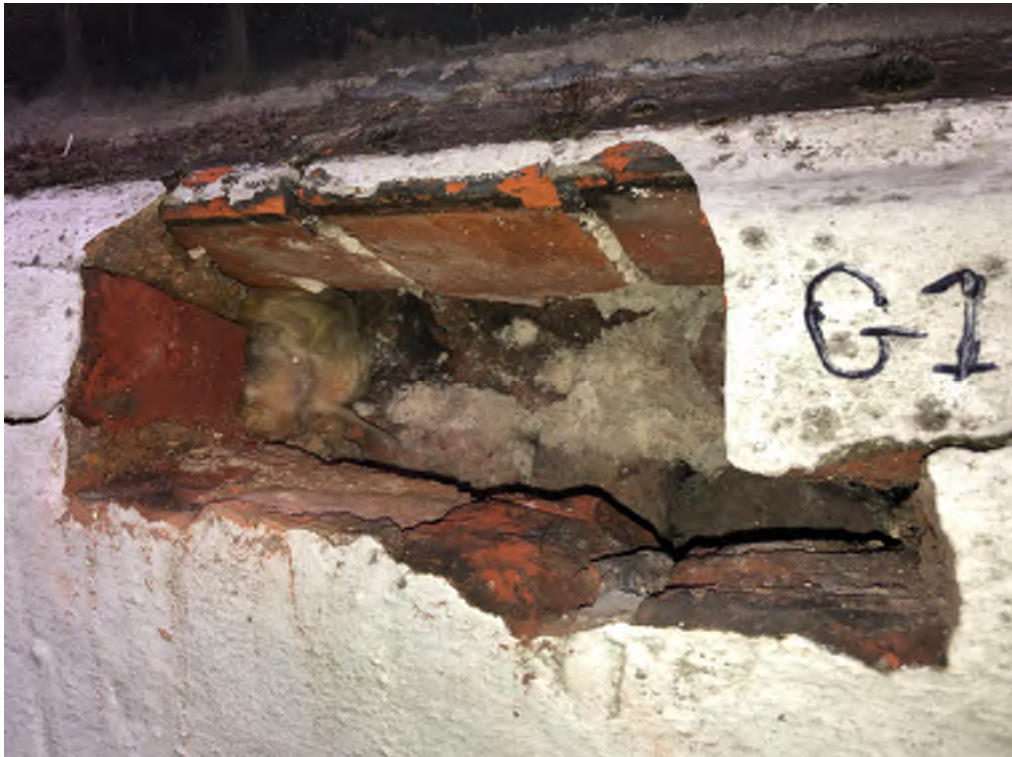
**Figure 4.3** Intrusive investigation of front elevation exterior at Ground floor

- At Ground floor level the refronting brickwork was found to have separated from the original brickwork by approximately 80mm where investigated (see Figure 4.3). Severe cracking and distortion of the brickwork pier between the windows at Ground floor was revealed on locally removing the internal finishes (see Figure 4.4). No cracking or other defects were revealed on locally removing the internal wall finishes at the pier between the door and window.

- 4.7 The information yielded by the intrusive investigations enabled us to establish that structurally concerning defects are limited to significant separation between the refronting brickwork and original brickwork wall between Ground and Second floor level and with severe cracking and distortion of the brickwork pier between the Ground floor windows.

- 4.8 The cause of this structural distress is very likely a combination of several different factors but the available evidence indicates it is primarily rooted in overstress of the relatively weak, low quality historic brickwork from which the pier is built coupled with its limited lateral restraint enhanced by the use of snapped headers within the body of the wall, thereby increasing the risk of delamination, load concentration and buckling-related movement.

- 5.1 To remedy the problems described above we recommend the reconstruction of irreparably defective parts of the brickwork pier between the Ground floor windows which, as far as it is possible to tell based on the information obtained from the intrusive investigations, largely comprises the original front elevation's late 18<sup>th</sup> century brickwork.

- 5.3 Ideally the later 19<sup>th</sup> century refronting brickwork will remain in situ whilst suitably propped for safety and protection before it is structurally tied into the brickwork pier progressively using stainless steel wall ties during the course of the construction works. This will result in the formation of a single consolidated pier with sufficient strength to safely withstand the loads applied by the wall and floors above, will maximise the retention of undamaged historic fabric and will minimise the aesthetic impact on the most visible street facing elements of the front elevation.

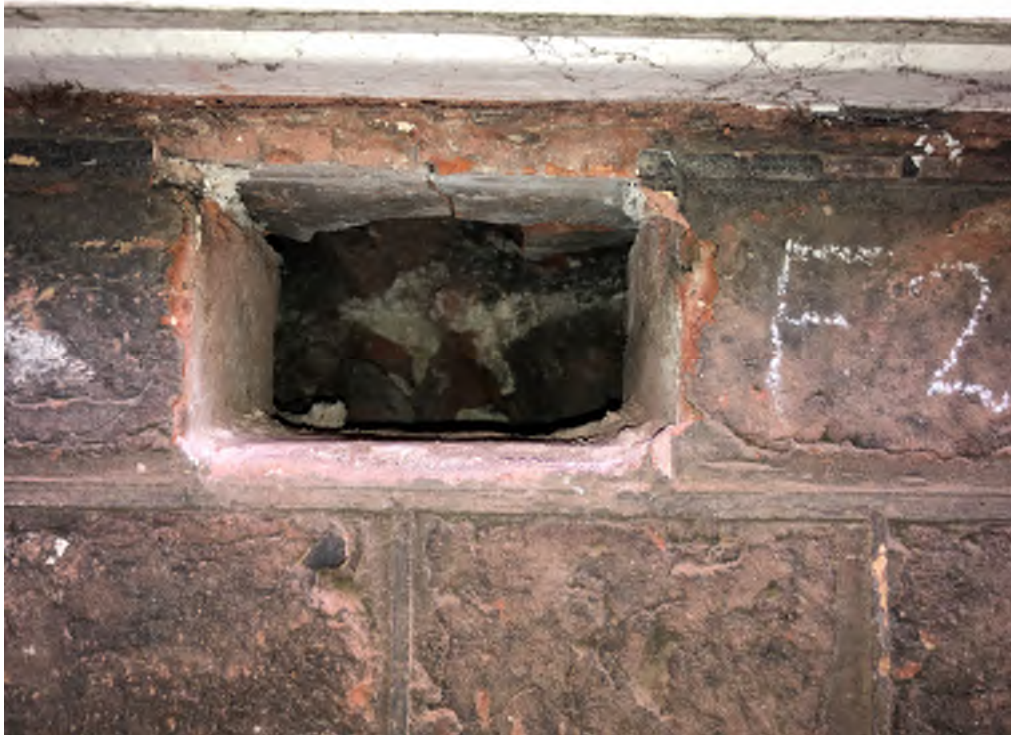
**Figure 4.5** Intrusive investigation of front elevation exterior at First floor

- At First floor level the refronting brickwork was found to have separated from the original brickwork by approximately 90mm (see Figure 4.5). No cracking or other defects were revealed on locally removing the internal wall finishes at the piers between windows, however remedial measures in the form of timber posts connected to each brickwork pier at mid height and spanning vertically between the timber wall plates were found to have been installed at some stage to enhance their lateral restraint (see Figure 4.6).

- 5.5 We also recommend the installation of Helifix ResiTie at 900mm horizontal centres and 900mm and 450mm vertical centres in a limited number of locations through the external face of the front elevation brickwork wall between Basement level and Second floor level (or alternatively through the internal face if penetration through the external face is deemed unacceptable by the Conservation Officer). This will reconnect the refronting brickwork with the original brickwork in areas where significant separation has occurred in order to reduce further movement and minimise the risk of future defects.

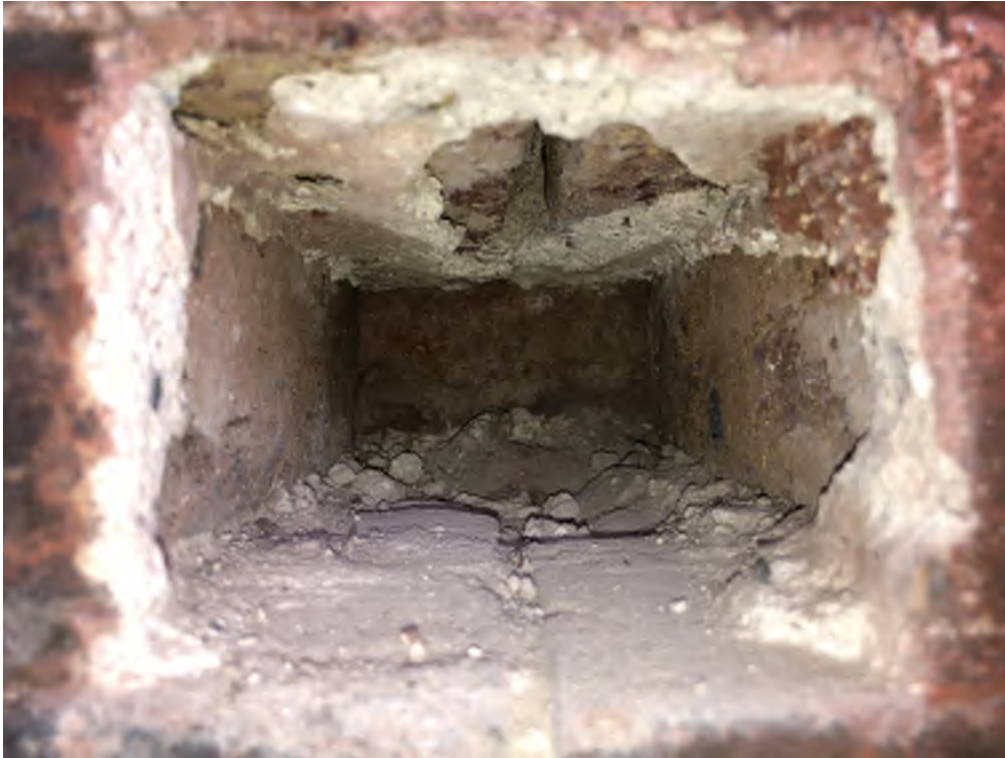
**Figure 4.7** Intrusive investigation of front elevation exterior at Second floor

- At Second and Third floor levels the front elevation brickwork wall was found to be in good condition where investigated with no noteworthy separation between the refronting brickwork and the original brickwork (see Figures 4.7 & 4.8).
- Opening up of localised areas of the ceilings at Basement, Ground and First floor confirmed that the floors are of traditional timber construction, comprising primary timber beams spanning front to back and bearing on the brickwork piers of the front elevation via timber wall plates, supplemented with timber floor joists spanning side to side between the primary beams (see Figures 4.9 & 4.10). The floor structure was found to be in good condition where investigated.
