Arboricultural Impact Assessment and Method Statement

Site: 99 Frognal, Hampstead, London, NW3 6XR

Date: 1 November 2023

Reference: 21/109 AMS

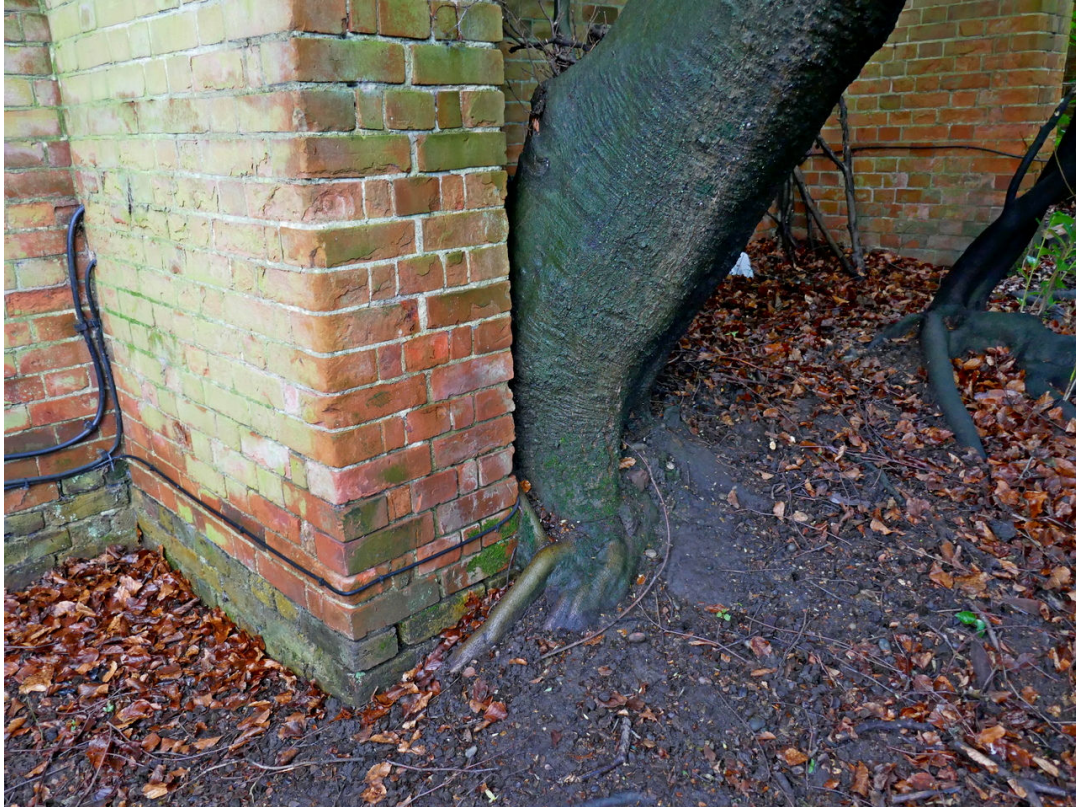
- 3.2 Most of the trees are sound and healthy, but some are in poor condition and need to be removed before they cause damage or for safety. Tree 7, a beech, has seeded itself next to the corner of a buttress in the boundary wall to no.97 and the base of the trunk is distorting round it as it grows. So far the wall appears to be sound, but further growth could damage it and the tree's stability is suspect as it leans heavily over the drive. (photo 1)

1) Base of tree 7 and boundary wall to no.97

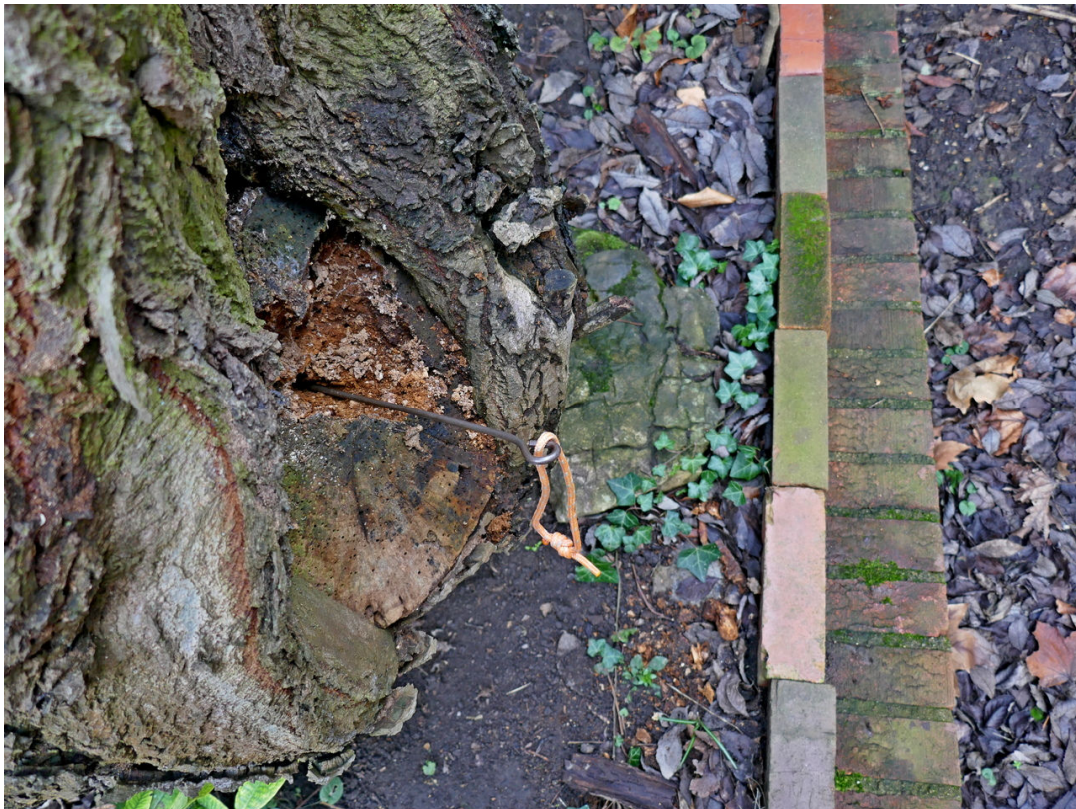
- 3.3 Tree 19, the goat willow in the enclosed lawn has extensive decay in a wound in the lower trunk. It was possible to push a blunt probe 400mm into this without with little resistance, indicating that the decay is deep and extensive. There is also decay in a stump above that and signs of decay in the main fork. It has been reduced but is beyond any practical remedial work and should be removed. (photo 2)

2) Steel probe in decaying wound at the base of tree 19. This went in 400mm with minimal resistance.

- 5.4 Trees 19, 33 and 34 are in such poor condition that they could be removed under the exemption for removing dead, or dangerous trees, although if that exemption is used there is a duty to plant a tree of an appropriate size and species at the same place as soon as they reasonably can. If trees are removed under the normal six week Section 211 notice the council have no power to require replacement planting, unlike trees covered by a TPO.
