S1268-J1-R1

REPORT

on a single tree at

9 Northington Street, London, WC1N 2JF

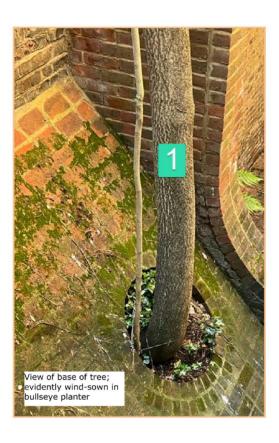
Tree number	Tree type	Height (m)	Stem diameters (mm)	Comments
1	common	10	240	Evidently a wind-sown sapling, young and of high vitality but very poorly sited for growth to maturity. It has developed within a bull's-eye planter, a feature of the hard landscaping, and would in my view rather pointlessly damage or destroy this feature if it is left to grow on.
				The tree is not visible from truly public viewpoints and makes only a very slight contribution to views from rear elevations of dwellings and/or commercial properties nearby.
				Remove; treat stump to prevent growth

Removal of the tree will have negligible impact on public amenity.

Tree number	Tree type	Height (m)	Stem diameters (mm)	Comments
1	common ash	10	240	Remove; treat stump to prevent growth
