Donald Insall Associates

Discharge of Conditions 4a - LBC application 2021/4813/L - approved on 19th of May 2022

Floorboard Repairs Method Statement

January 2024

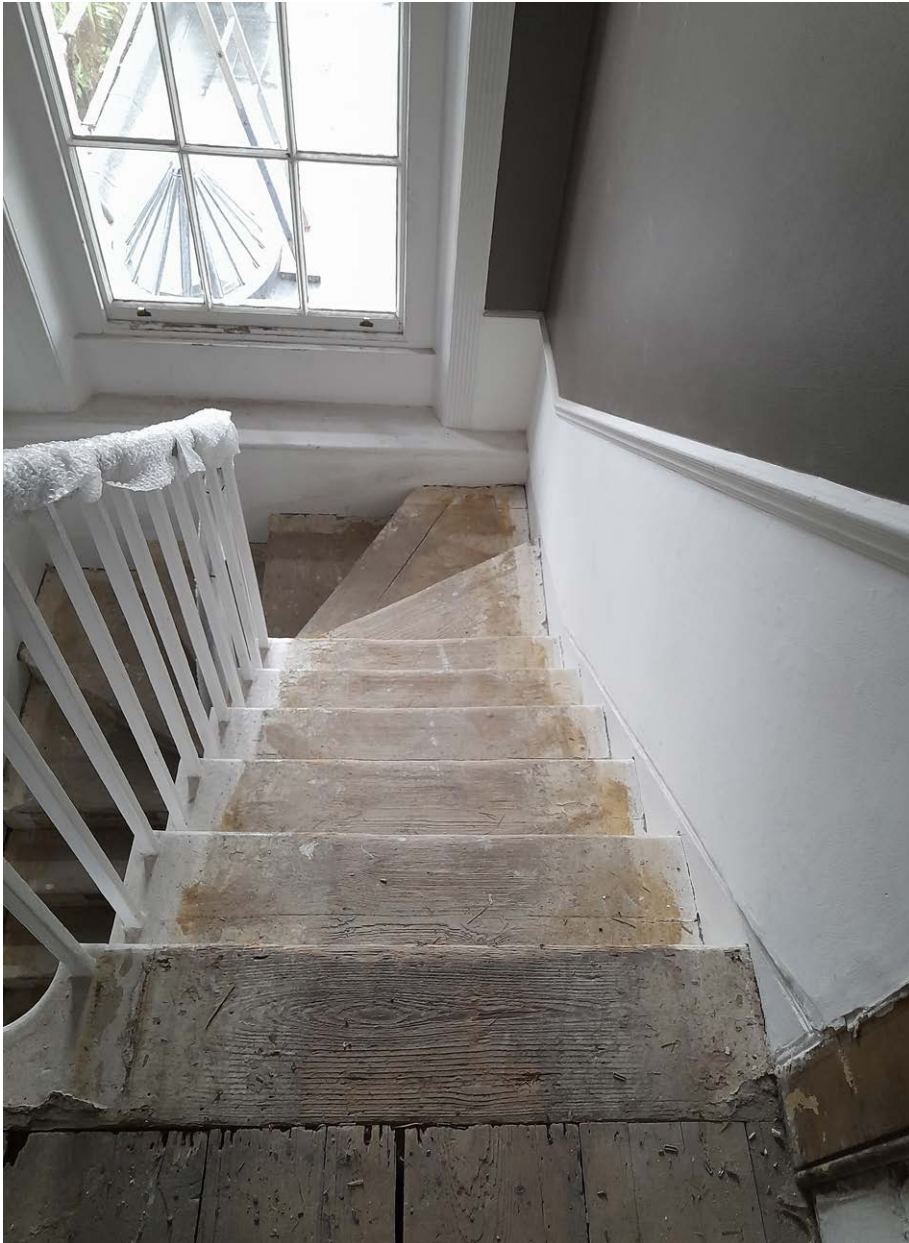
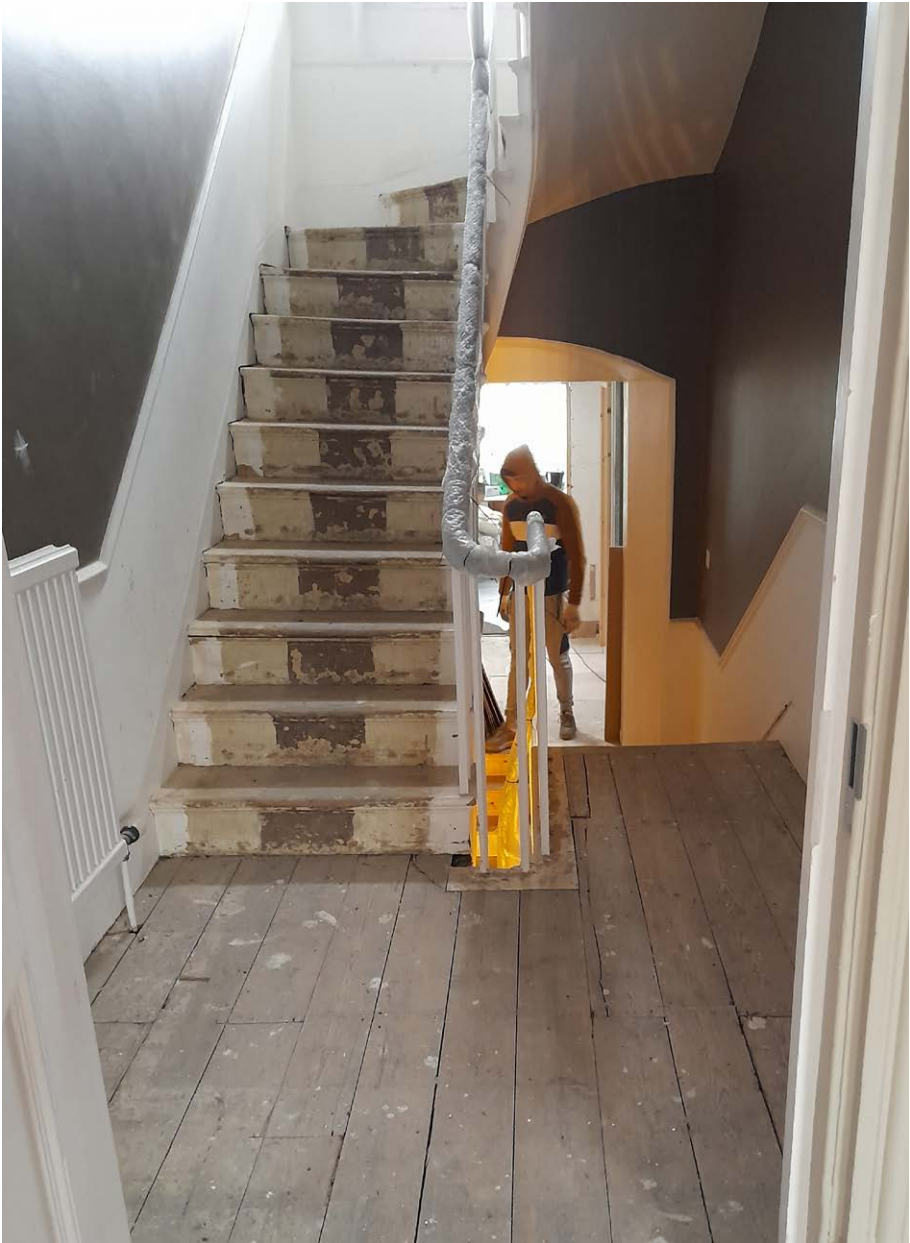
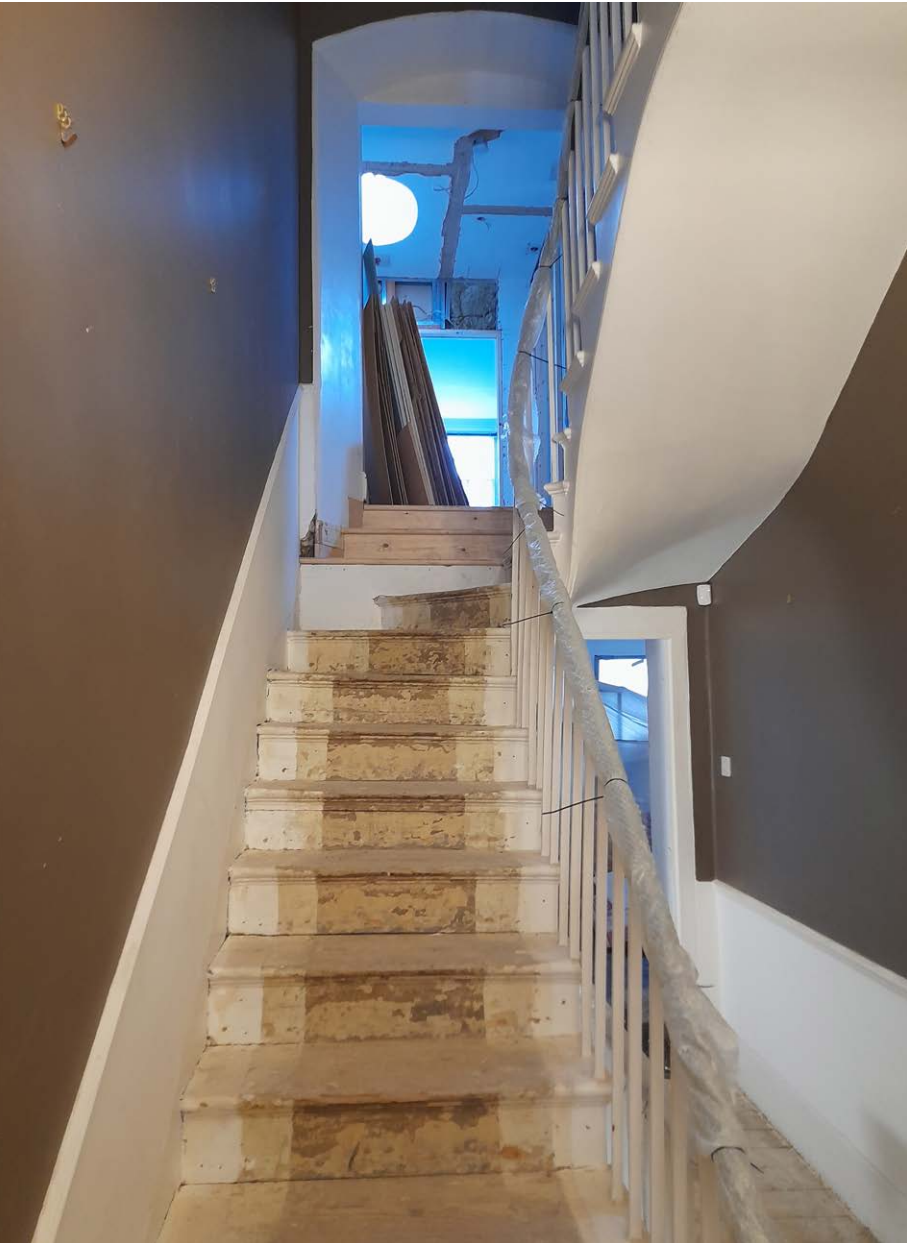
The removal of the office carpets also revealed a build up of recent paint, on the main stairs, including both risers and treads, from ground to second floor.

Main staircase after removal of office carpet.

The timber floorboards are in the process of being cleaned and repaired. The boards will not be sanded, to retain the historic patina, texture and variety of colour tonalities which are typical of aged timber floors. The boards will be carefully washed by hand using a solution of warm water and mild soap.

The more stubborn stains and paint residues will also be carefully removed by hand, with an appropriate brush.

All modern nails have been removed by hand, and visible holes left over from the removal of modern fixings, will be subsequently filled in with OSMO wood filler in pine/spruce or antique oak colour as required, to match the colour shade of the associated timber board.

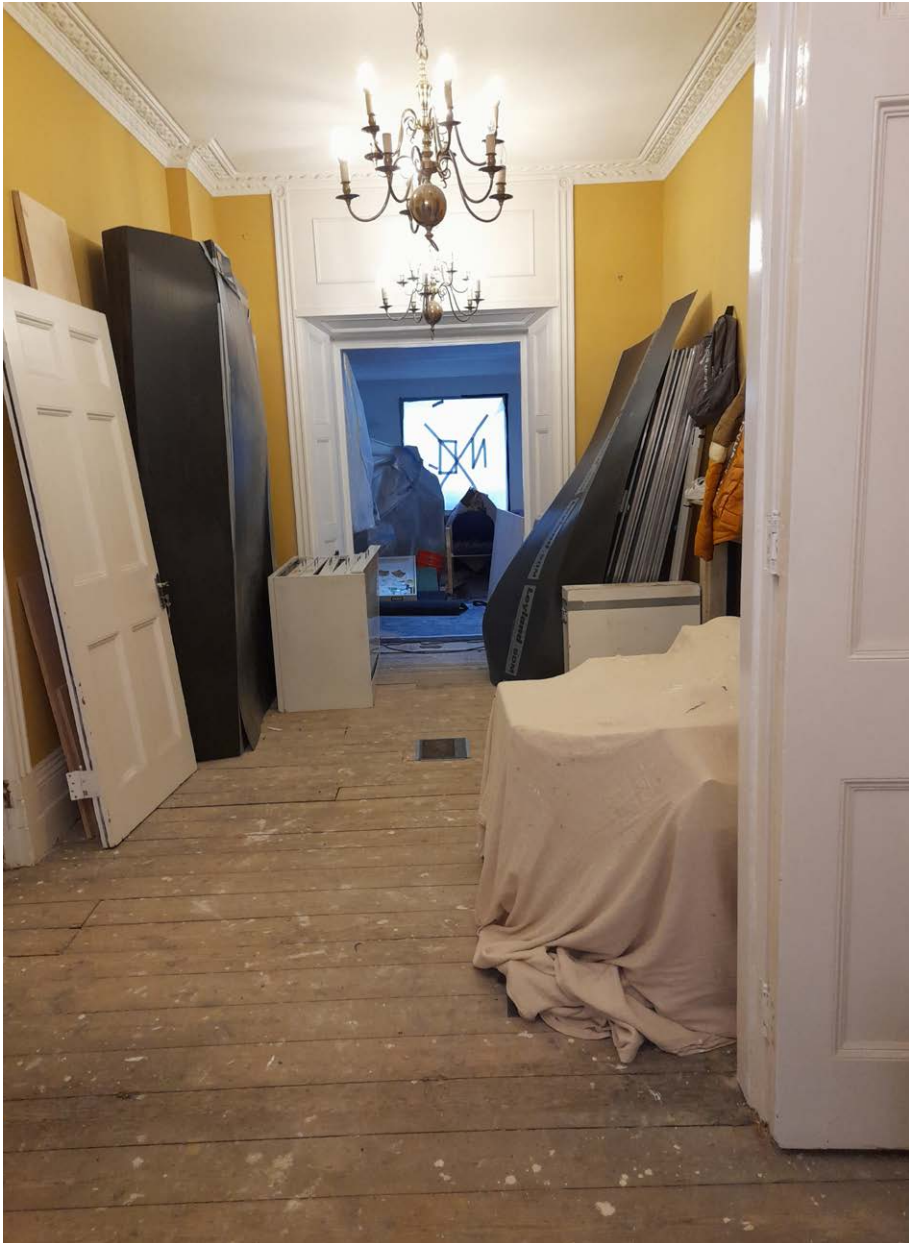
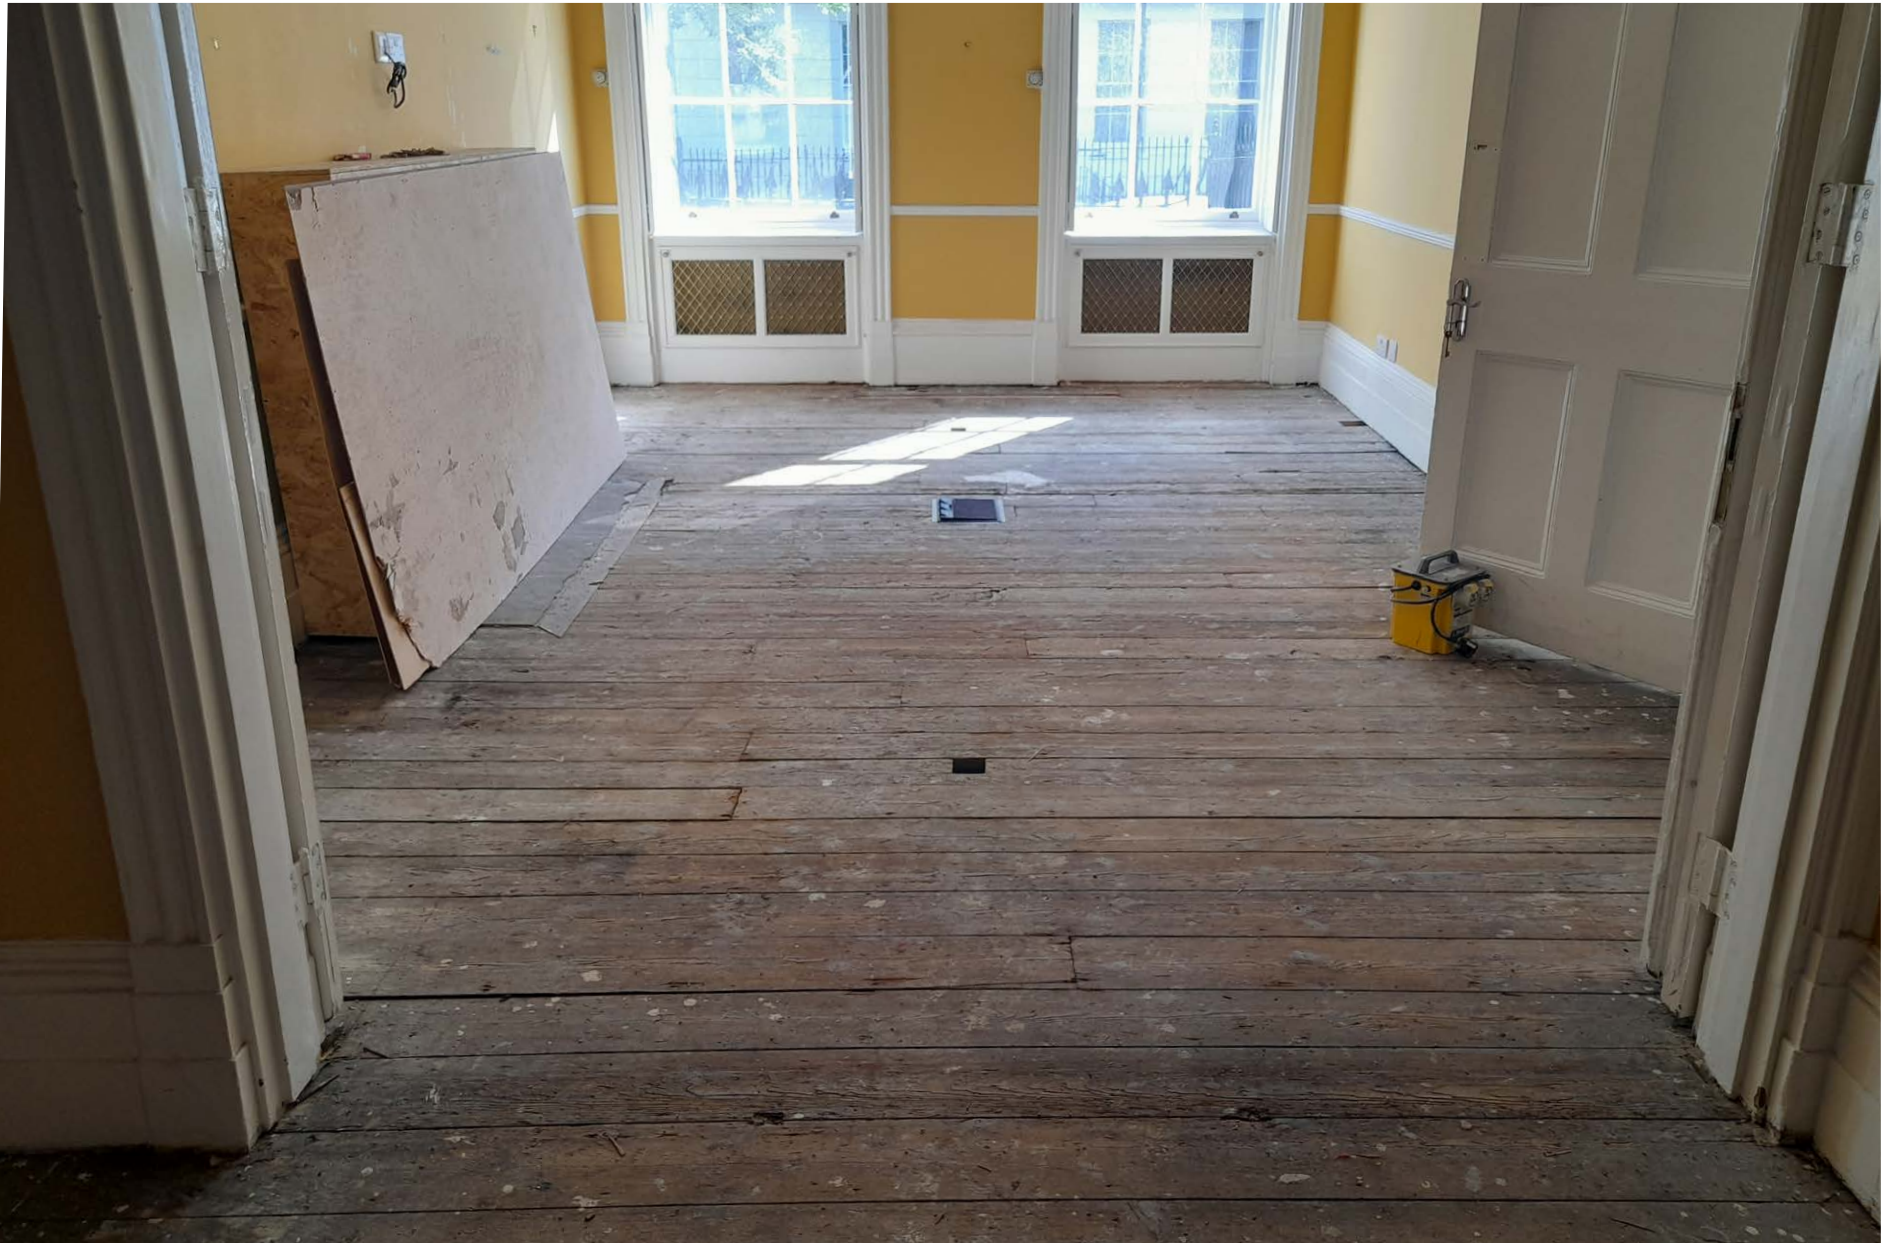
The original flooring has been altered by later alterations throughout the property, particularly in the bathrooms, to suit the supply of services and drainage. Some of the boards have been replaced with plywood.

Reception rooms at ground floor level after removal of office carpet.

All later coverings or replacement such as plywood will be removed where found and replaced with floor boards to match existing. The replacement floorboards will be made of reclaimed timber boards to match the adjacent ones in the same room.

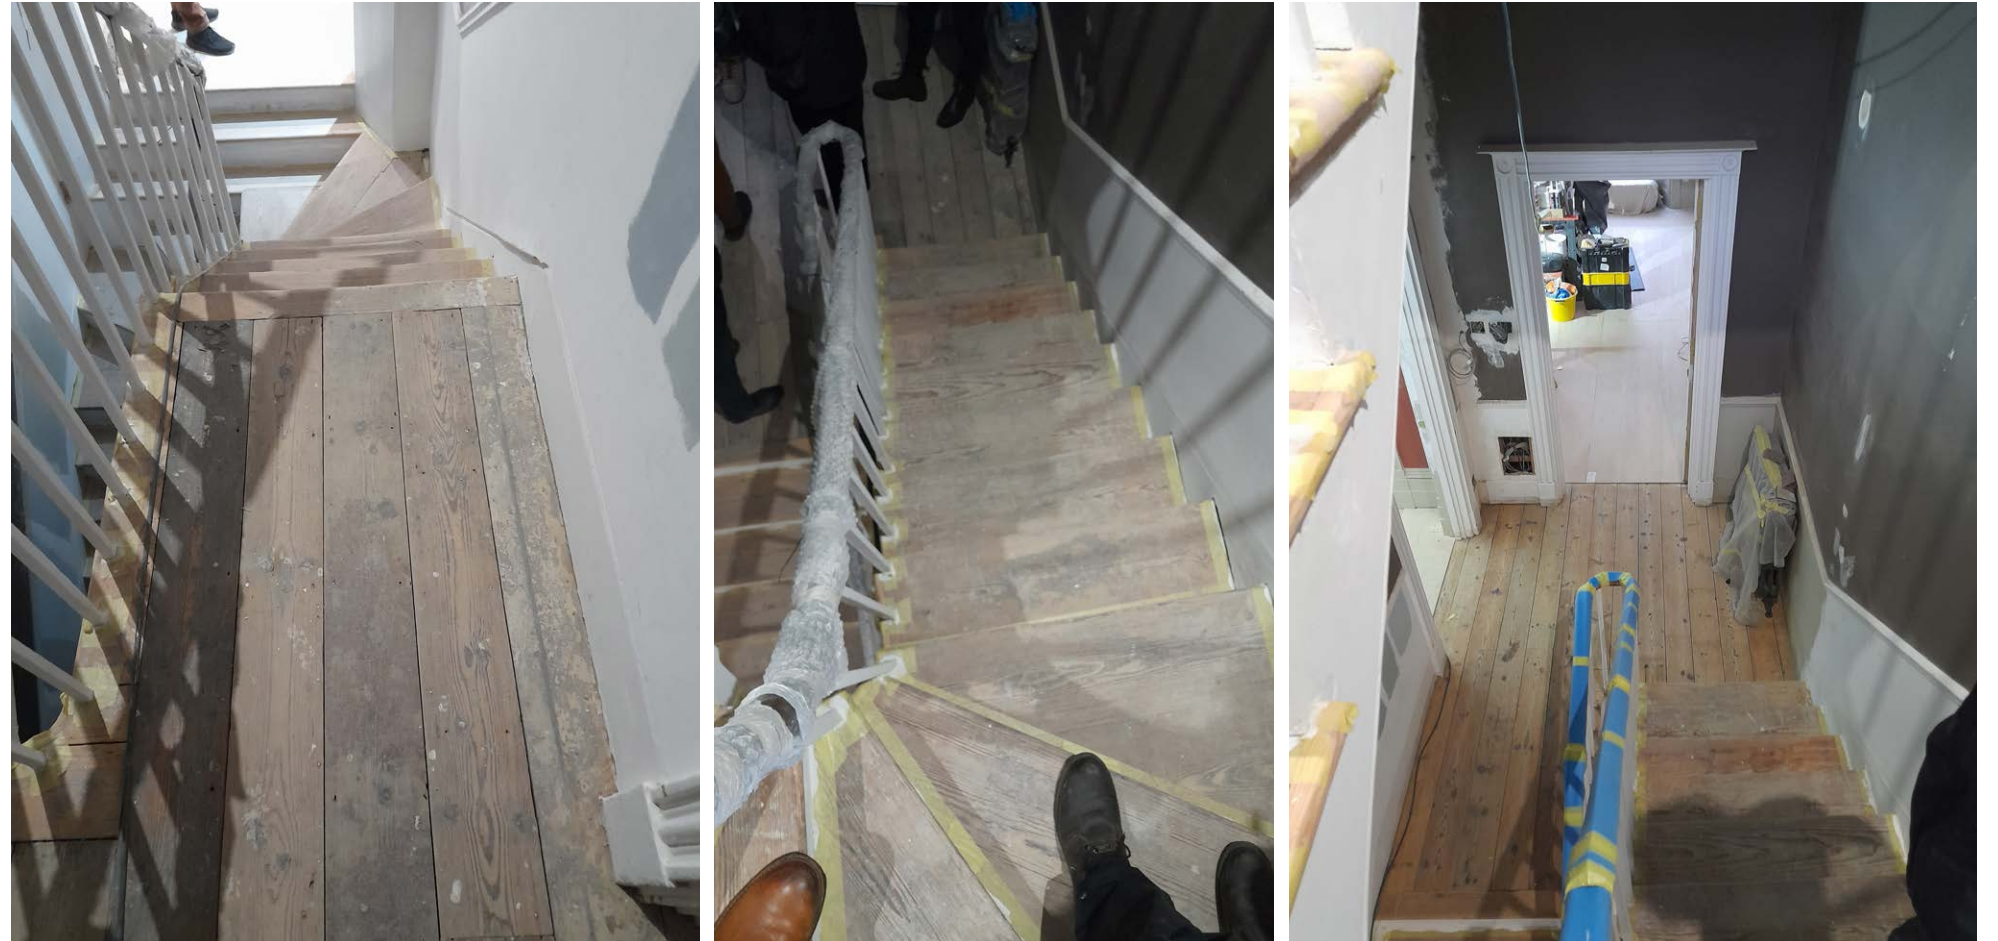
Timber stairs and floorboards at landing levels in the process of being cleaned and repaired.

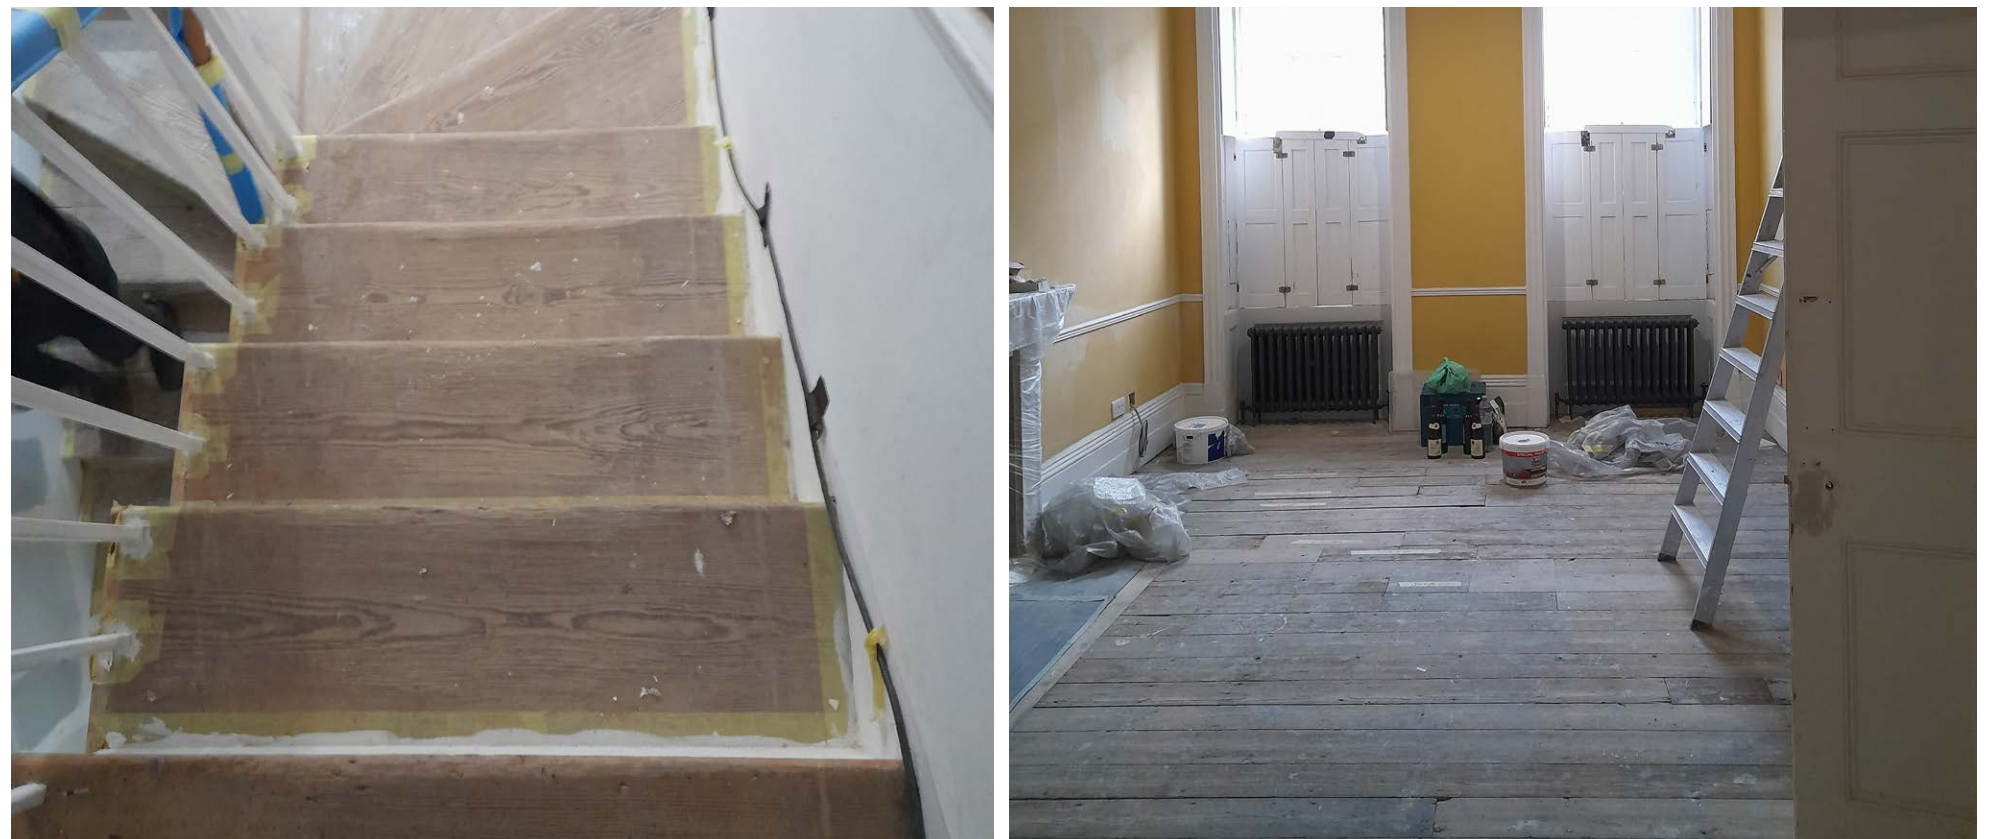
Timber stairs and floorboards in ground floor front room in the process of being cleaned and repaired.

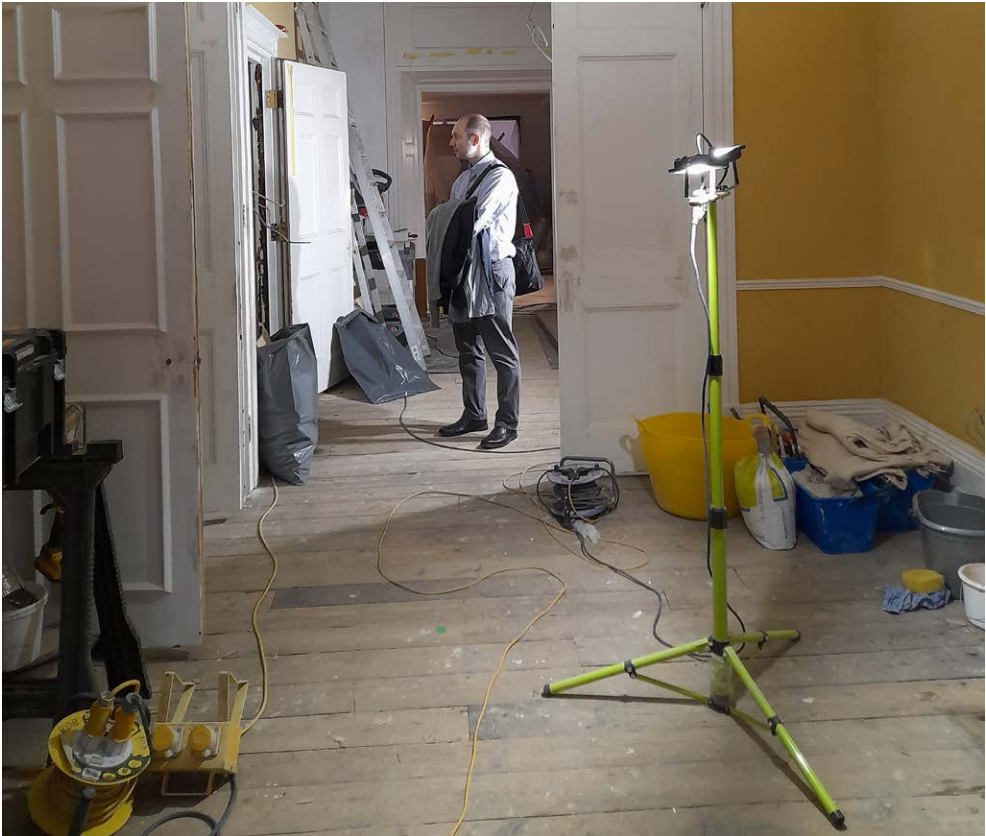
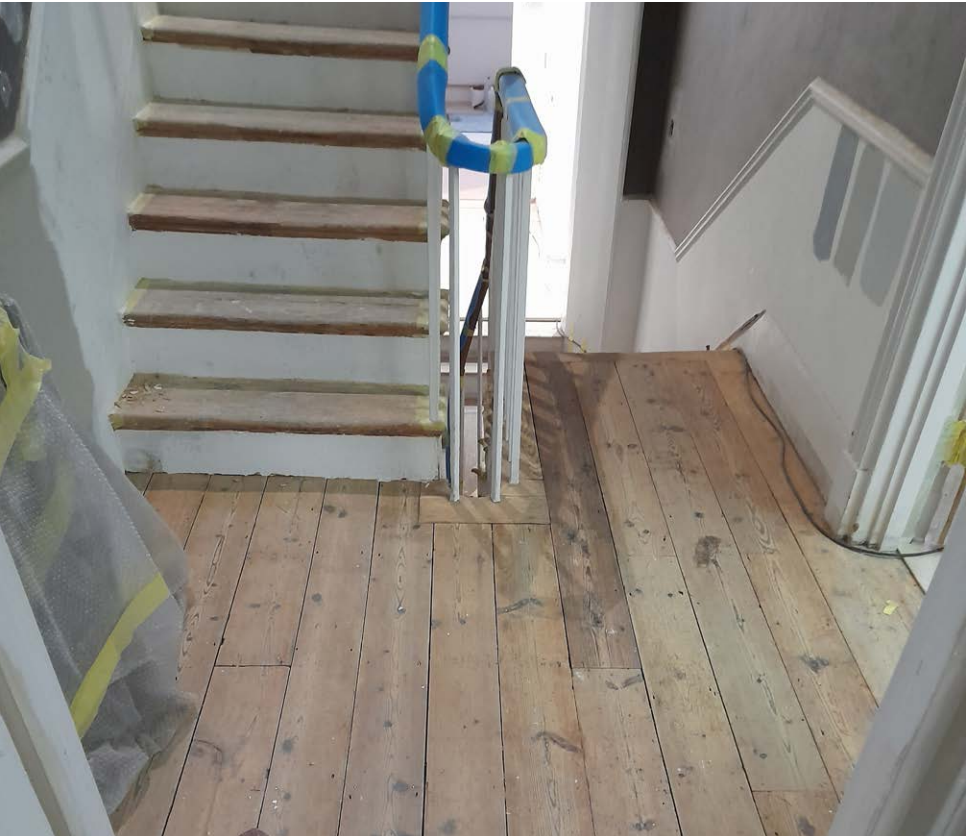
Timber stairs and floorboards in ground floor front room, and first floor landing, in the process of being cleaned and repaired
