13 December 2023

Our Ref: P5641/IH

## **26A FERNCROFT AVENUE – STRUCTURAL REPORT ON IMPACT OF TREE**

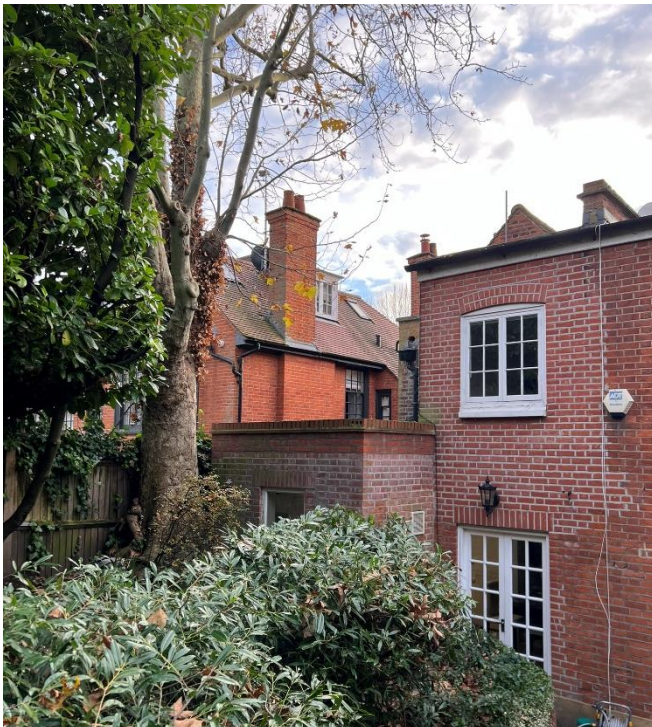
To the rear of the property there is a substantial London Plane tree in very close proximity to the rear elevation. Refer photographs 1,2 & 3 attached. The tree is in within an elevated bed approximately 1m above the ground level generally at the rear of the building. The distance from the trunk to the rear elevation is circa 300mm.

Photograph 1 – View of rear of property showing proximity of tree

On the basis of the above, we would strongly recommend that the tree should be removed, subject to the necessary approvals, to prevent further damage to the Listed building and to the retaining structures within the garden.

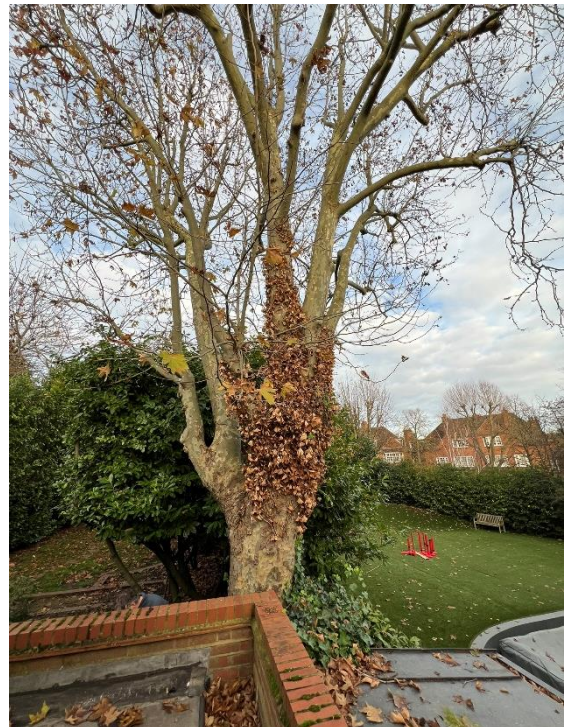
Photograph 2 – View from roof of building showing proximity of tree

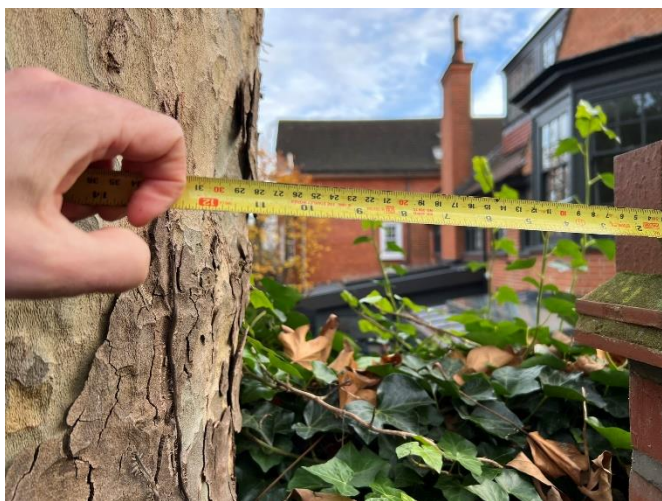
**Photograph 3 – Trunk less than 300mm from rear wall of building**

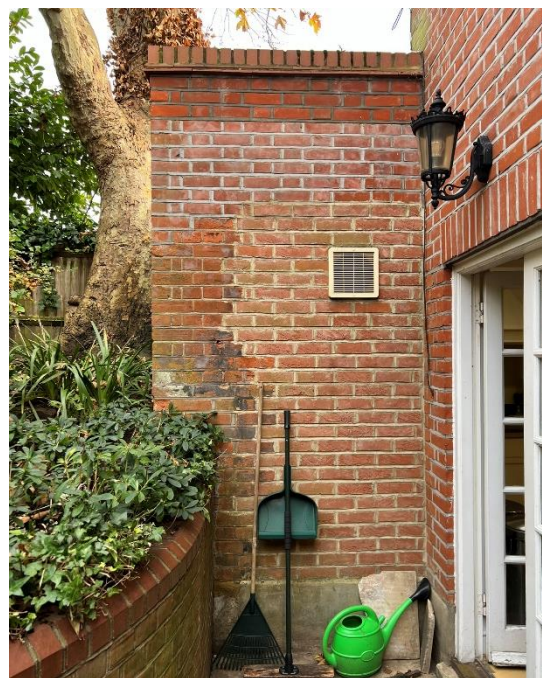
- There is evidence that the rear part of the building has been subjected to repeated repairs and partial rebuilding – refer photographs 4 and 5. It appears that one area has been reconstructed and tied into the existing, another area has been repointed, and the parapet looks to have been reconstructed.

The primary evidence of historic damage is the repairs carried out previously to the rear part of the building; these also look to have occurred at different times suggesting multiple incidences of damage rather than a single event.

**Photograph 4 – Side elevation of rear part of building**

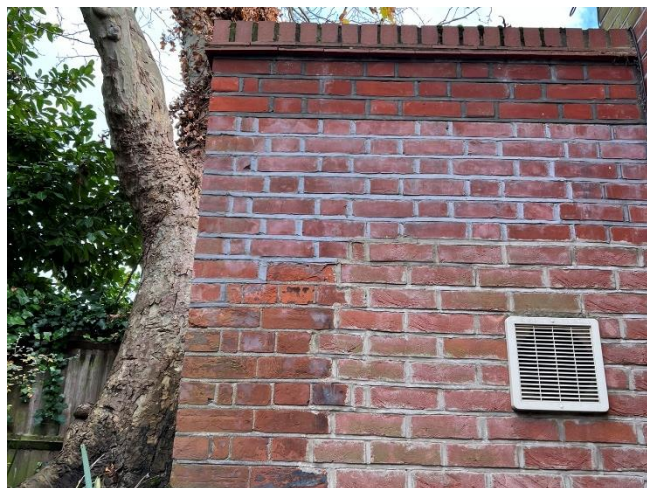
**Photograph 5 – Detail of side elevation**

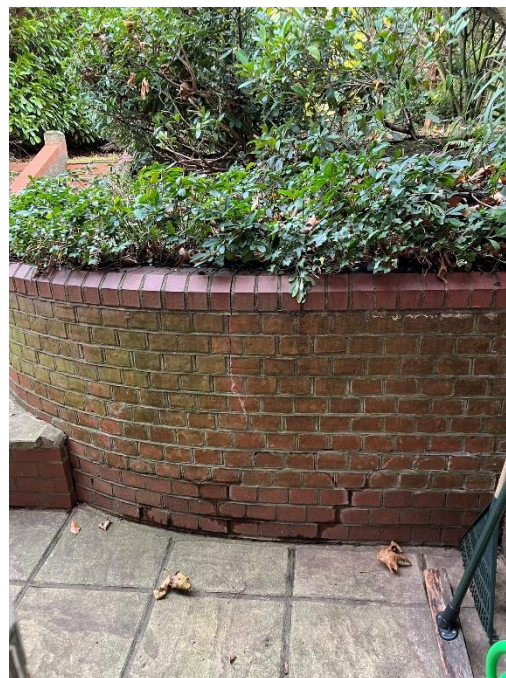
- There is a brickwork retaining wall surrounding the bed where the London Plane tree is located. There is significant cracking in several locations to this wall – refer photographs 6 & 7.
- At first floor there is evidence that the rear elevation has been reconstructed as the coursing of the rear elevation does not align with coursing of the side elevation – refer photograph 8.
- In the kitchen there is opening up of the joints in the flooring – refer photograph 9.
- To the first floor bathroom there is cracking in the tiling to the rear elevation - refer photograph 10.
- Internally at ground floor there are several cracks to the walls and ceilings to the rear part of the building. We understand that these have become apparent since a redecoration in 2022. Refer photographs 11-14.

Also of concern is the cracking to the rear garden retaining wall. If the cracking worsens it could lead to collapse of the retaining wall, which could in turn destabilise the tree. The same forces acting on this retaining wall will be also be acting on the retaining wall to the rear wall of the house; the concern would be that any damage would be concealed as the wall is hidden by kitchen units internally and is below ground level externally.

**Photograph 6 – Cracking to retaining wall**

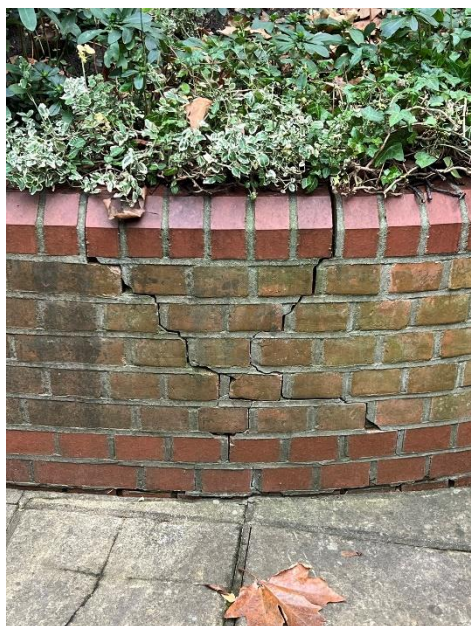
**Photograph 7 – Cracking to retaining wall**

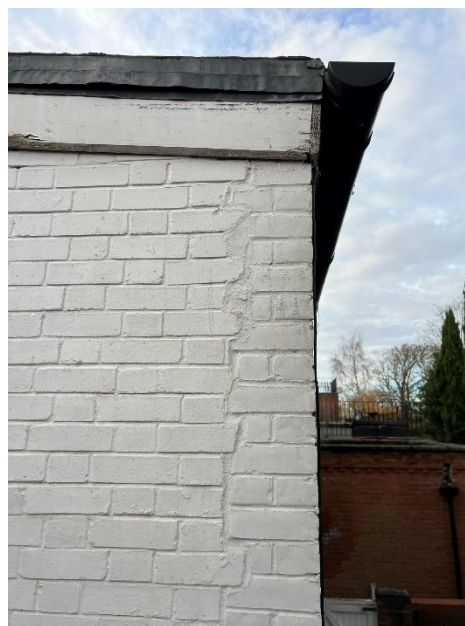
**Photograph 8 – Differing construction of side wall and rear elevation**

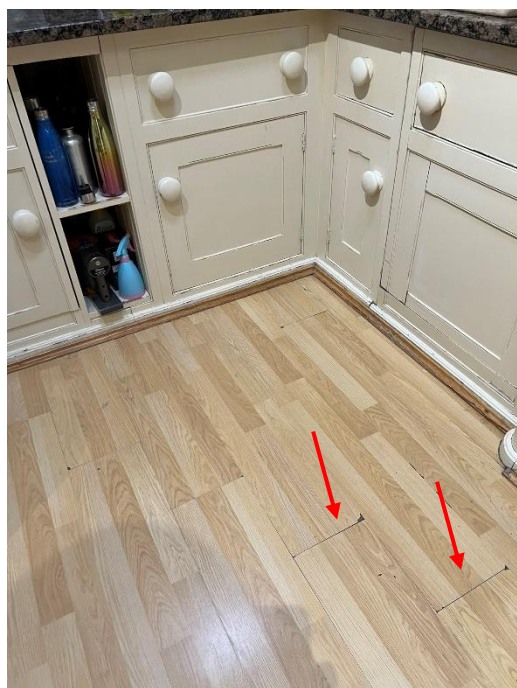
**Photograph 9 – Opening up of flooring in kitchen**

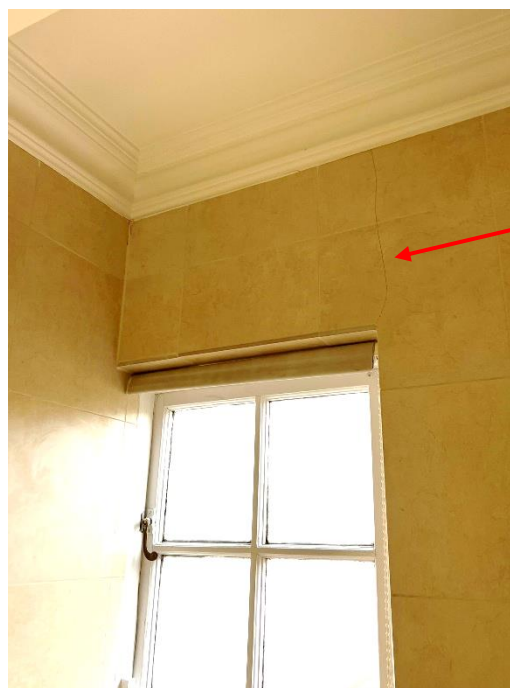
**Photograph 10 – Crack to tiling in bathroom**

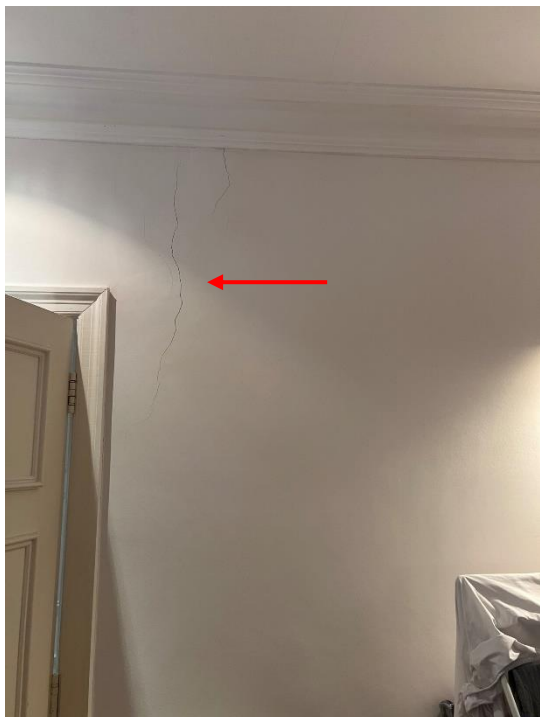
The large number of defects internally to the rear part of the building – in contrast to the low number of defects to the front of the property – again points to the tree being the cause. It is particularly of concern that many of these defects have only become apparent since a recent redecoration suggesting an ongoing issue.

**Photograph 11 – Cracking to wall**

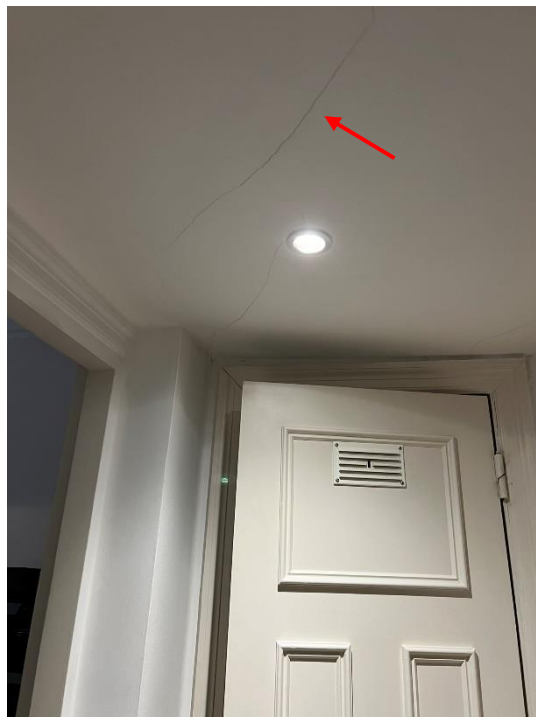
**Photograph 12 – Cracking to ceiling**

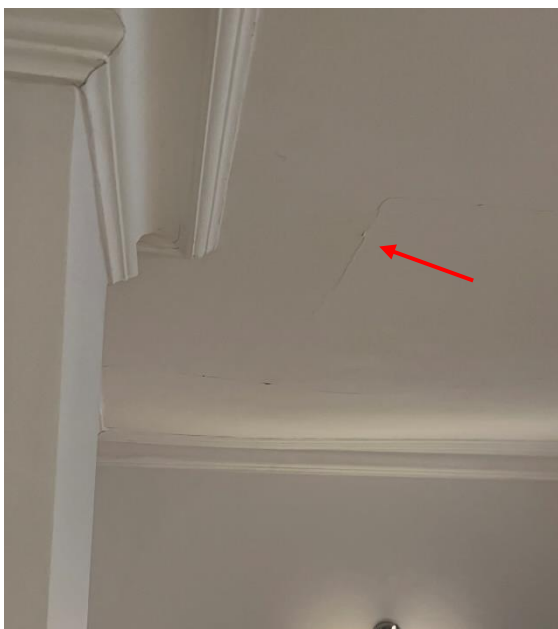
**Photograph 13 – Cracking to ceiling**

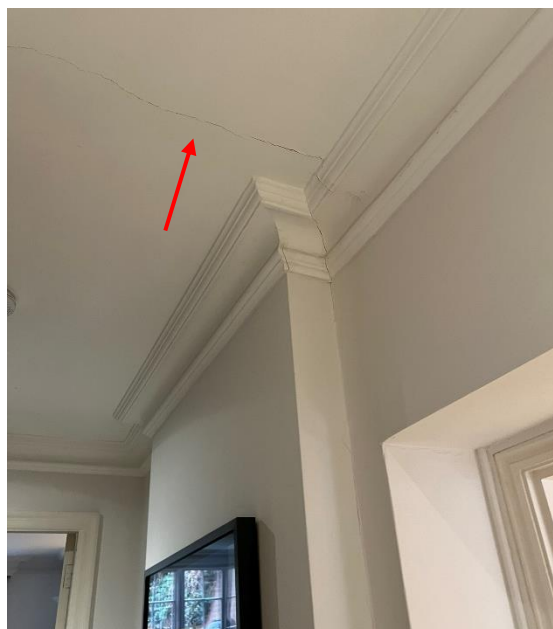
**Photograph 14 – Cracking to ceiling**
