**Demolition Survey (with  
MA only)**

London Borough of Camden  
5 Pancras Square  
London  
N1C 4AG

**Garage 1  
Ashington  
Warden Road  
41828  
NW5 4RB**

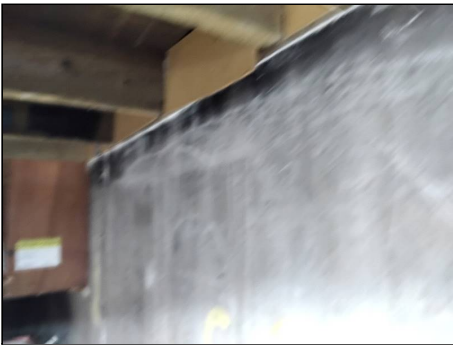
<b>Survey Date:</b>	<b>Lead Surveyor</b>	<b>Survey Type</b>	<b>Floor</b>	<b>Analysis</b>
	10 Jun 2021	Chaz Sharpley	Demolition Survey	Ground Floor	N/A
	<b>Building</b>	<b>Room</b>	<b>Item</b>	<b>Quantity</b>	
	Garage 1	External	No suspect materials found	N/A	
	<b>Sample No (S,SP,P,As)</b>	<b>Product Type</b>	<b>Surface Treatment</b>	<b>Condition</b>	<b>Accessibility</b>
	Visual (NS)	N/A	N/A	N/A	N/A
	<b>Material Risk Score</b>				
N/A					
<b>Recommended action</b>	No further action required				
<b>Surveyor comments</b>	N/A
