**Demolition Survey (with
MA + PA)**

**Garage 6
Wedmore
Queens Crescent
London
44881
NW5 4DT**

Report issue date:	14 May 2021

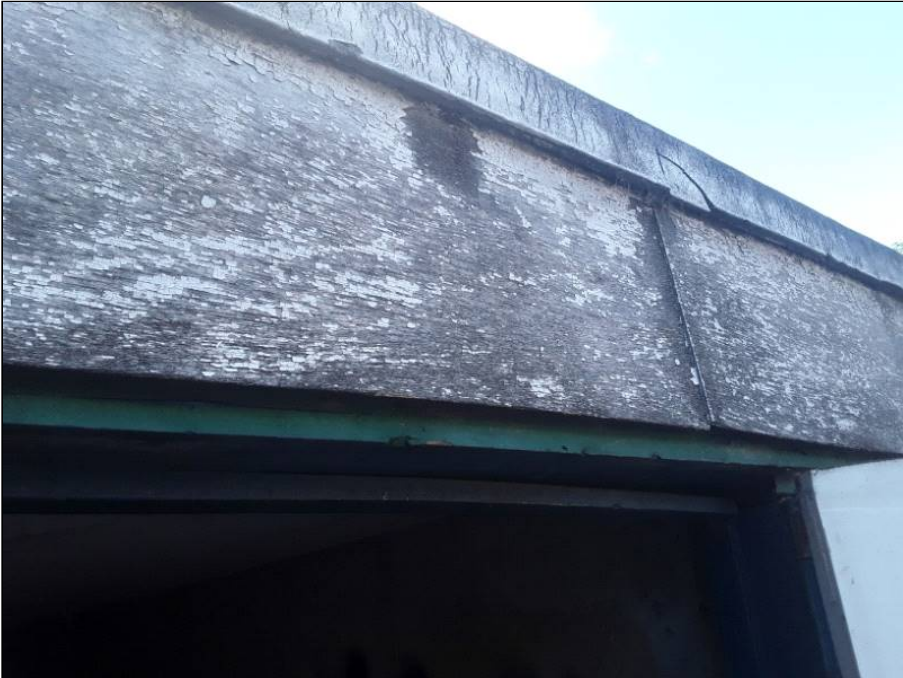
Survey Date:	Lead Surveyor	Survey Type	Floor	Analysis			
	12 May 2021 to 12 May 2021	Steve Beak	Demolition Survey	Ground Floor	No Asbestos Detected			
	Building	Room	Item		Quantity			
	Garage 6	External	Felt Roof covering		10m ²			
	Sample No (S,SP,P,As)	Product Type	Surface Treatment	Condition	Accessibility			
	KW005701 (S)	N/A	N/A	N/A	N/A			
	Normal Occupancy	Score	Likelihood of disturbance	Score	Exposure Potential	Score	Maintenance Activity	Score
	Main type of activity	N/A	Location	N/A	Number of occupants	N/A	Type of Maintenance	N/A
	Accessibility	N/A	Frequency of use	N/A	Frequency of maintenance	N/A		
	Amount	N/A	Average Time	N/A				
Average Score	N/A	Average Score	N/A	Average Score	N/A	Average Score	N/A	
Average of Priority	N/A							
Material Assessment Score	N/A							
Recommendation	No further action required

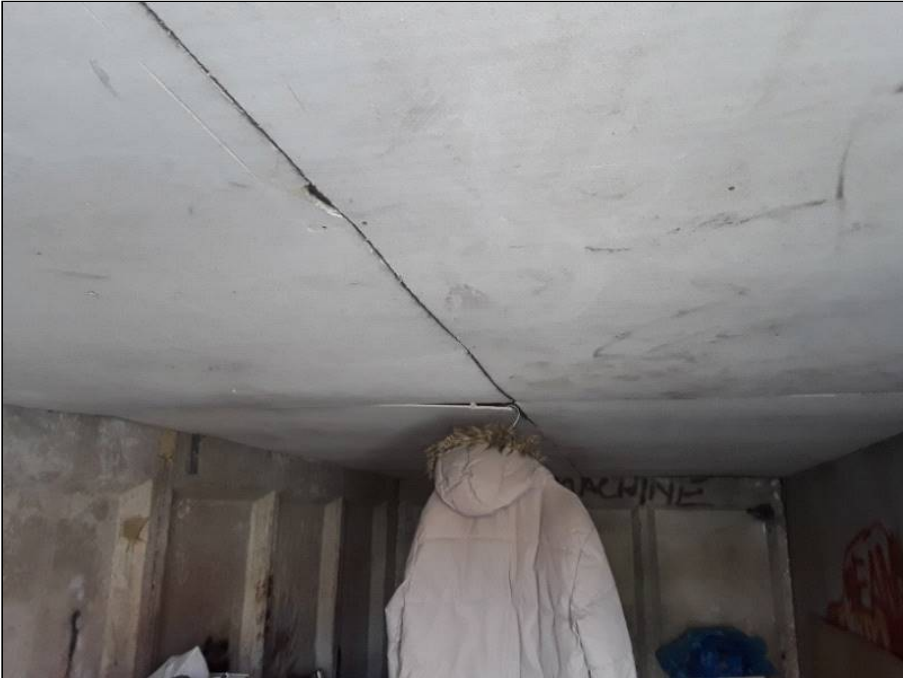
Survey Date:		Lead Surveyor		Survey Type		Floor		Analysis	
	12 May 2021 to 12 May 2021		Steve Beak		Demolition Survey		Ground Floor		No Asbestos Detected	
	Building		Room		Item				Quantity	
	Garage 6		Internal		Insulation board To ceiling				10m ²	
	Sample No (S,SP,P,As)		Product Type		Surface Treatment		Condition		Accessibility	
	KW005702 (S)		N/A		N/A		N/A		N/A	
	Normal Occupancy		Score	Likelihood of disturbance	Score	Exposure Potential	Score	Maintenance Activity	Score	
	Main type of activity		N/A	Location	N/A	Number of occupants	N/A	Type of Maintenance	N/A	
	Accessibility		N/A	Frequency of use	N/A	Frequency of maintenance	N/A			
	Amount		N/A	Average Time	N/A					
Average Score		N/A	Average Score	N/A	Average Score	N/A	Average Score	N/A		
Average of Priority		N/A								
Material Assessment Score		N/A								
Recommendation		No further action required
