**Demolition Survey (with
MA + PA)**

**Garage 11
Wedmore
Queens Crescent
London
42150
NW5 4DT**

Report issue date:	14 May 2021

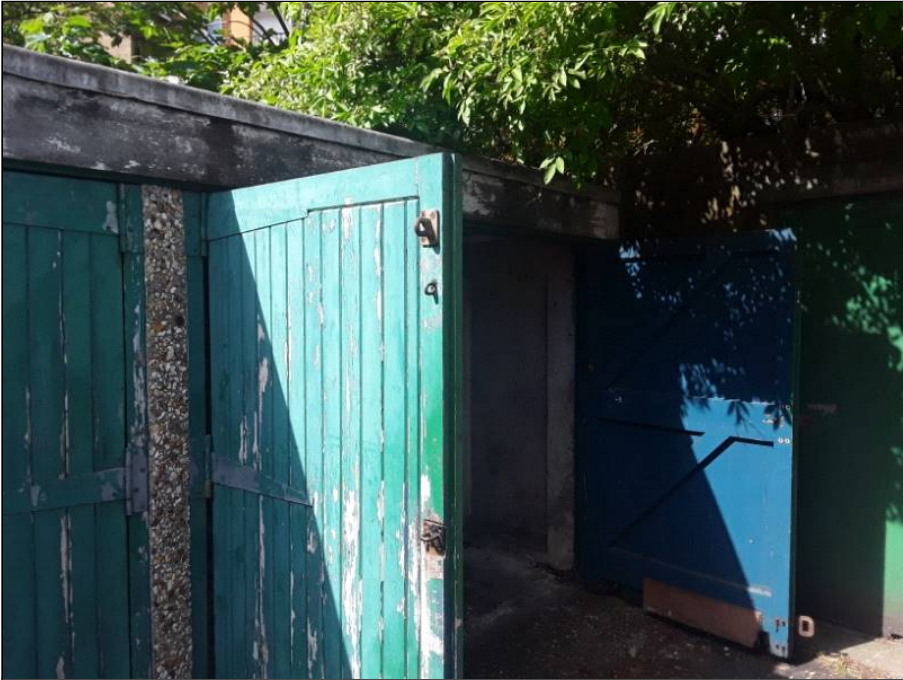
Survey Date:		Lead Surveyor		Survey Type		Floor		Analysis	
	12 May 2021 to 12 May 2021		Steve Beak		Demolition Survey		Ground Floor		No Asbestos Detected	
	Building		Room		Item				Quantity	
	Garage 11		External		Felt Roof covering				10m ²	
	Sample No (S,SP,P,As)		Product Type		Surface Treatment		Condition		Accessibility	
	KW005695 (S)		N/A		N/A		N/A		N/A	
	Normal Occupancy	Score	Likelihood of disturbance	Score	Exposure Potential	Score	Maintenance Activity	Score		
	Main type of activity	N/A	Location	N/A	Number of occupants	N/A	Type of Maintenance	N/A		
	Accessibility	N/A	Frequency of use	N/A	Frequency of maintenance	N/A				
	Amount	N/A	Average Time	N/A						
Average Score	N/A	Average Score	N/A	Average Score	N/A	Average Score	N/A	Average Score	N/A	
Average of Priority	N/A									
Material Assessment Score	N/A									
Recommendation	No further action required

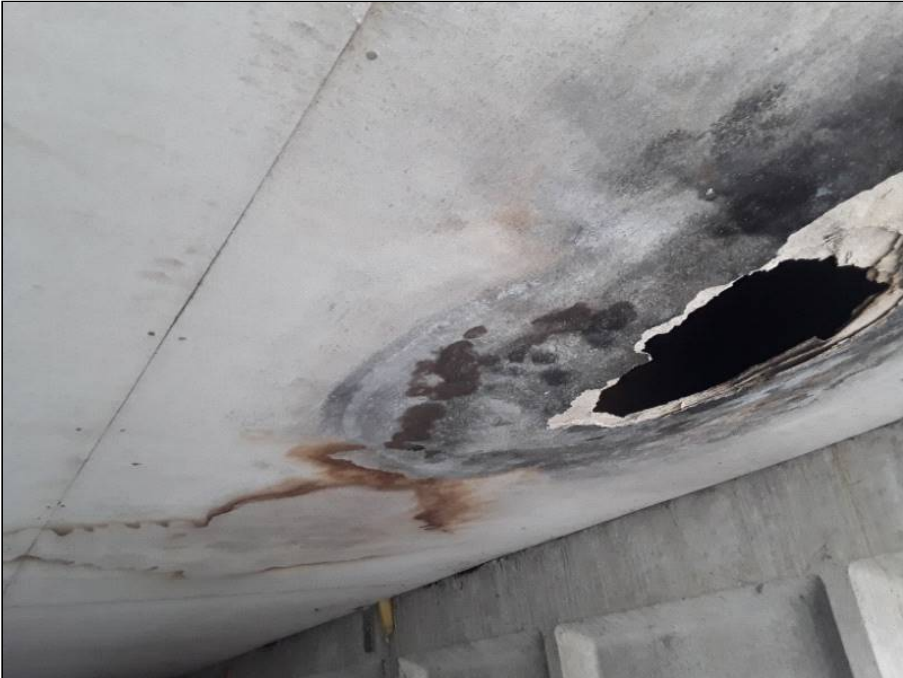
Survey Date:		Lead Surveyor		Survey Type		Floor		Analysis	
	12 May 2021 to 12 May 2021		Steve Beak		Demolition Survey		Ground Floor		No Asbestos Detected	
	Building		Room		Item				Quantity	
	Garage 11		Internal		Insulation board To ceiling				10m ²	
	Sample No (S,SP,P,As)		Product Type		Surface Treatment		Condition		Accessibility	
	KW005696 (S)		N/A		N/A		N/A		N/A	
	Normal Occupancy	Score	Likelihood of disturbance	Score	Exposure Potential	Score	Maintenance Activity	Score		
	Main type of activity	N/A	Location	N/A	Number of occupants	N/A	Type of Maintenance	N/A		
	Accessibility	N/A	Frequency of use	N/A	Frequency of maintenance	N/A				
	Amount	N/A	Average Time	N/A						
Average Score	N/A	Average Score	N/A	Average Score	N/A	Average Score	N/A	Average Score	N/A	
Average of Priority	N/A									
Material Assessment Score	N/A									
Recommendation	No further action required
