**Tree Health & Condition Assessment & Tree Management Report.**

**Site Details:** 12a Hollycroft Avenue, London, NW3 7QL

**Title:** MAY\_12aHA\_HCA\_002

**Published Date:** 18<sup>th</sup> January 2024

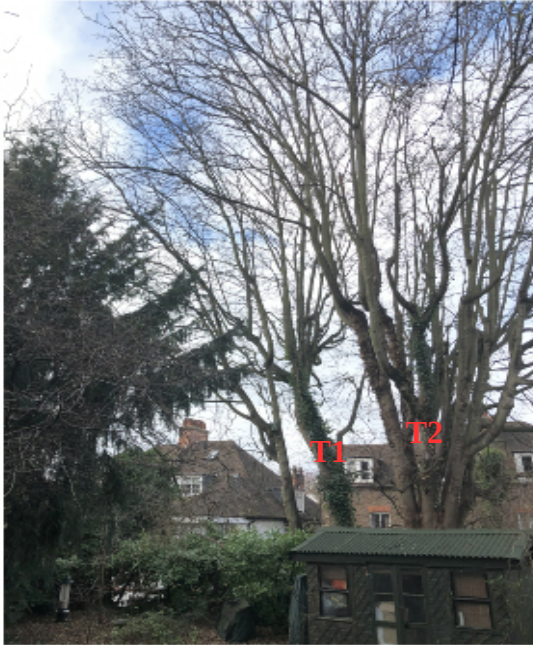
*T1 and T2 are located behind the shed on the rear (west) boundary.*

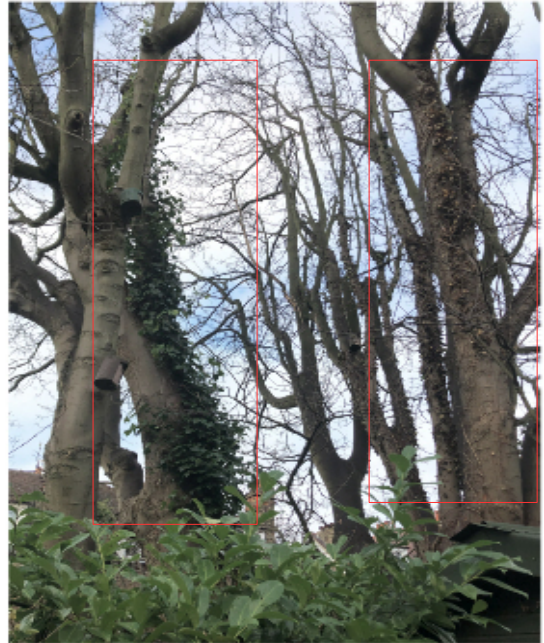
*Live and dead Ivy vines present on both tree stems and extending into the crown frameworks.*

Ivy removal is recommended to remove live and dead Ivy vines from the stems and crown limbs of both trees, to control the growth of the Ivy which can often be neglected and result in chronic colonisation of the tree.

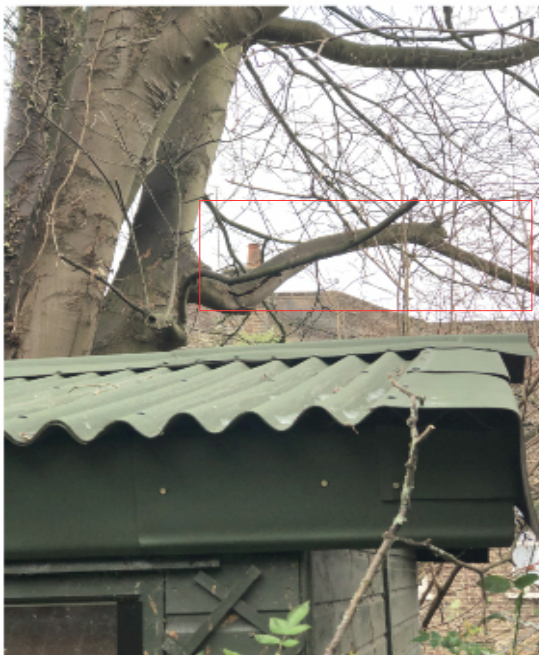
*Hazard Beam split limb on the north side of T2 at approx. 4m.*

The recommendation made to remove all hazardous deadwood from both of the trees and the Hazard Beam split limb from T2 is a proactive exercise to reduce the risk of large, dead or structurally impaired branches/limbs falling from the crown and potentially causing property damage and/or personal injury.

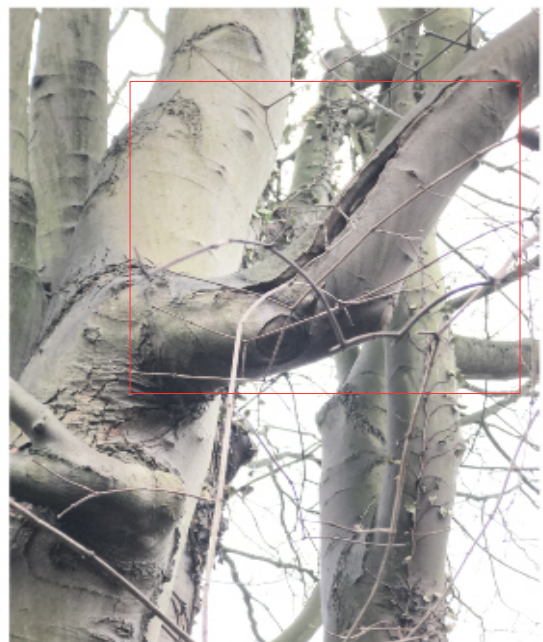
*Close up photo of the Hazard Beam split limb on the north side of T2 at approx. 4m*

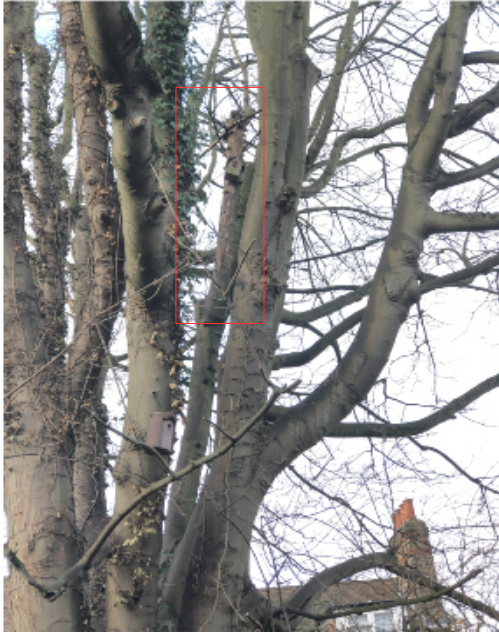
*Dead 2m top section of central pillar on T2. (Bird box attached).*

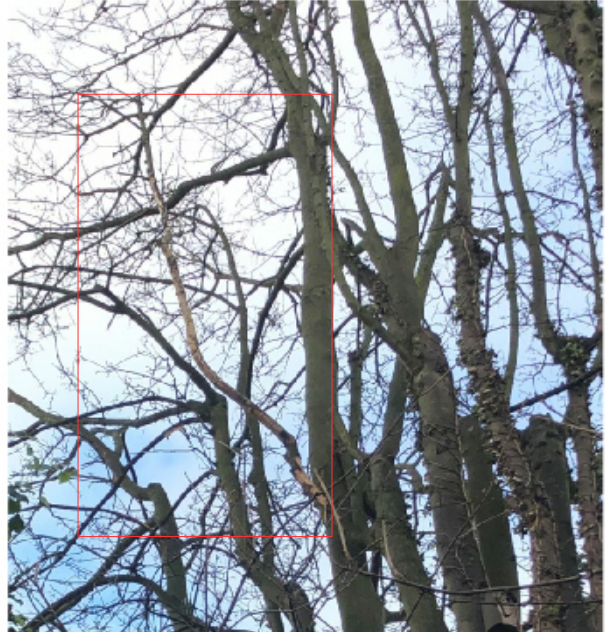
*Major sized deadwood in the crown of T2 and overhanging the neighbouring garden to the west.*

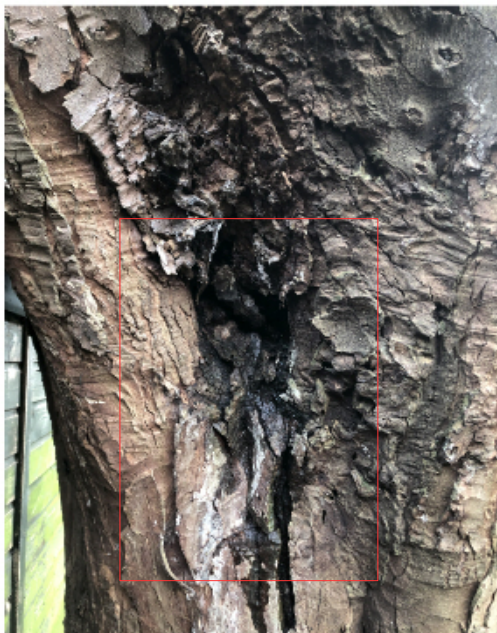
*Suspected bacterial canker on the north side of the stem of T2.*

The observed cavity on the north side of the stem of T2 will be re-assessed at the next scheduled assessment of the trees, which our client is advised to commission as per the guidance provided in Sections 2.1 and 8.0.

*To be re-assessed at next inspection in 16 months time.*

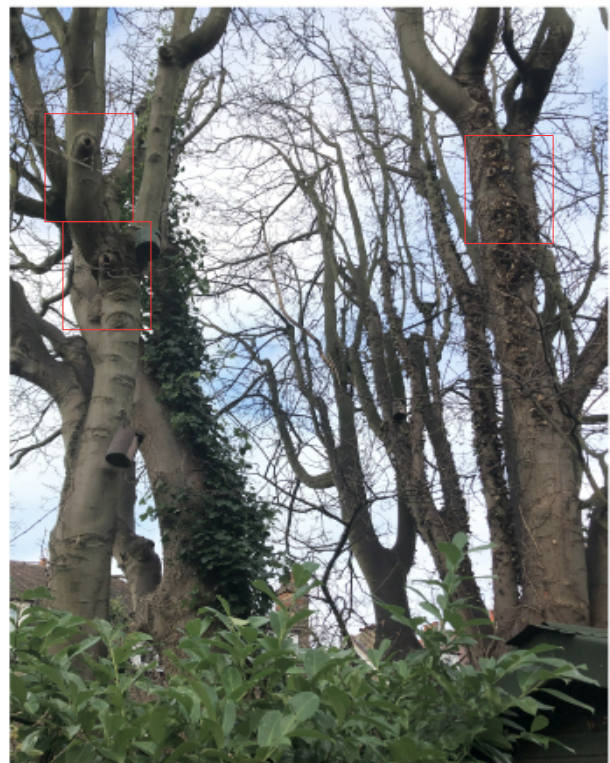
These areas relate to where included bark is visible in the crotch points of co-dominant, fastigate limbs, where branches are crossing and in some cases fused together and where partially occluded cavities were observed in the crown framework, where historical branch loss/removals have occurred.

*Part occluded pruning wounds on T1 and fused co-dominant stems on T2.*

The recommend climbed inspection for T2, is to allow for a close up assessment of identified areas where structural defects were observed (*i.e. cavities, fused limbs and included bark at branch / co-dominant stem unions*). The results of the climbed inspection will dictate whether or not any additional tree surgery works are necessary at this time.

*To be checked and evaluated by a climbed or aerial inspection.*
