**Tree Health & Condition Assessment & Tree Management Report.**

**Site Details:** 12a Hollycroft Avenue, London, NW3 7QL

**Title:** MAY\_12aHA\_HCA\_002

**Published Date:** 18<sup>th</sup> January 2024

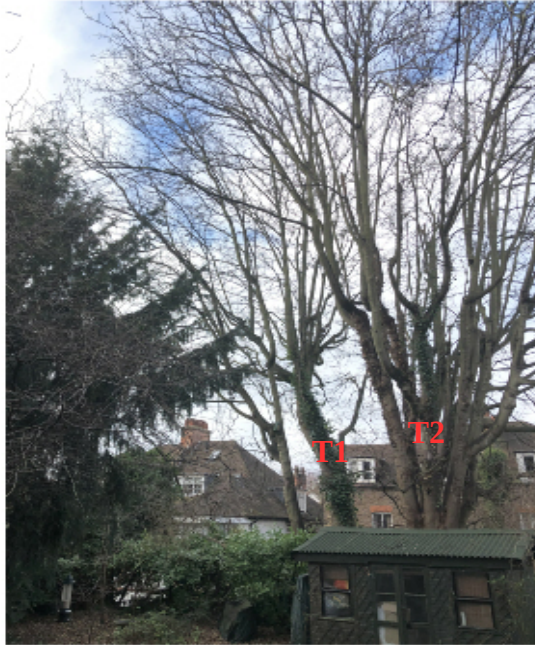
*T1 and T2 are located behind the shed on the rear (west) boundary.*

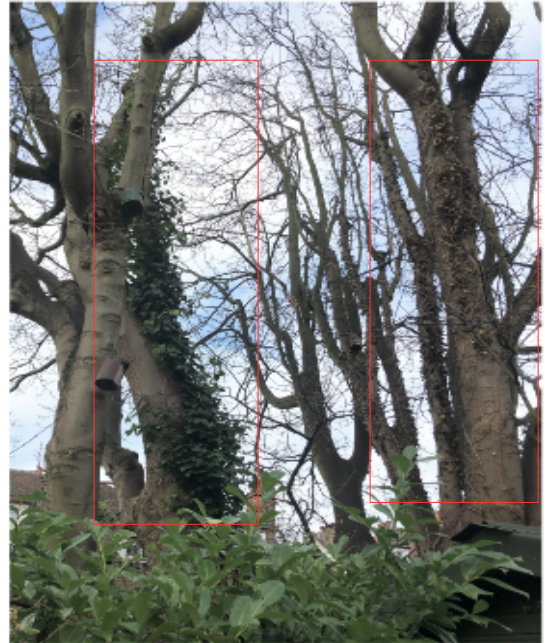
*Live and dead Ivy vines present on both tree stems and extending into the crown frameworks.*

Ivy removal is recommended to remove live and dead Ivy vines from the stems and crown limbs of both trees, to control the growth of the Ivy which can often be neglected and result in chronic colonisation of the tree.

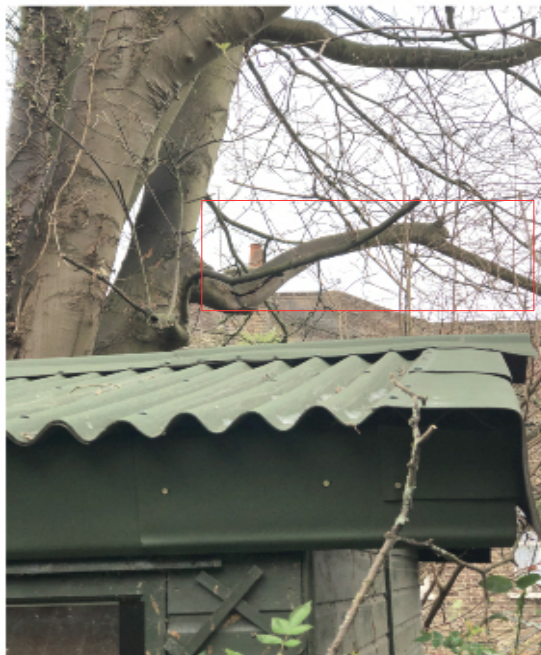
*Hazard Beam split limb on the north side of T2 at approx. 4m.*

The recommendation made to remove all hazardous deadwood from both of the trees and the Hazard Beam split limb from T2 is a proactive exercise to reduce the risk of large, dead or structurally impaired branches/limbs falling from the crown and potentially causing property damage and/or personal injury.

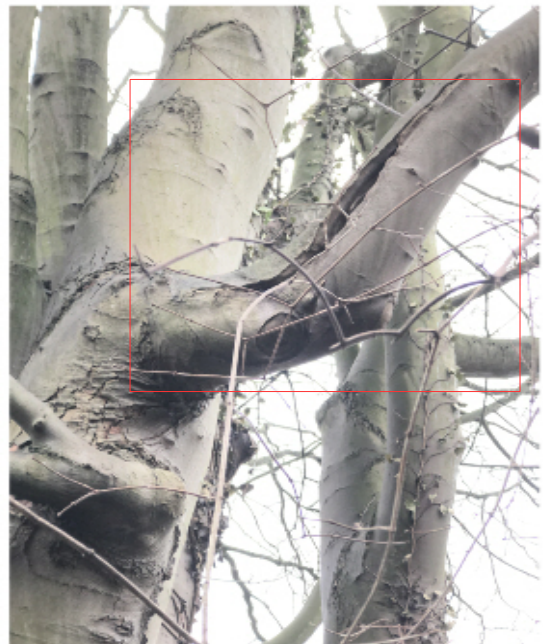
*Close up photo of the Hazard Beam split limb on the north side of T2 at approx. 4m*

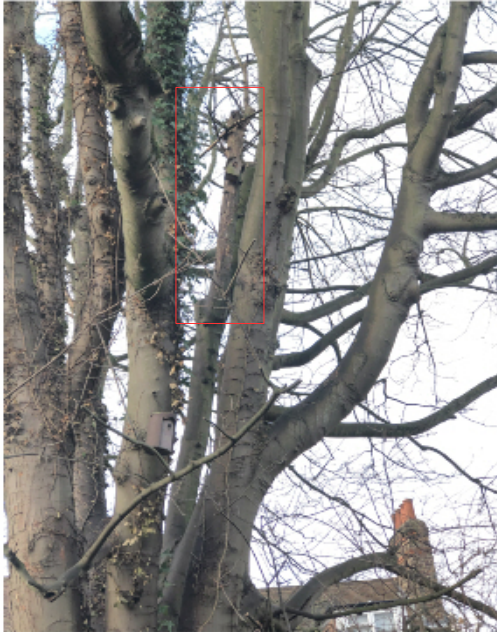
*Dead 2m top section of central pillar on T2.  
(Bird box attached).*

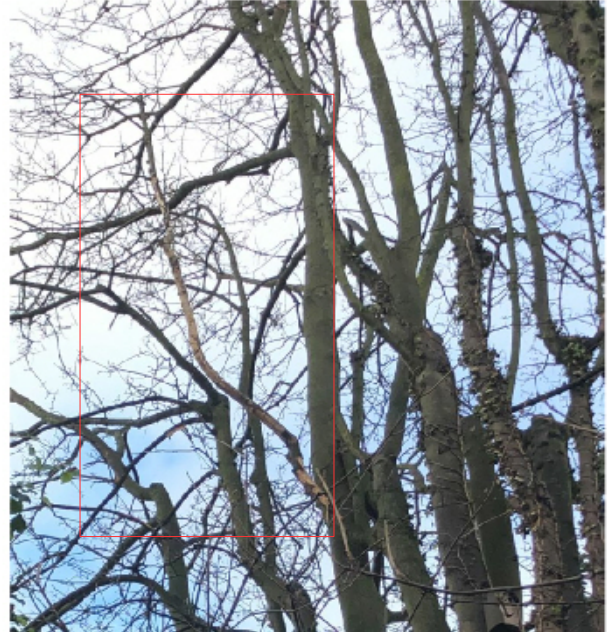
*Major sized deadwood in the crown of T2  
and overhanging the neighbouring garden to  
the west.*

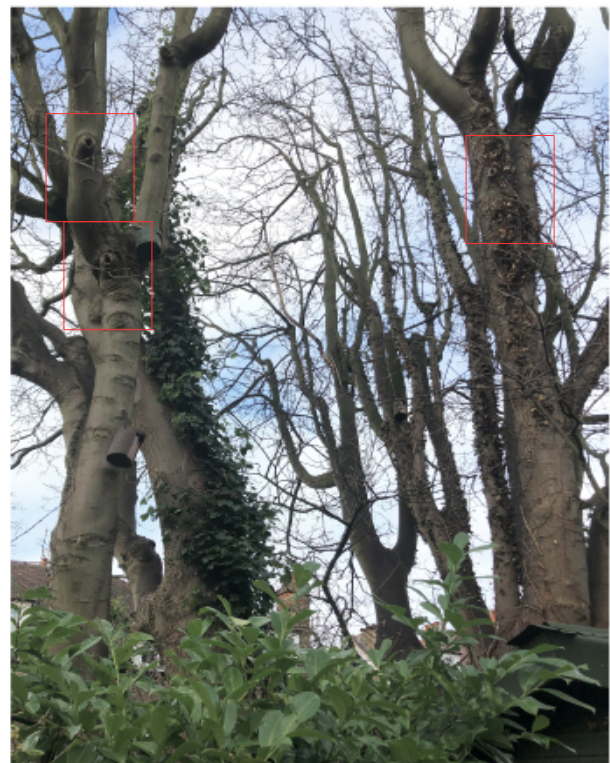
*Part occluded pruning wounds on T1 and fused  
co-dominant stems on T2.*

The recommended climbed inspection for T2, is to allow for a close up assessment of identified areas where structural defects were observed (*i.e. cavities, fused limbs and included bark at branch / co-dominant stem unions*). The results of the climbed inspection will dictate whether or not any additional tree surgery works are necessary at this time.

*To be checked and evaluated by a climbed or  
aerial inspection.*
