REMEDIAL WORKS TO BASEMENT AND GROUND FLOOR:

State Street Street Proposed Basement & Ground Floor Plans PROJECT REF. | SHEET NO. CP-2023-41 | S1-10 SCALE SHEET SIZE DATE CLIENT PURPOSE 1:50 A2 02|10|2023 - PURPOSE

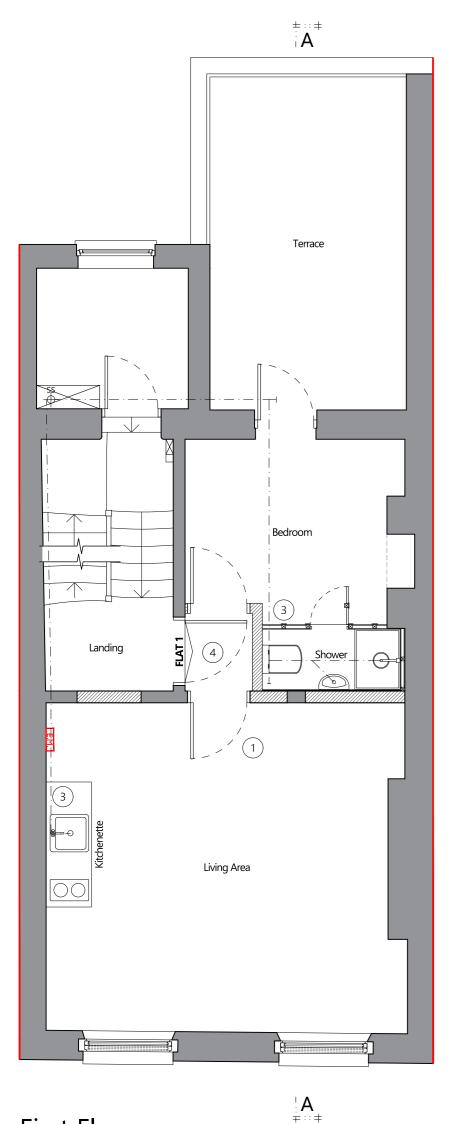
First Floor Scale: 1:50 @ A2

- 1. The timber floors at the upper levels show extensive sag / deflection due to both age and historic defects such as excessive notching. The additional load applied due to partition works has also contribute to the joists becoming overstressed and hence deflecting further than expected. New joists are to be introduced adjacent to the existing joists or at 600mm ctrs (whichever greater), supported on the external walls at one end and the central spine structure at the other end of the joist. They shall be through bolted to the existing joists at regular centres. The new joists shall be installed to be level across the entire floor plate.

- 2. Where joists meet the external walls, brick repairs are likely required. Investigations show the façade may reduce to one brick thickness through the zone of the floor. New reclaimed brickwork to be introduced in lime based mortars.

- Proposed drainage run through floor to connect to existing soil pipe.
- 4. Historic (blocked up) opening to be reinstated to form new fire protected entrance lobby into Flat 1.
