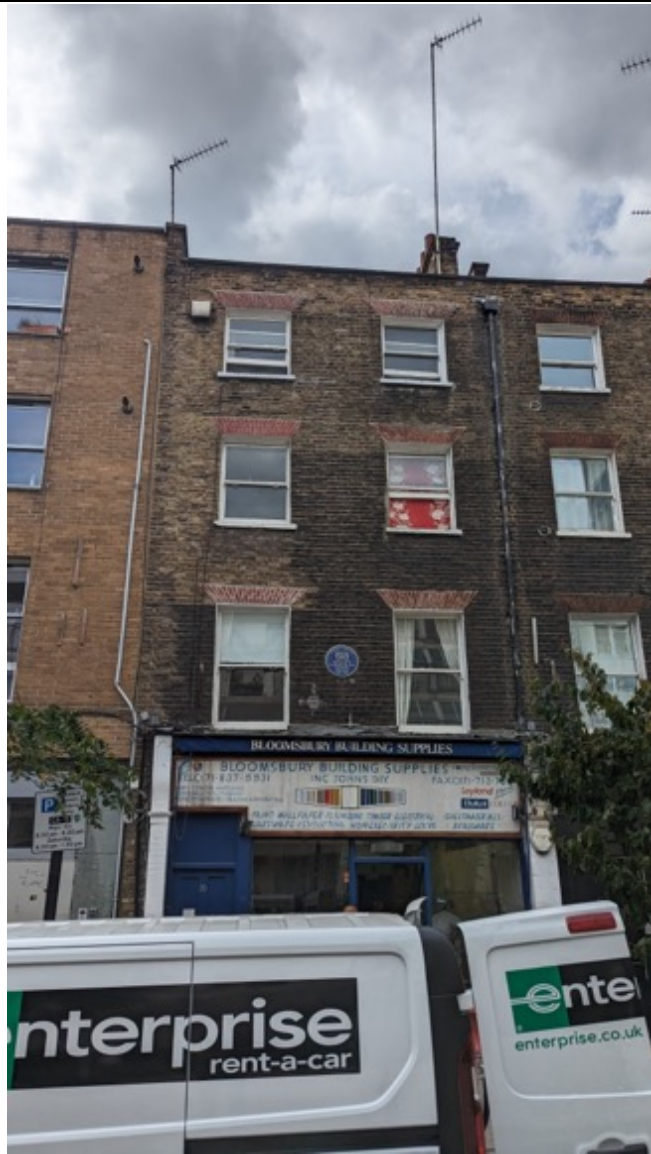
Photo 01: Front elevation taken from street opposite

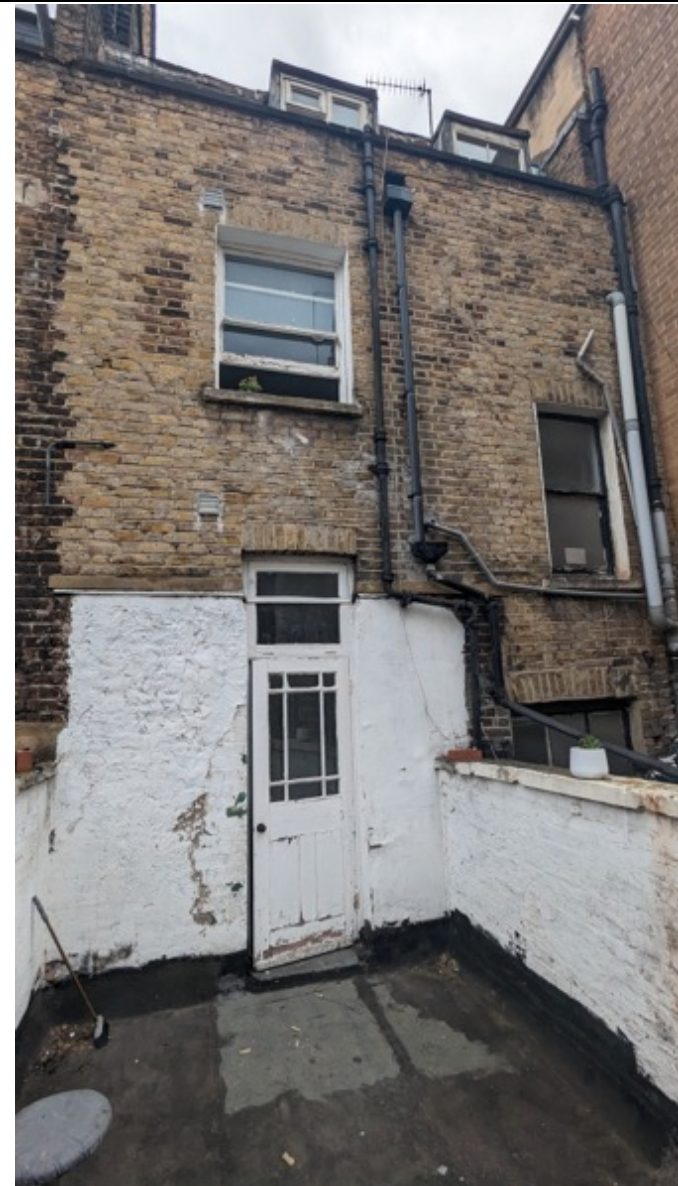
Photo 02: Rear elevations taken from street opposite

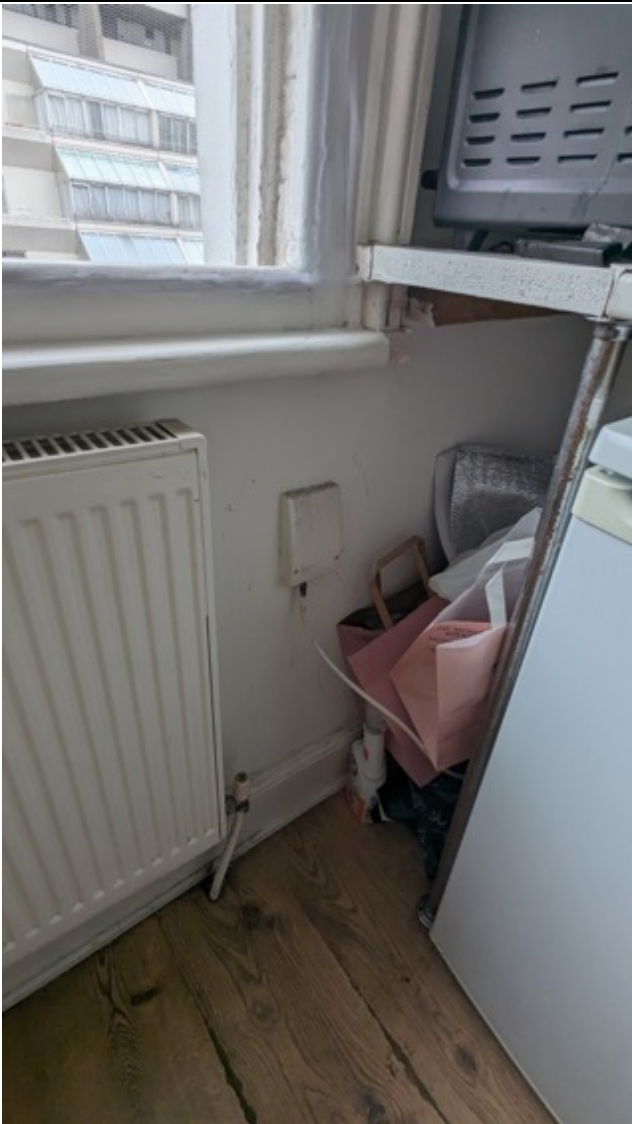
Photo 03: Second Floor flat (front elevation) showing crack from corner of window to floor

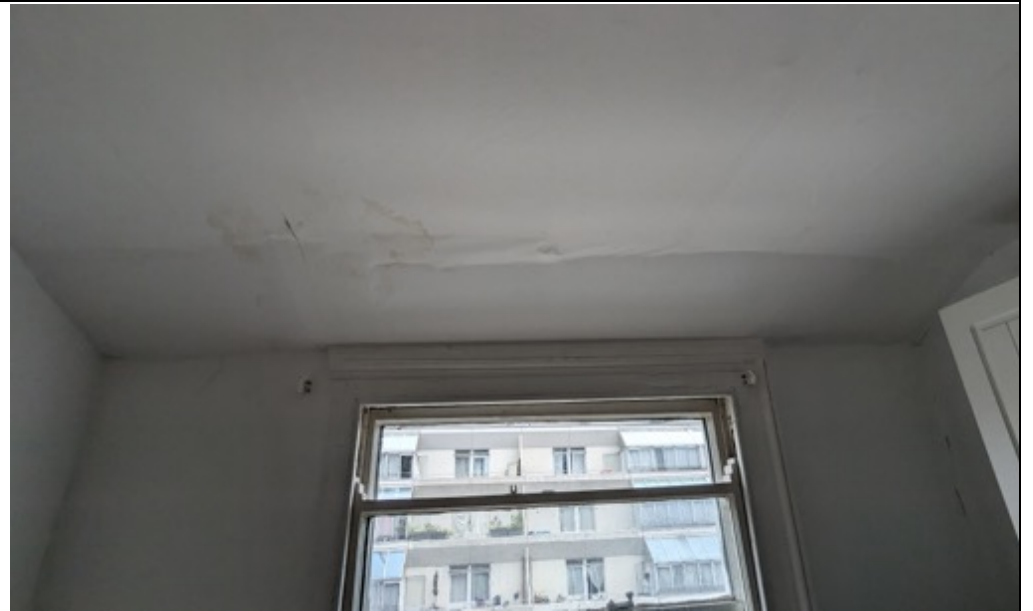
Photo 04: Top floor flat (front elevation) showing water damage to ceiling

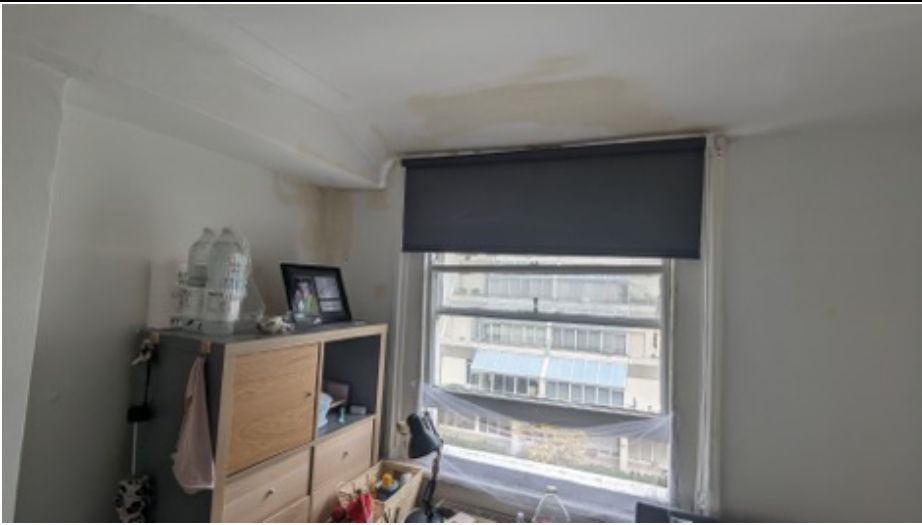
Photo 05: Top floor flat (front elevation) showing water damage to ceiling

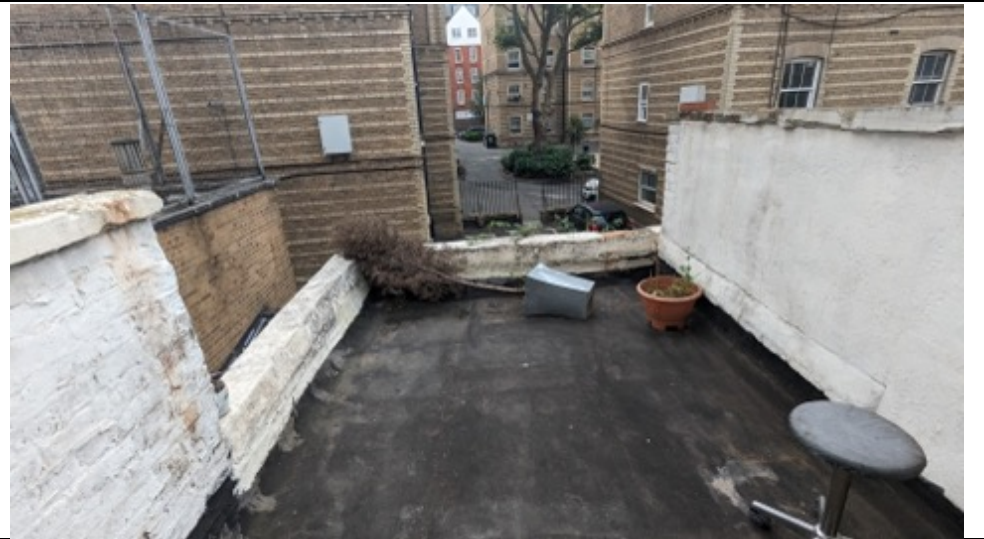
Photo 06: First floor flat roof terrace

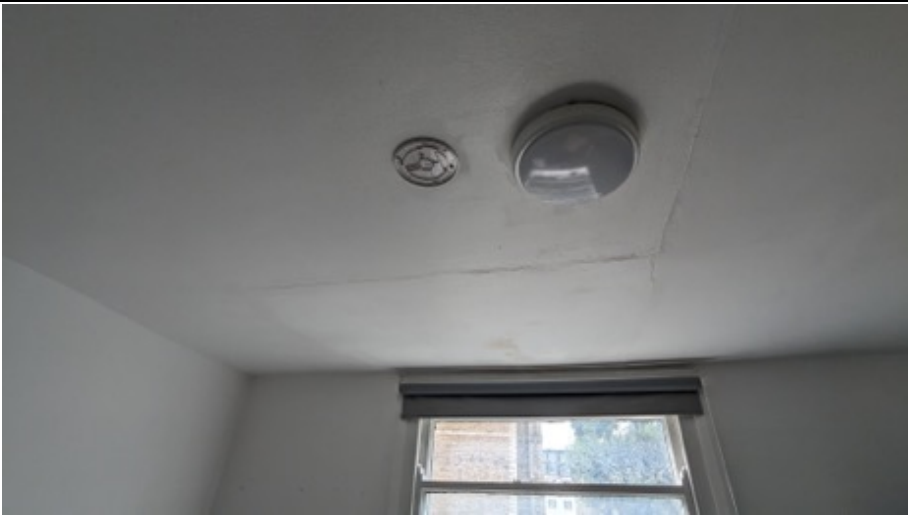
Photo 07: Second floor flat ceiling showing cracks in plaster

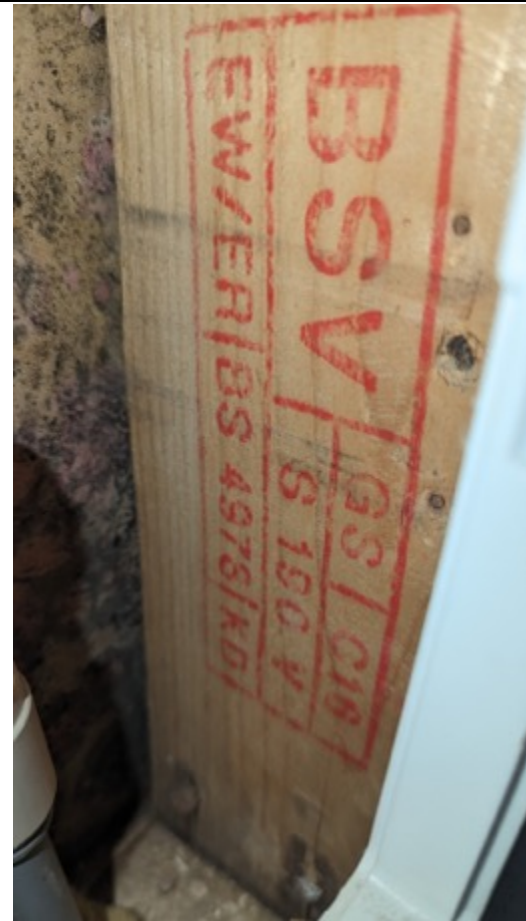
Photo 08: Second floor flat showing grade stamped timber stud

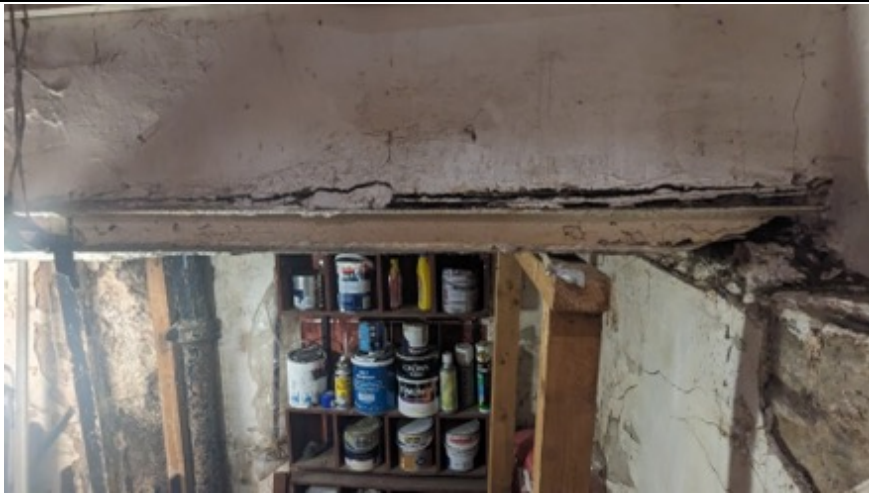
Photo 09: Corroding steel beam at basement level

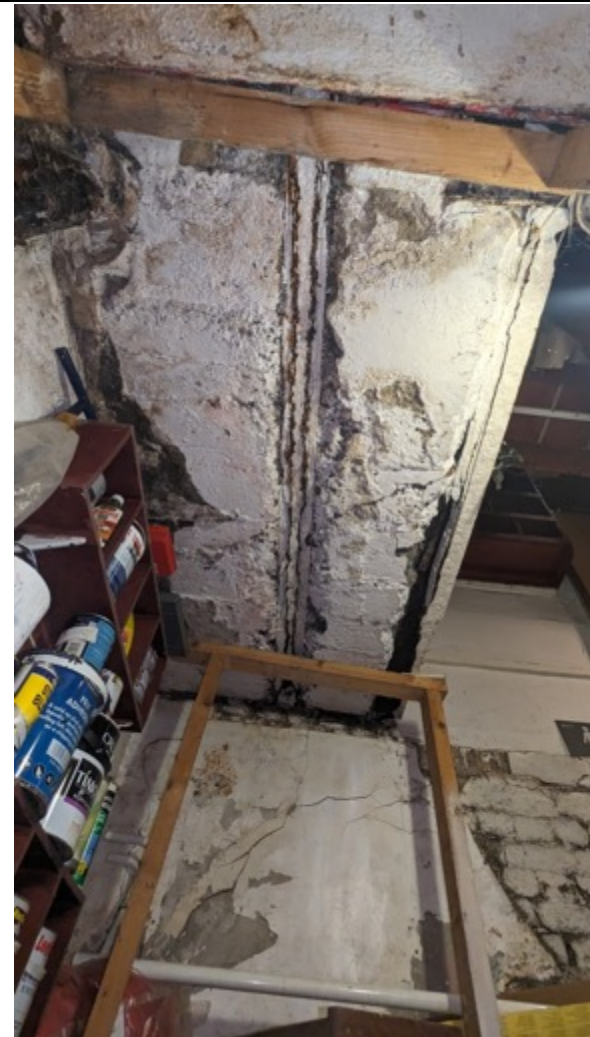
Photo 10: Corroding steels / filler joist floor, partially supported on temporary timber

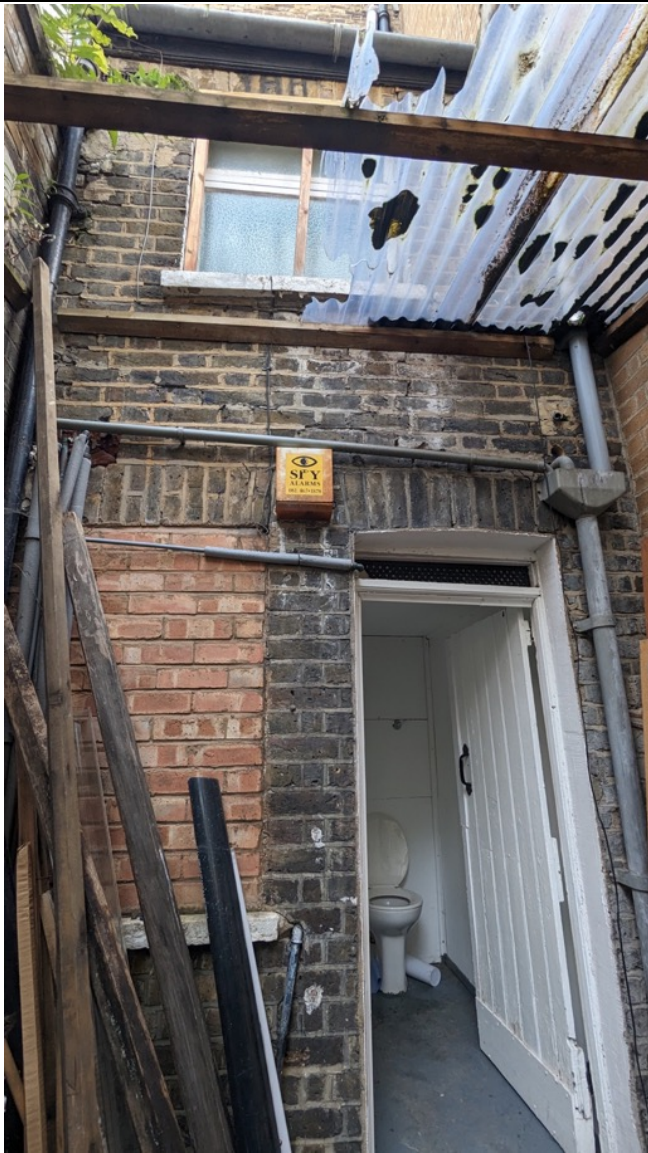
Photo 11: Flat brick arch lintels over door / infilled window have failed. Cracking observed in masonry above

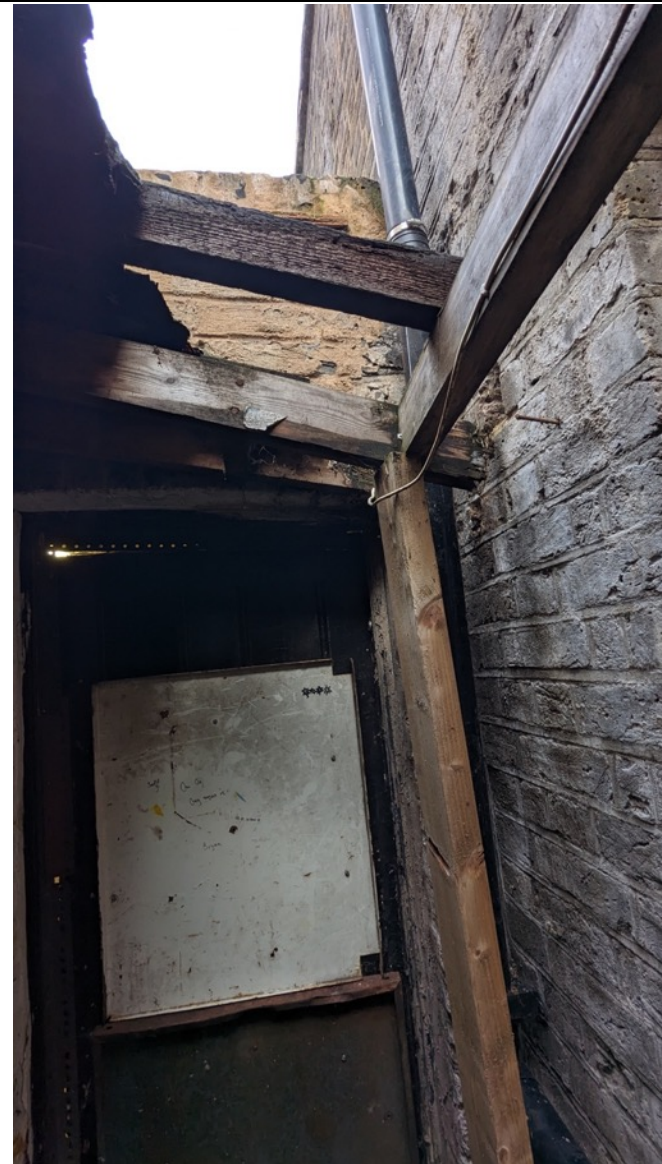
Photo 12: Delapidated timber roof structure over courtyard. Roof coverings missing in places

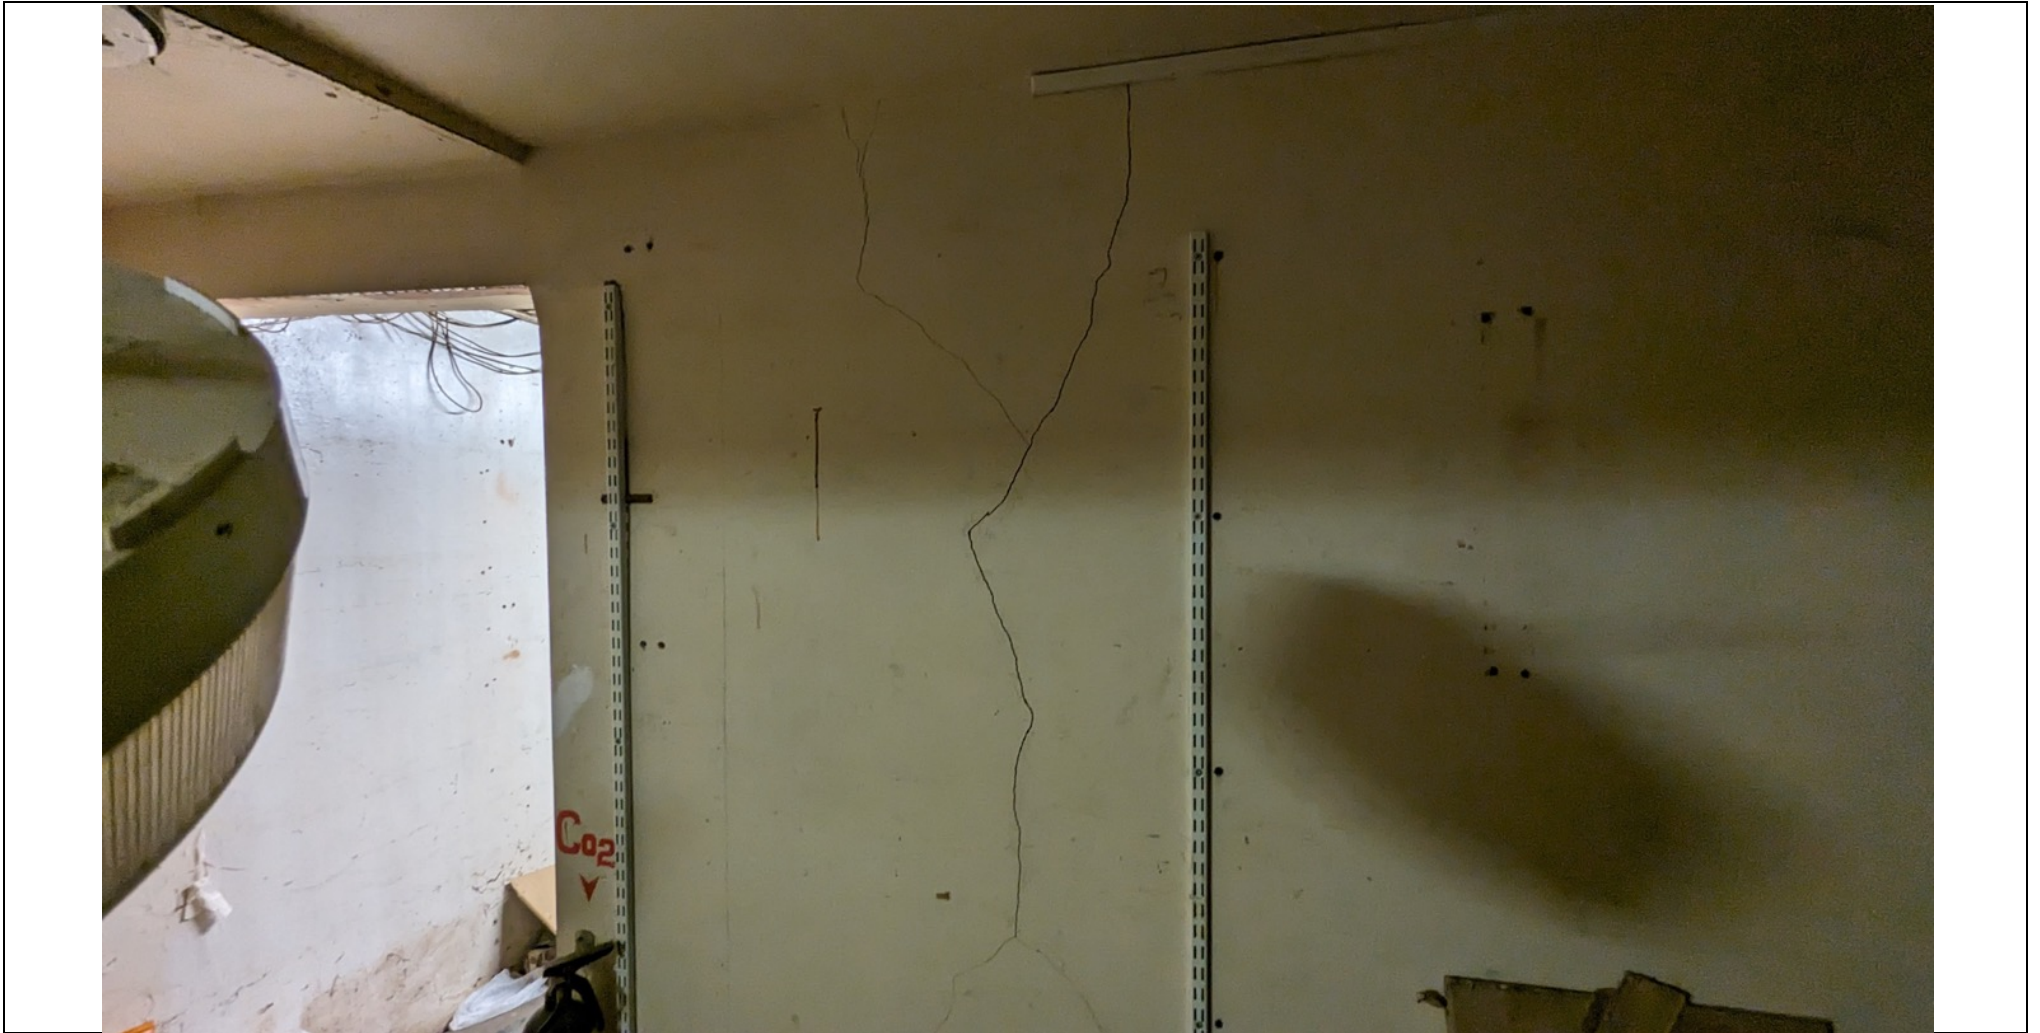
Photo 13: Cracking to central basement masonry wall

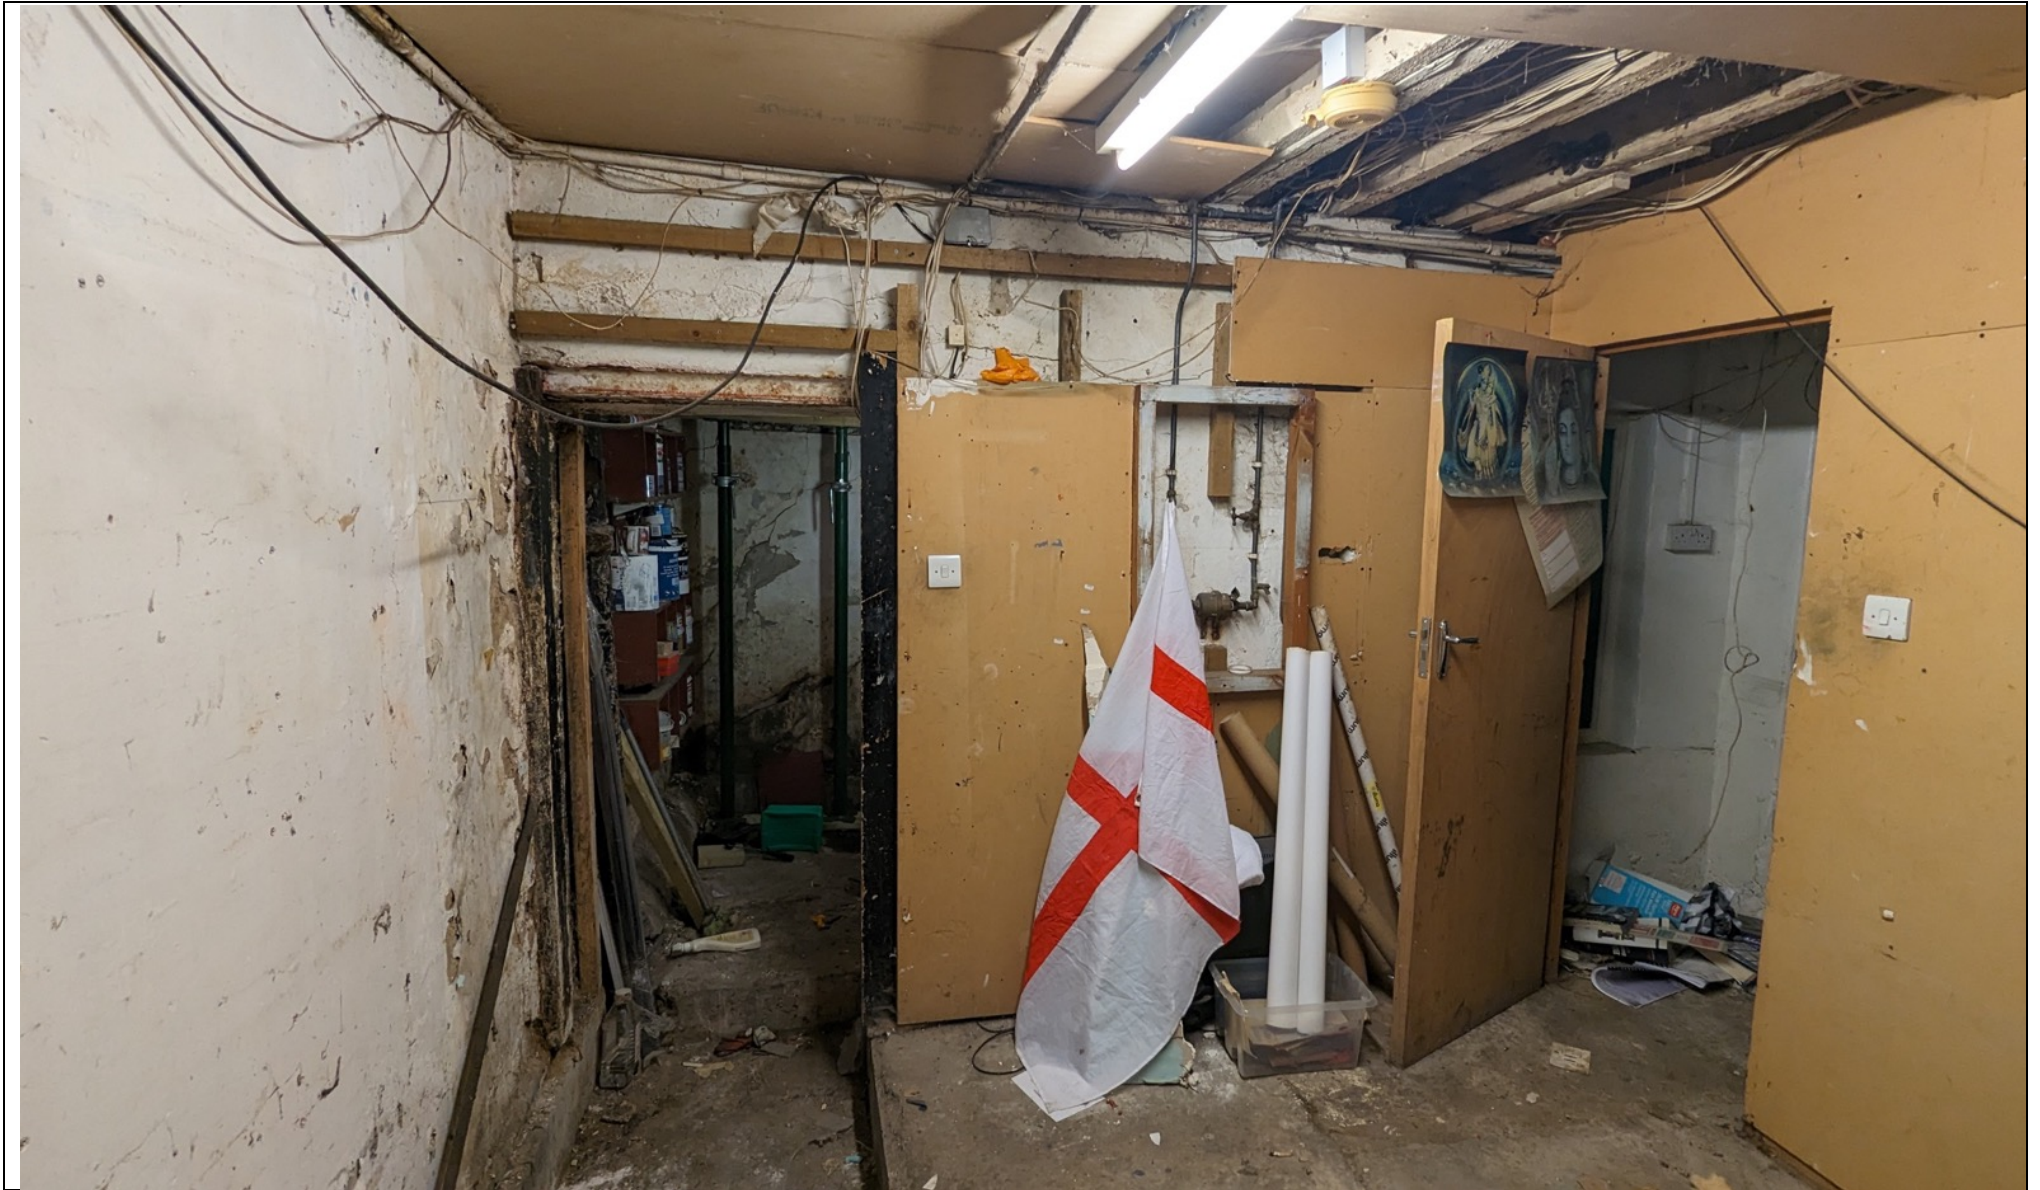
Photo 14: Rear wall of basement space. Cracking observed behind wooden panels horizontally and continues over top of door

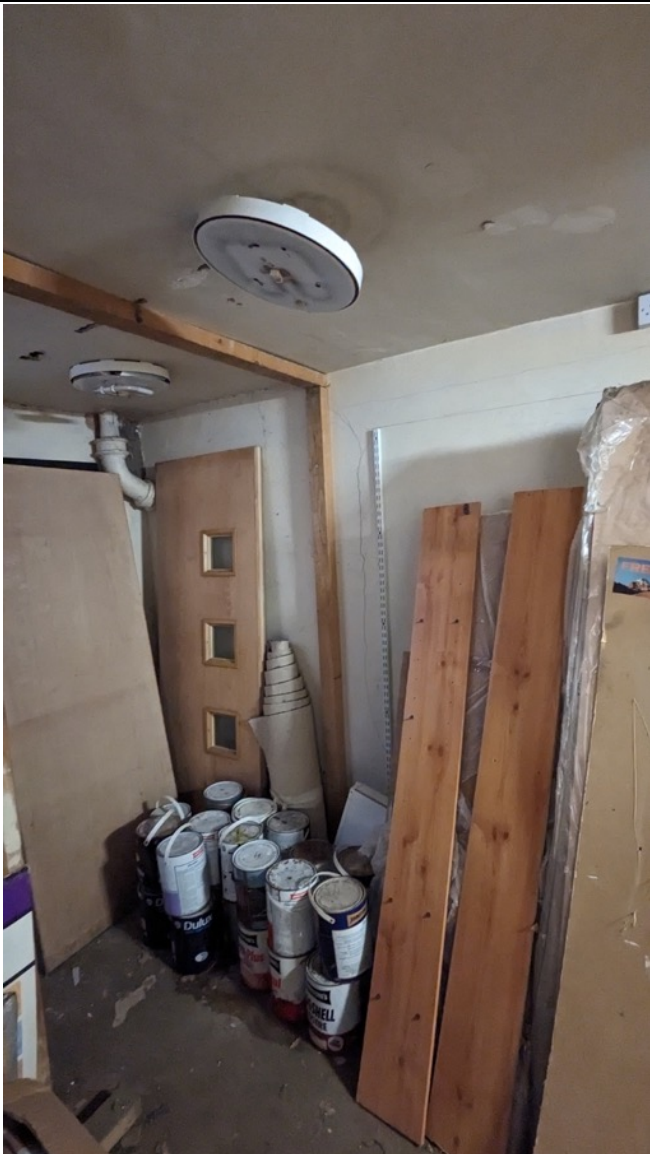
Photo 15: Vertical crack in wall to front of basement, extends to the horizontal position just below ceiling level

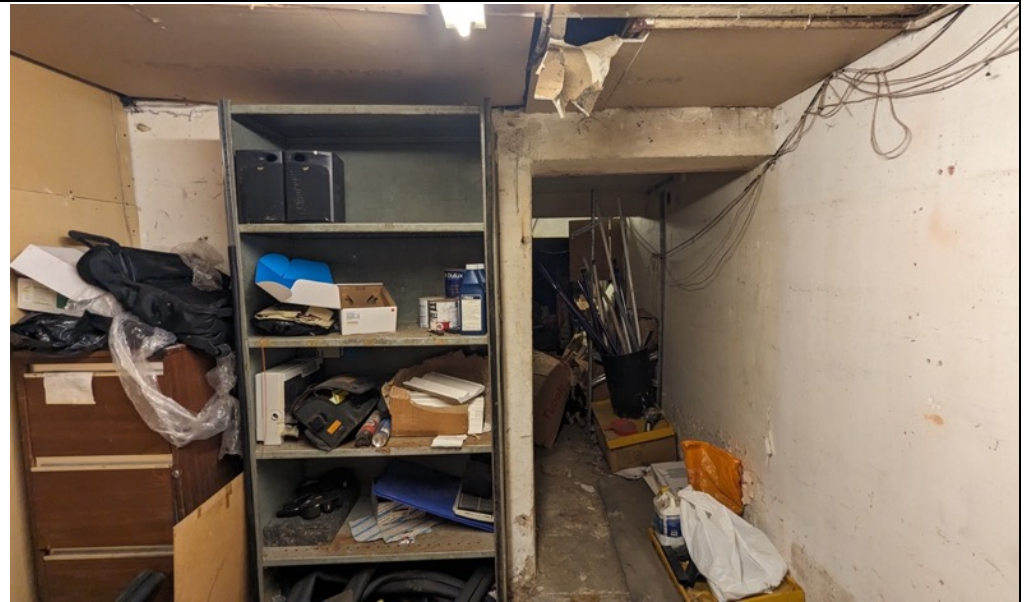
Photo 16: Dropped lintel over door opening in central basement wall

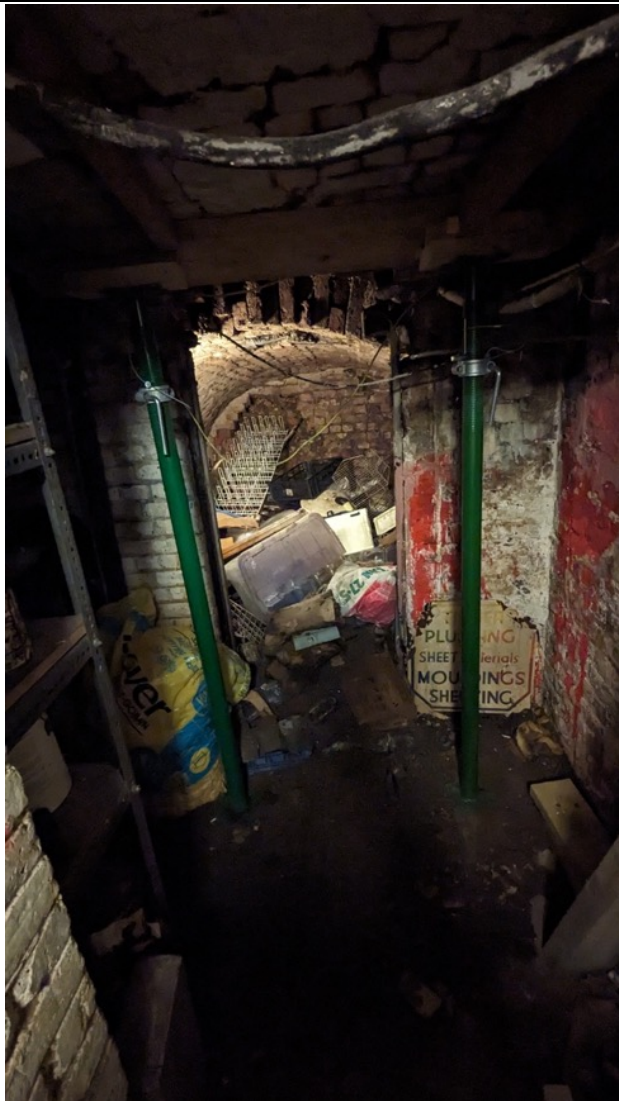
Photo 17: Brick wall at back of vault has collapsed exposing earth behind. Across temporarily installed to support collapsed ceiling of brick arch vault

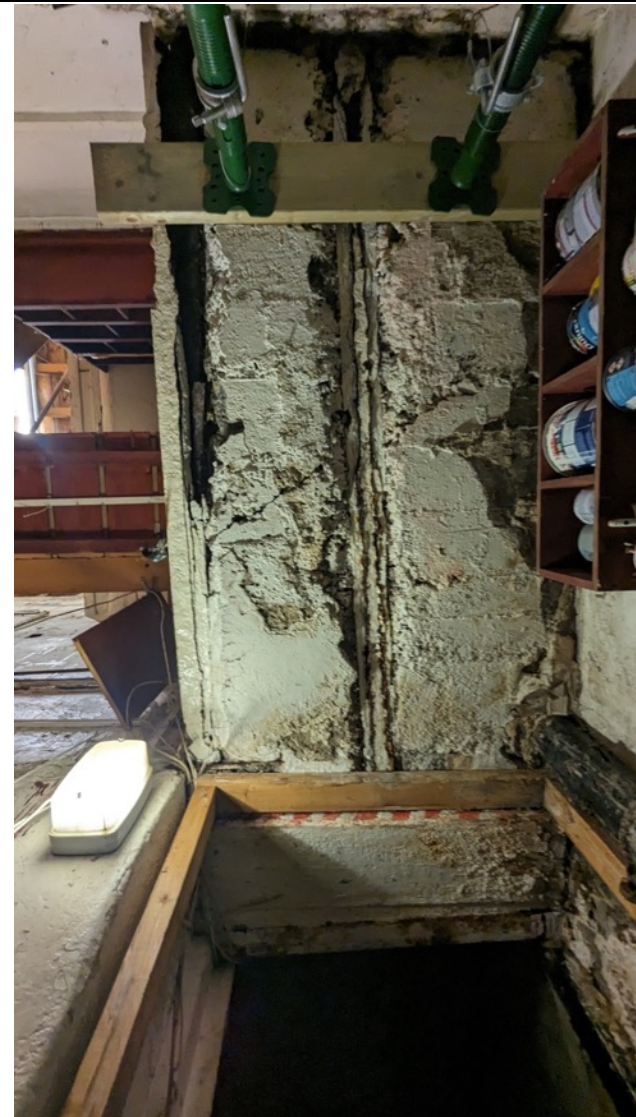
Photo 18: Across temporarily installed to support failed filler joist floor above basement

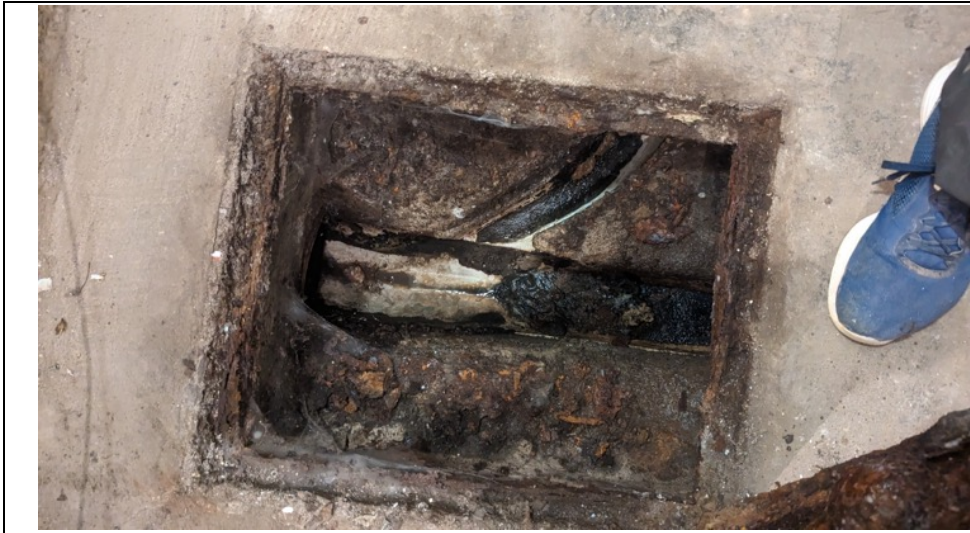
Photo 19: Manhole at rear of basement. Flow direction towards front of building, lateral intercept from adjacent SVP

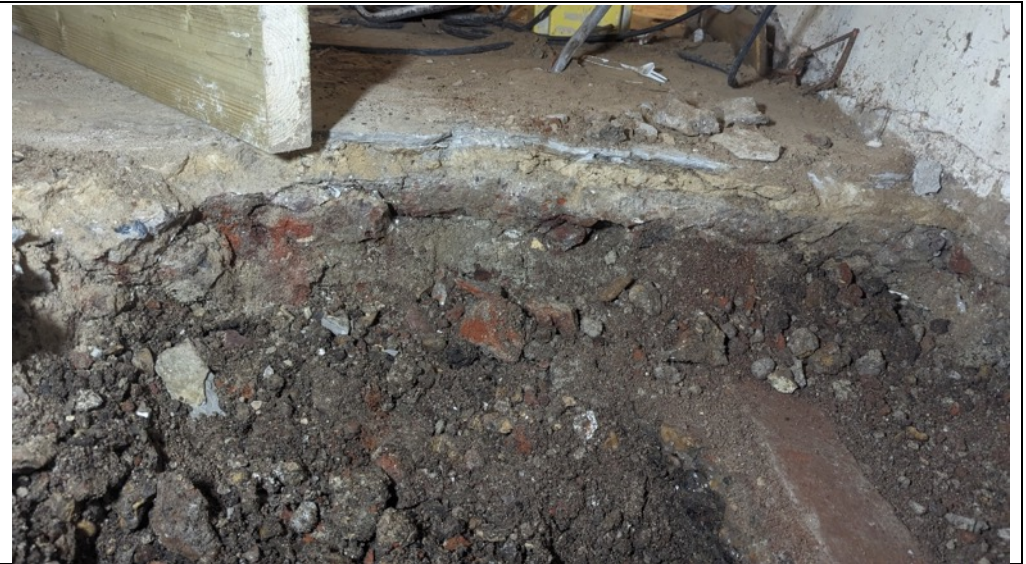
Photo 20: Trial Pit One adjacent to spine wall. Showing thin screed, slab, made ground and projecting concrete footing

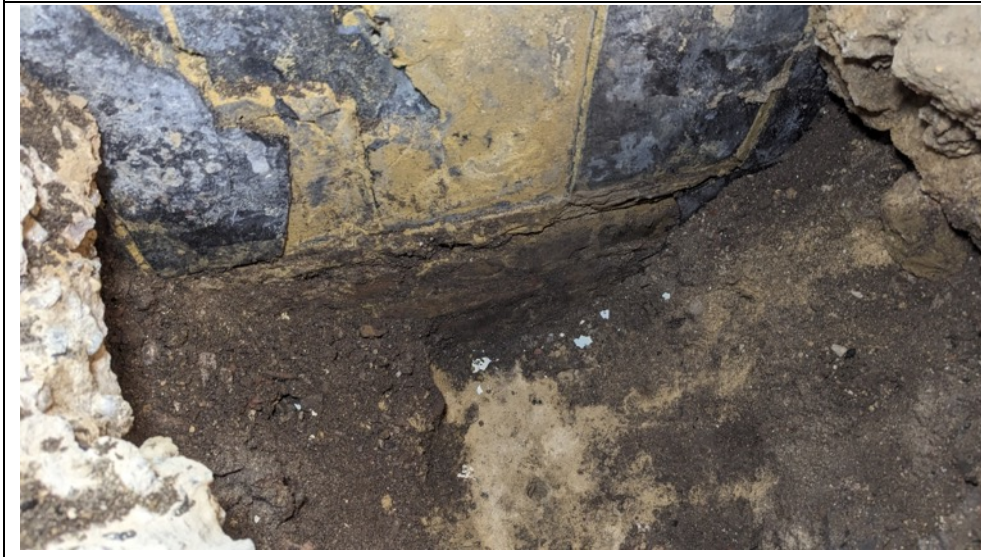
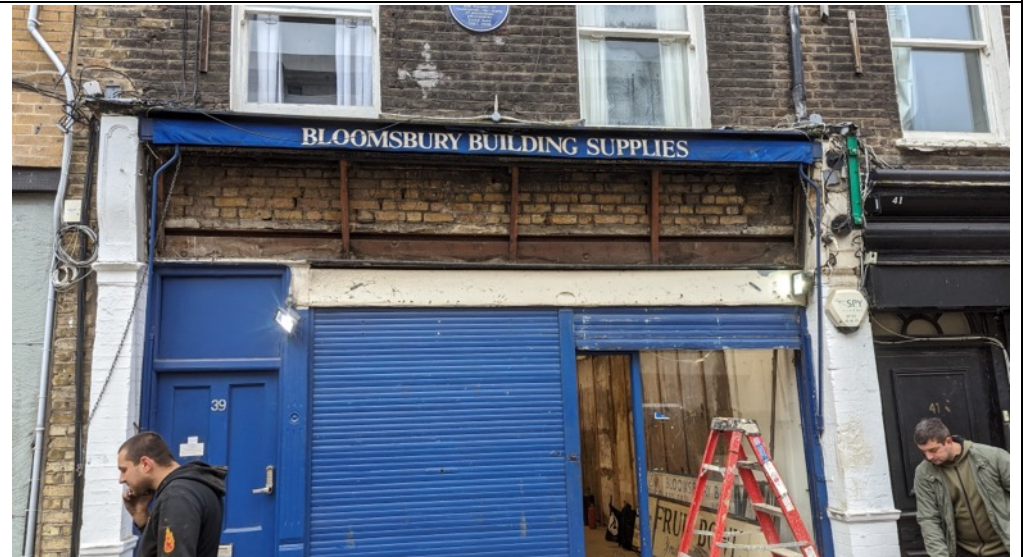
Photo 21: Trial Pit Two adjacent the party wall showing screed, slab, made ground and projecting concrete footing. Depth and extent of concrete footing unknown. Bottom / edge not found

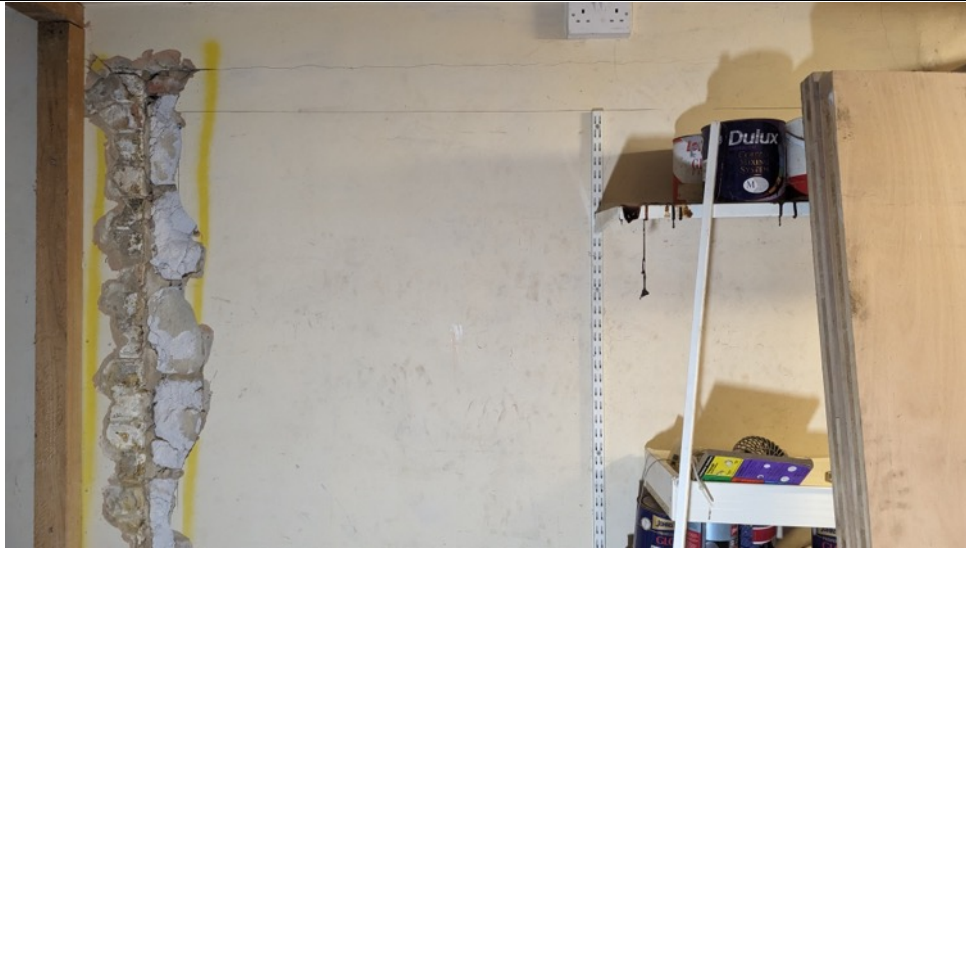
Photo 24: Central spine wall. Cracking has manifested through the brickwork. Damaged bricks, loose and spalling mortar, soft crumbled face to bricks. Repairs / reinstatement required

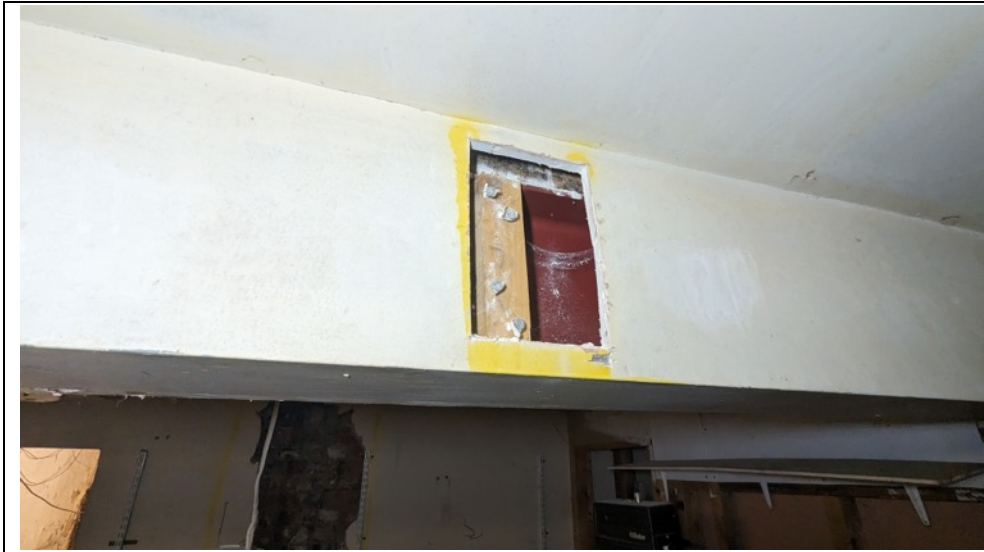
Photo 25: Downstand bulkhead reveals RSJ at high level in basement

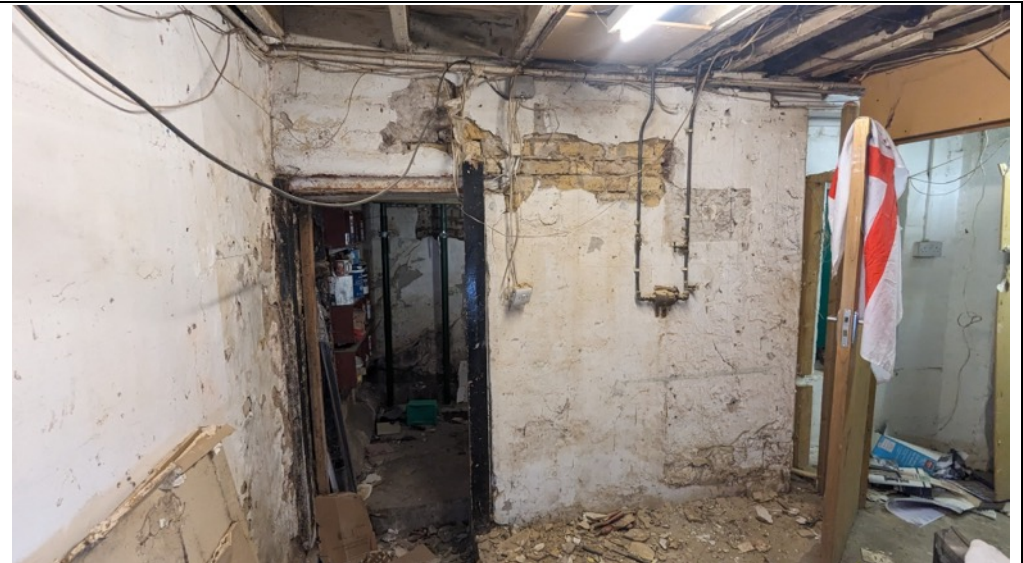
Photo 26: Rear wall of basement space. Removal of plaster shows various different brick types and historic interventions. Repair required

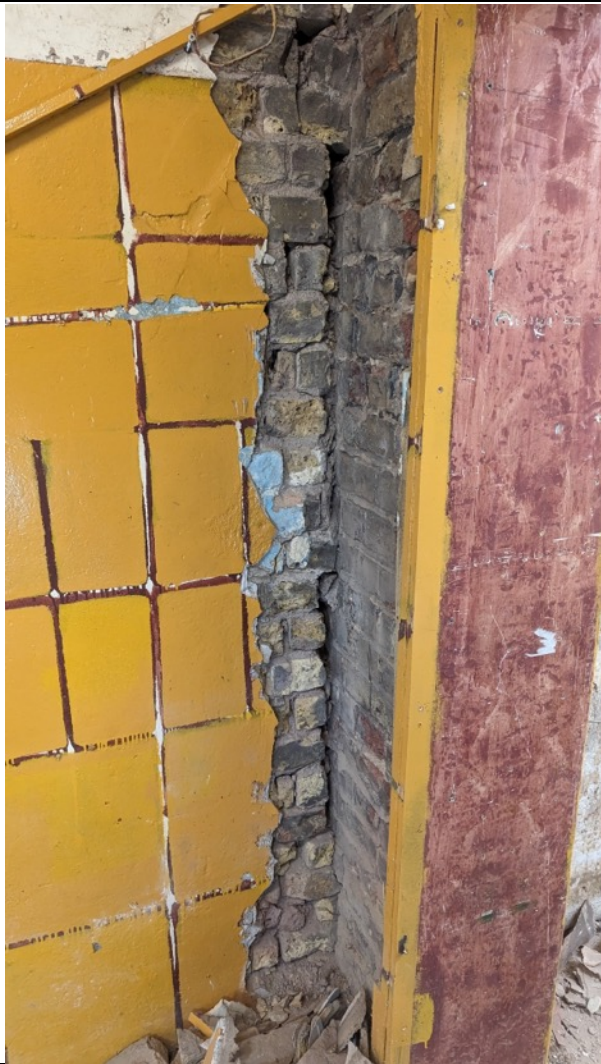
Photo 27: Spine wall at ground floor rear of shop is de-bonded from the party wall. Repair required

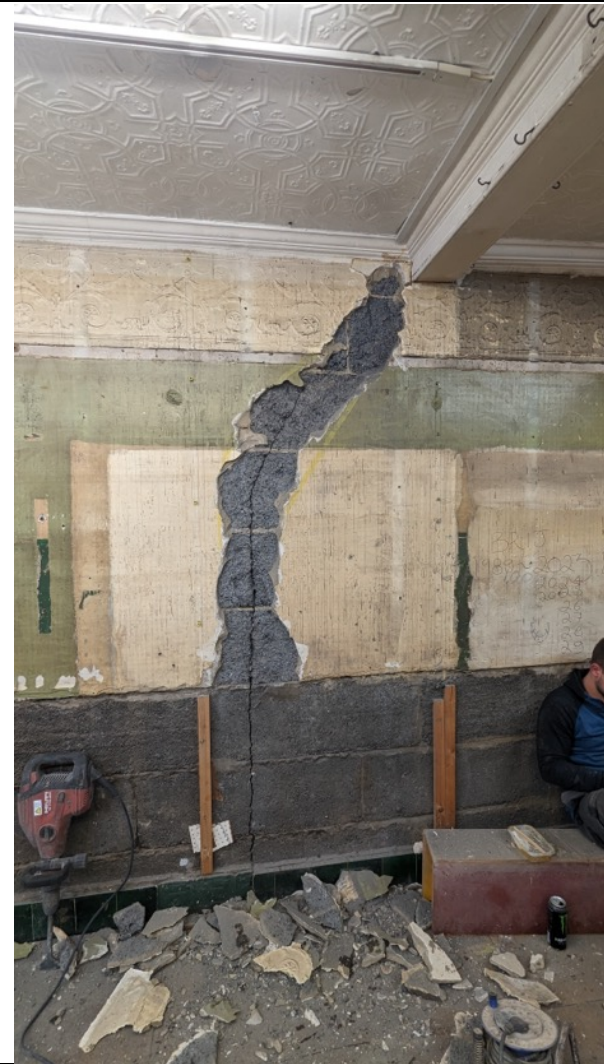
Photo 28: Ground floor wall separating the corridor and the shop unit, crack manifests through the plaster into the blockwork. Repair required

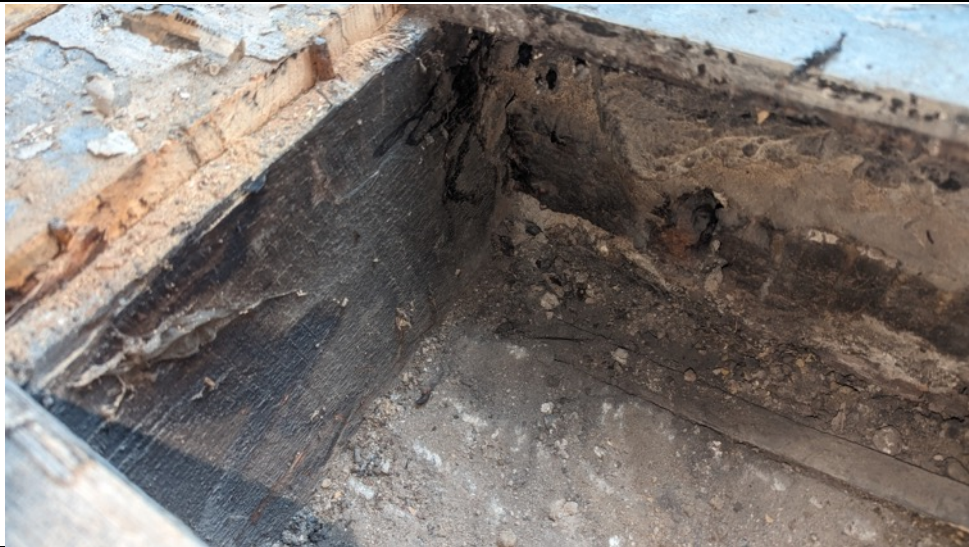
Photo 29: View of first floor timber joists after lifting floorboards at rear of property.
