Proposed Extension, Travelodge, Drury Lane, Covent Garden, WC2B 5RE

Appendix D – COMMERCIALDW Report

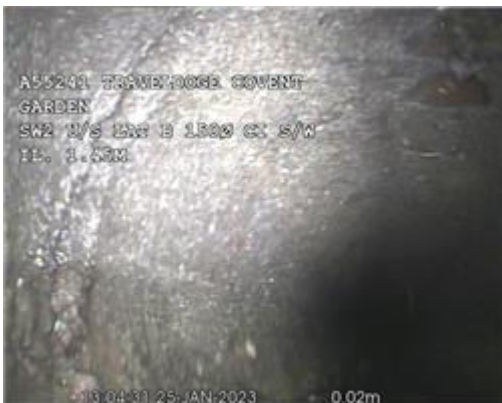
00.02m	0:00:02	LRQ	Line of drain/sewer deviates right [quarter]	Image Provided - Ref: 3_2

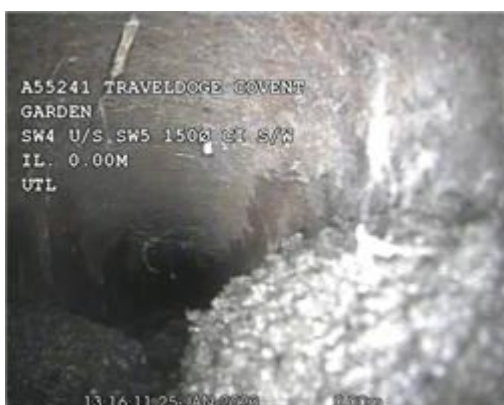
<p>A55241 TRAVELDOGE COVENT GARDEN SW4 U/S SW5 1500 BT S/W IL. 0.00M UTL</p> <p>13.16.11.25 JAN 2020</p>
00.00m	0:00:00	DES	Settled deposits fine: 10% Cross sectional area loss - Severity 3	Image Provided - Ref: 6_2

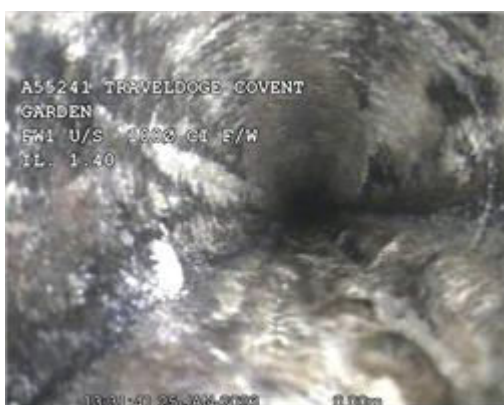
00.00m	0:00:00	S1 DEE	Attached deposits, encrustation 0m - 7.03m from 04 o'clock to 08 o'clock: 10% Cross sectional area loss - Severity 3	Image Provided - Ref: 7_2

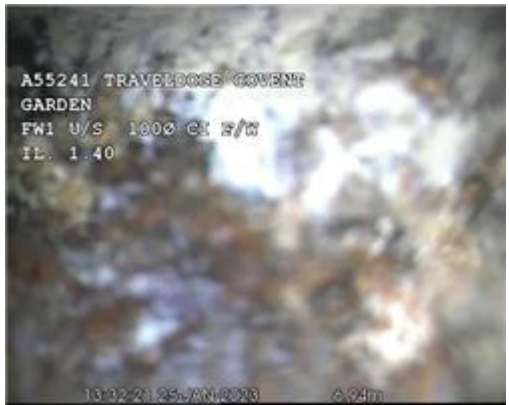
06.94m	0:00:39	LUQ	Line of drain/sewer deviates up [quarter]	Image Provided - Ref: 7_4

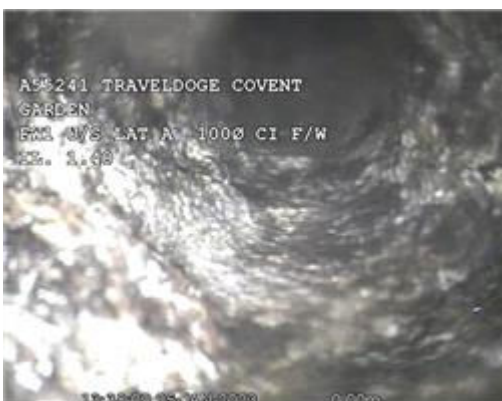
00.00m	0:00:00	S1 DEE	Attached deposits, encrustation 0m - 2.17m from 03 o'clock to 09 o'clock: 5% Cross sectional area loss - Severity 3	Image Provided - Ref: 8_2

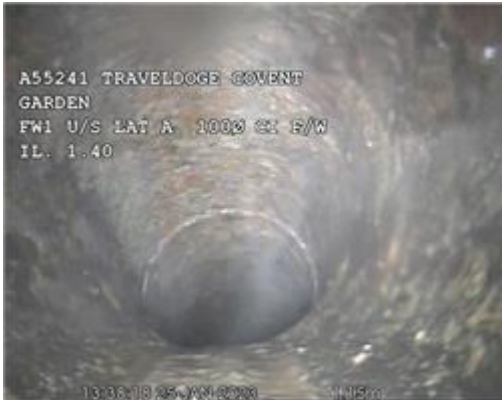
Pos	Video Ref	Code	Description	Image
01.15m	0:00:09	LDH	Line of drain/sewer deviates down [half]	Image Provided - Ref: 8_3

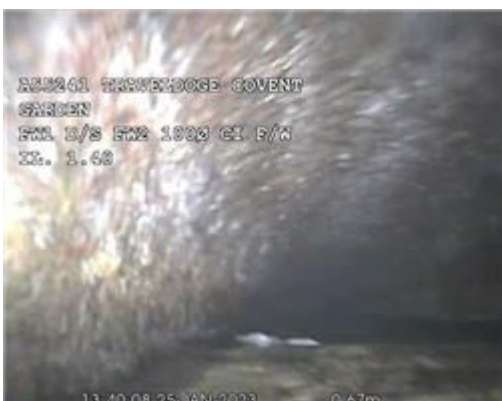
00.67m	0:00:07	WL	Water level: 10% Height/Diameter	Image Provided - Ref: 9_2

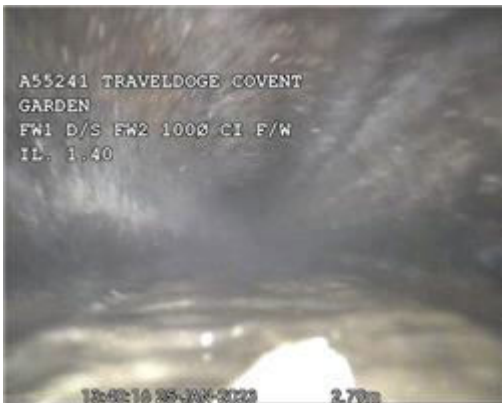
Pos	Video Ref	Code	Description	Image
03.00m	0:00:16	S1 DEE	Attached deposits, encrustation 3m - 6.07m from 04 o'clock to 08 o'clock: 5% Cross sectional area loss - Severity 3	Image Provided - Ref: 9_3

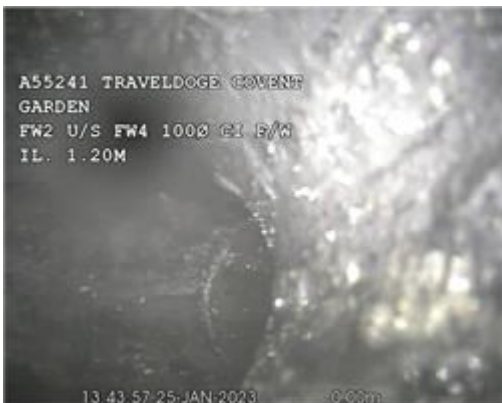
00.00m	0:00:00	LRQ	Line of drain/sewer deviates right [quarter]	Image Provided - Ref: 10_2

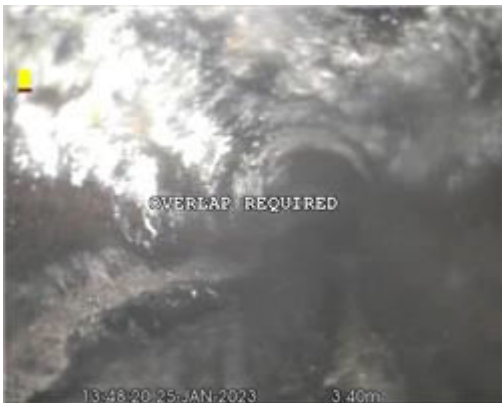
Pos	Video Ref	Code	Description	Image
02.30m		MHF	Finish node type, manhole FW3,OVERLAP REQUIRED UNABLE TO PUSH AROUND BEND	<p>Image Provided - Ref: 12_9999</p>

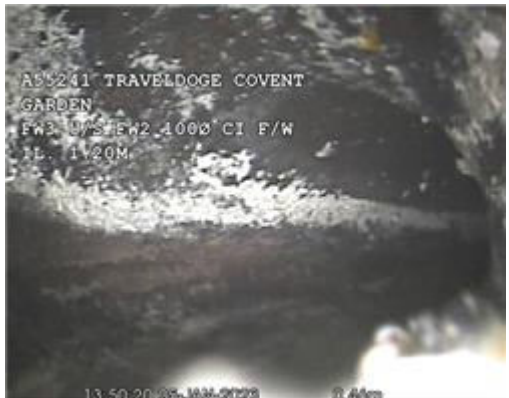
00.46m	0:00:05	LRQ	Line of drain/sewer deviates right [quarter]	<p>Image Provided - Ref: 13_2</p>
