Asbestos Survey Report
Project Ref. No: 144432
113C Rowley Way
Refurbishment survey

113C Rowley Way

Survey Type: Refurbishment survey

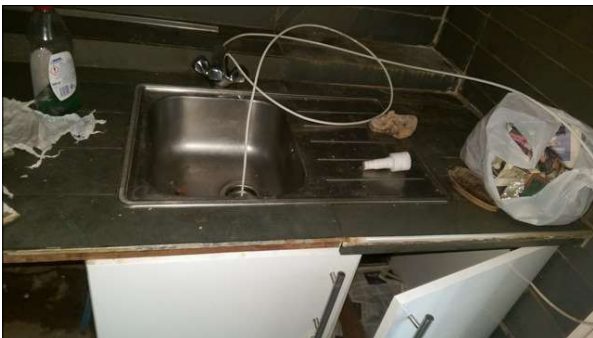
Non asbestos bitumen sink pad (1no.) (1m2)

| Action required: | None | | |

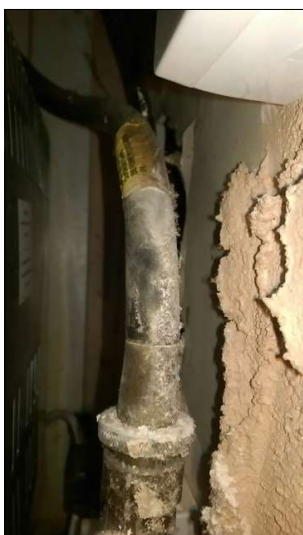
Non asbestos plasterboard panel to wall behind cooker (1m2)

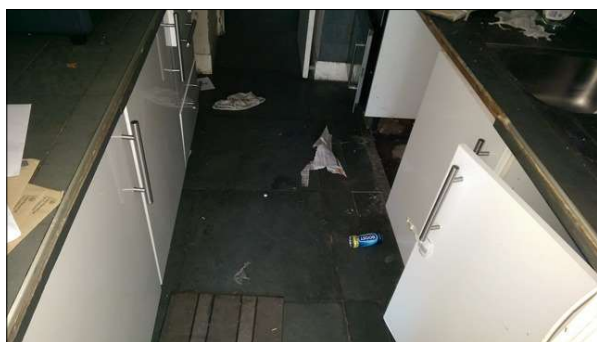
Non asbestos bitumen adhesive to concrete floor (10m2)

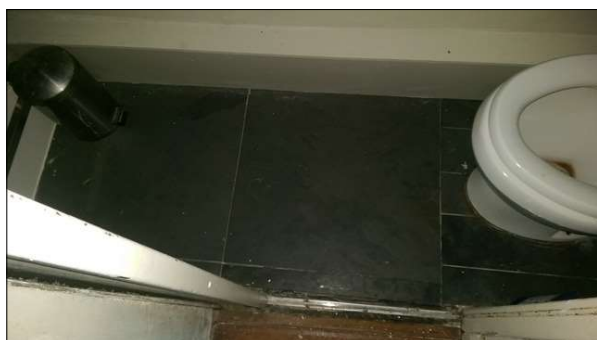
Non asbestos bitumen adhesive to concrete floor (3m2)

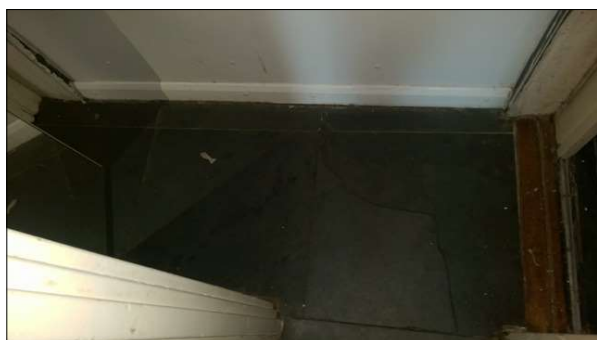
Non asbestos bitumen adhesive to concrete floor (4m2)

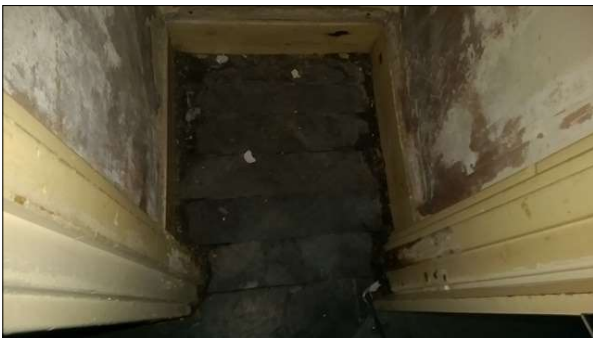
Non asbestos bitumen adhesive to concrete floor (1m2)

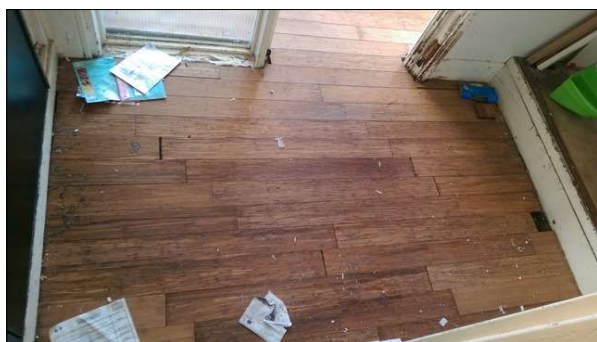
Non asbestos bitumen adhesive to concrete floor (4m2)

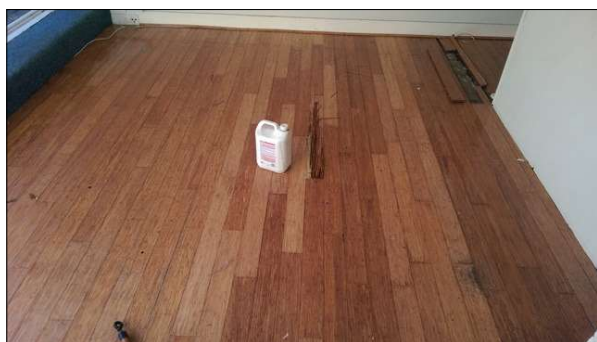
| Condition: | Good condition | Accessibility: | Occasional disturbance likely (1) |
| Position: | Room up to 100 sq m (2) | RISK: | VERY LOW (2) |

Asbestos thermoplastic floor tile (grey) to non asbestos bitumen adhesive (20m2)

| Ref. No. | Location | ACM | Action |
|---|---|---|---|
| 04a | Main, floor level 1, Lounge | Thermoplastic floor tile | Inspect |

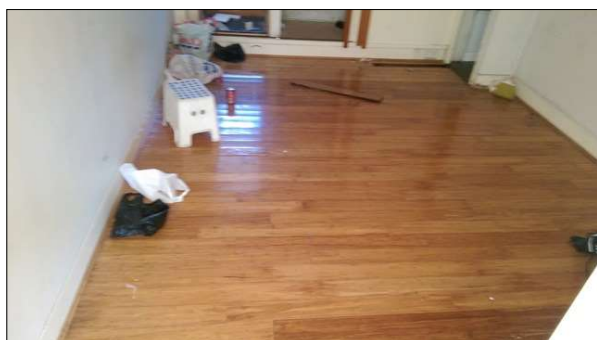
| Condition: | Good condition | Accessibility: | Occasional disturbance likely (1) |
| Position: | Room up to 100 sq m (2) | RISK: | VERY LOW (2) |

Strongly presumed asbestos thermoplastic floor tile (grey) to non asbestos bitumen adhesive (16m2)

| Ref. No. | Location | ACM | Action |
|---|---|---|---|
| 04m01 | Main, floor level 1, Bedroom1 | Thermoplastic floor tile | Inspect |

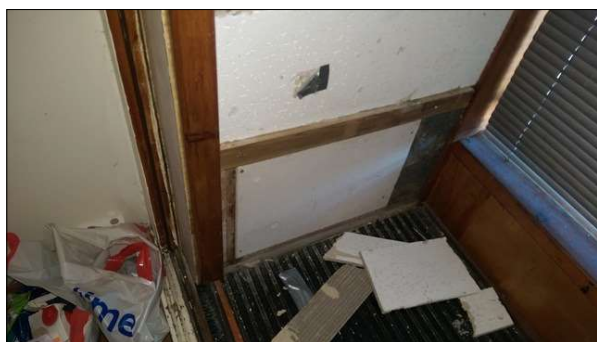
Non asbestos insulating board panel forming low level access hatch to wall (1m2)

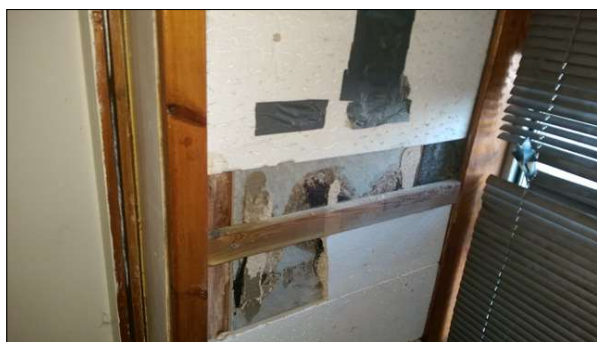
| Condition: | Low damage | Accessibility: | Occasional disturbance likely (1) |
| Position: | Room up to 100 sq m (2) | RISK: | LOW (6) |

Asbestos cement panel to wall forming access hatch (1m2)

| Ref. No. | Location | ACM | Action |
|---|---|---|---|
| 06a | Main, floor level 1, BedCup | Moulded cement product | Encapsulate, label & inspect |
