Job Number
RS100215

23a Ravenshaw Street
London
NW6 1NP

CCTV Inspection Report

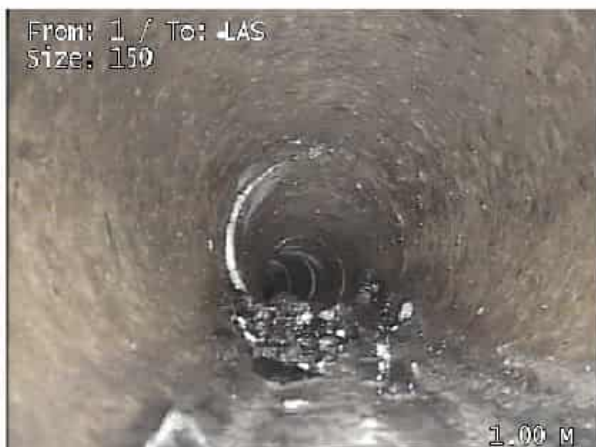
1.00	REM	Enter comment here...	1/5.jpg	Comment / 0
1.00	DER	Settled deposits coarse 15% cross-sectional area loss, Start	1/6.jpg	Service / 3
M/H Ref: LAS I/L: 3 metres

Settled deposits coarse 15% cross-sectional area loss, Start

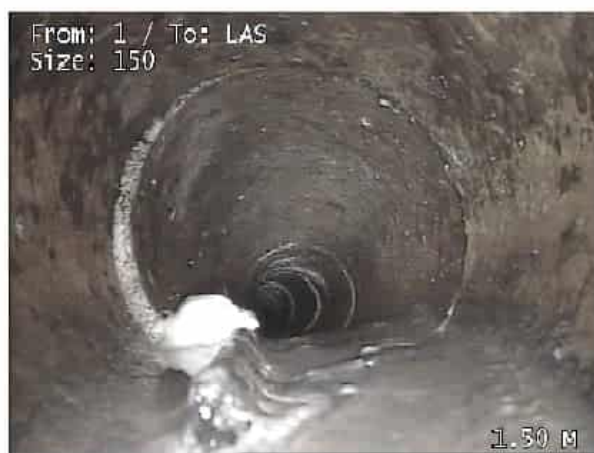
Attached deposits, encrustation at 5 o'clock 10% cross-sectional area loss

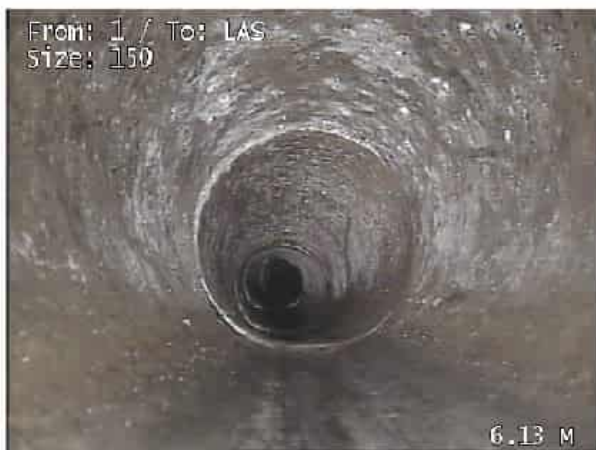
At boundary approx sewer depth 2.5

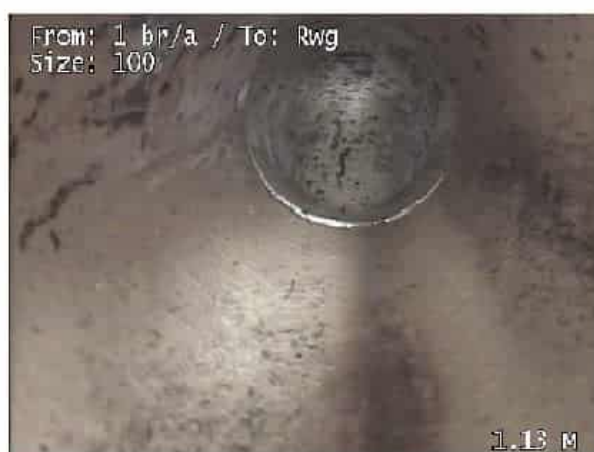
Line of drain/sewer deviates up half

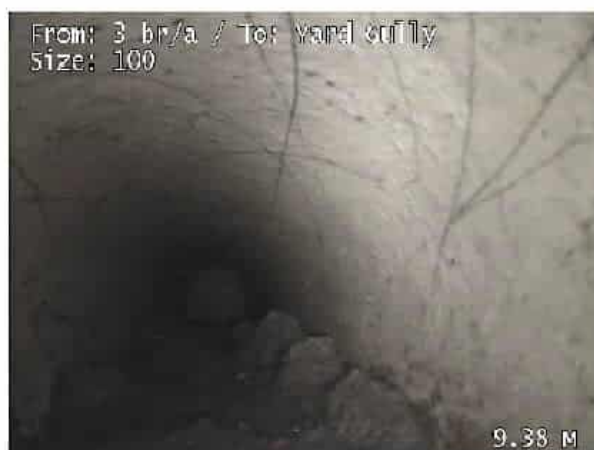
9.38	DER	Settled deposits coarse 25% cross-sectional area loss, Start	7/5.jpg	Service / 4
10.25	REM	Yard gully Reached	7/6.jpg	Comment / 0
M/H Ref: Yard Gully I/L: 0.2 metres

Settled deposits coarse 25% cross-sectional area loss, Start

HPWJ CLEAN RECOMMENDED
