Arboricultural Appraisal Report

Subsidence Damage Investigation at:

84B Bartholomew Road
London
NW5 2AS

CLIENT:	Crawford & Company
CLIENT REF:	[REDACTED]
MWA REF:	[REDACTED]
MWA CONSULTANT:	Andy Clark
REPORT DATE:	16/06/2023

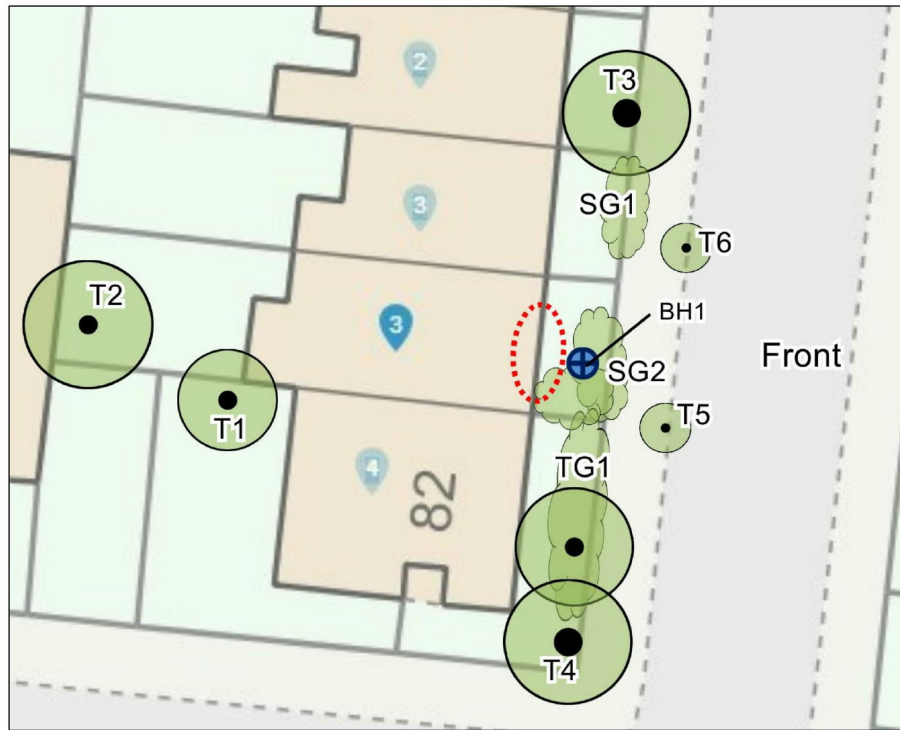
Site Plan

Approximate areas of damage

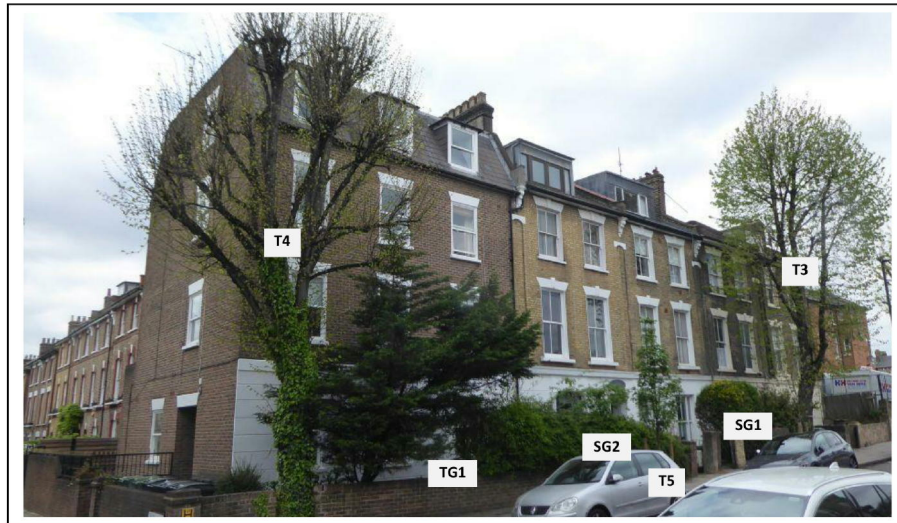
Irrespective of the identification of recovered root samples, our survey has identified vegetation within influencing distance of the building with a current potential to influence soil volumes below foundation level; the most significant of which in relation to the current damage are the SG2 shrub group, and the TG1 group, as well as the limes T3 and T4.

Overview of vegetation at property frontage

If an arboricultural solution is to be implemented to mitigate the influence of the implicated trees/vegetation we recommend that SG2 and TG1 groups are removed, and the limes T3 and T4 are subject to significant crown management [pollarding].

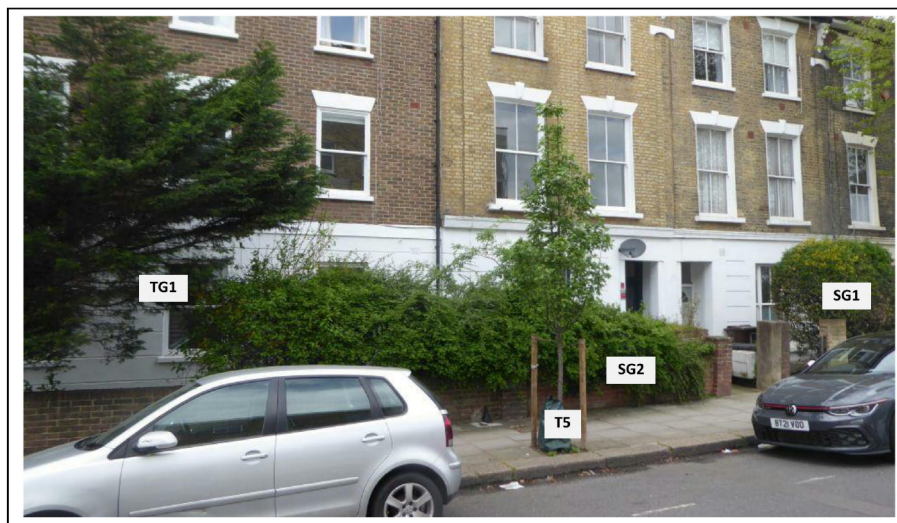
View of proximal vegetation
