TECHNICAL REPORT ON A SUBSIDENCE CLAIM

84B Bartholomew Road
London
NW5 2AS

SUBSIDENCE CLAIM

DATE 28 November 2023

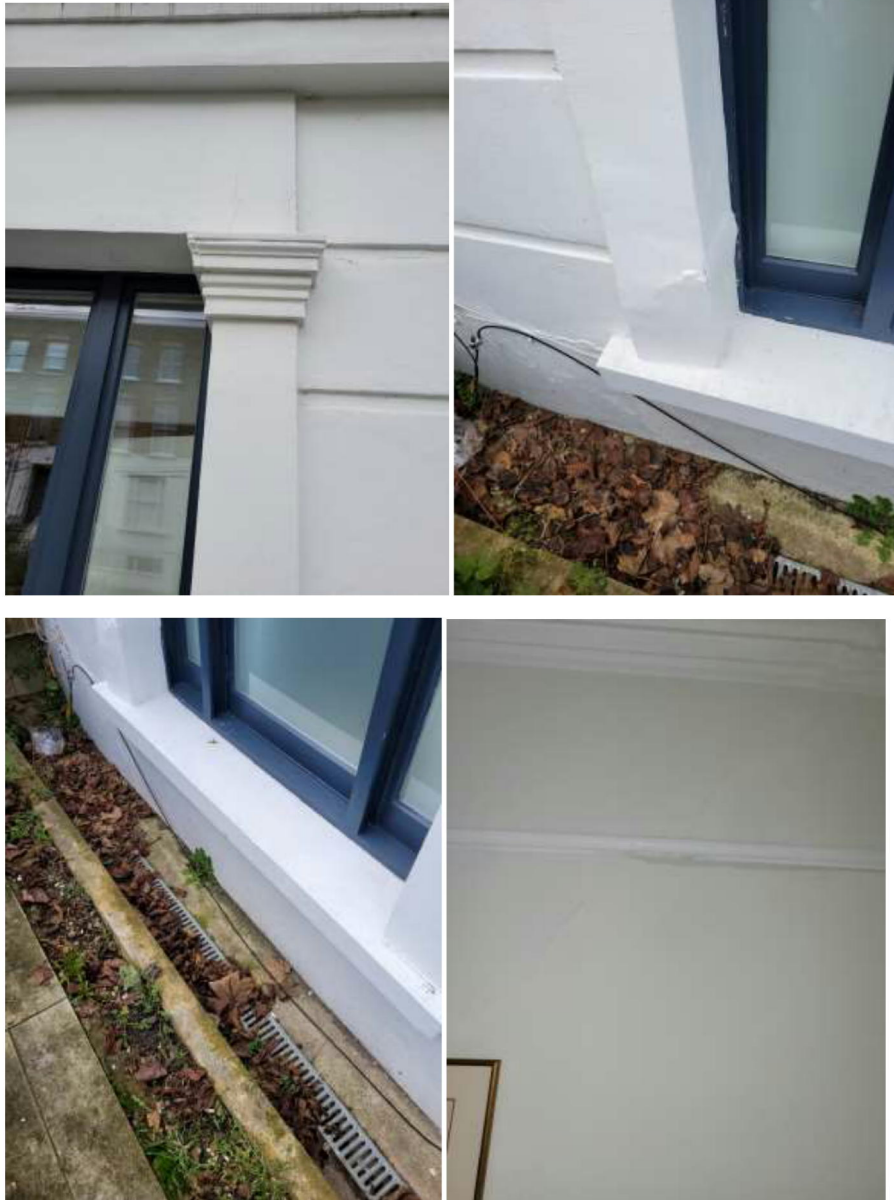
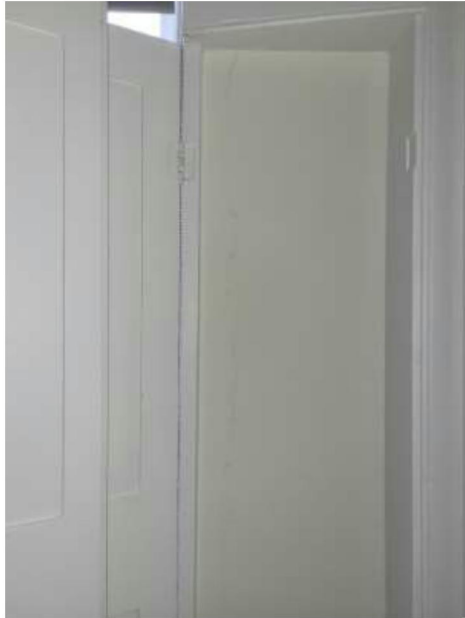
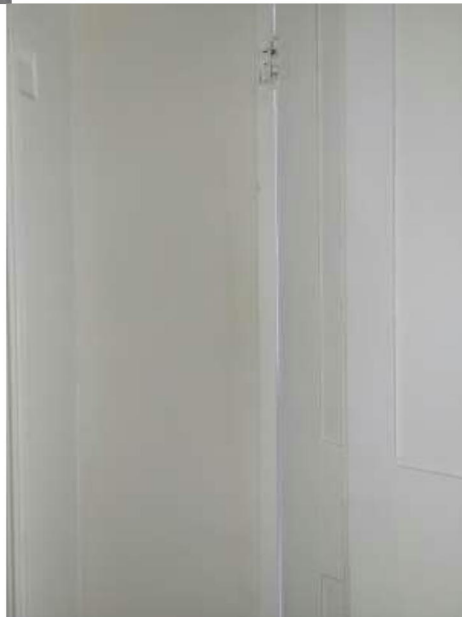
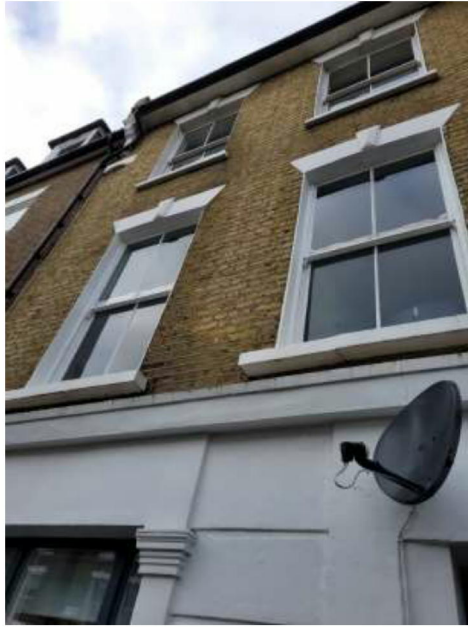
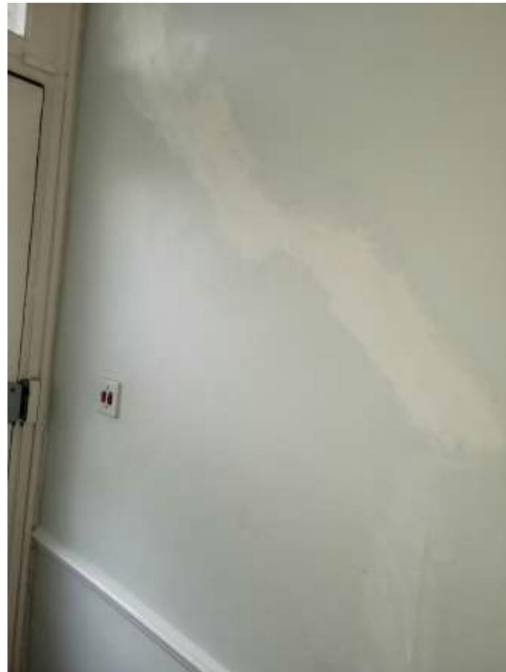
Front lounge ground floor flat - Vertical cracks left and right side of front window - 1-2mm wide.
Diagonal crack - 1-2mm wide in internal brick wall with adjoining communal hallway.

Communal Hallway - Diagonal crack - circa 1-3mm wide on internal brick wall with ground floor flat.

Various isolated cracks 1-2mm wide in render of front elevation at ground floor level.

In structural terms the damage falls into Category 2 of Table 1, Building Research Establishment⁵ Digest 251, which describes it as "slight".
