## TECHNICAL REPORT ON A SUBSIDENCE CLAIM

84B Bartholomew Road  
London  
NW5 2AS

### SUBSIDENCE CLAIM

DATE 28 November 2023

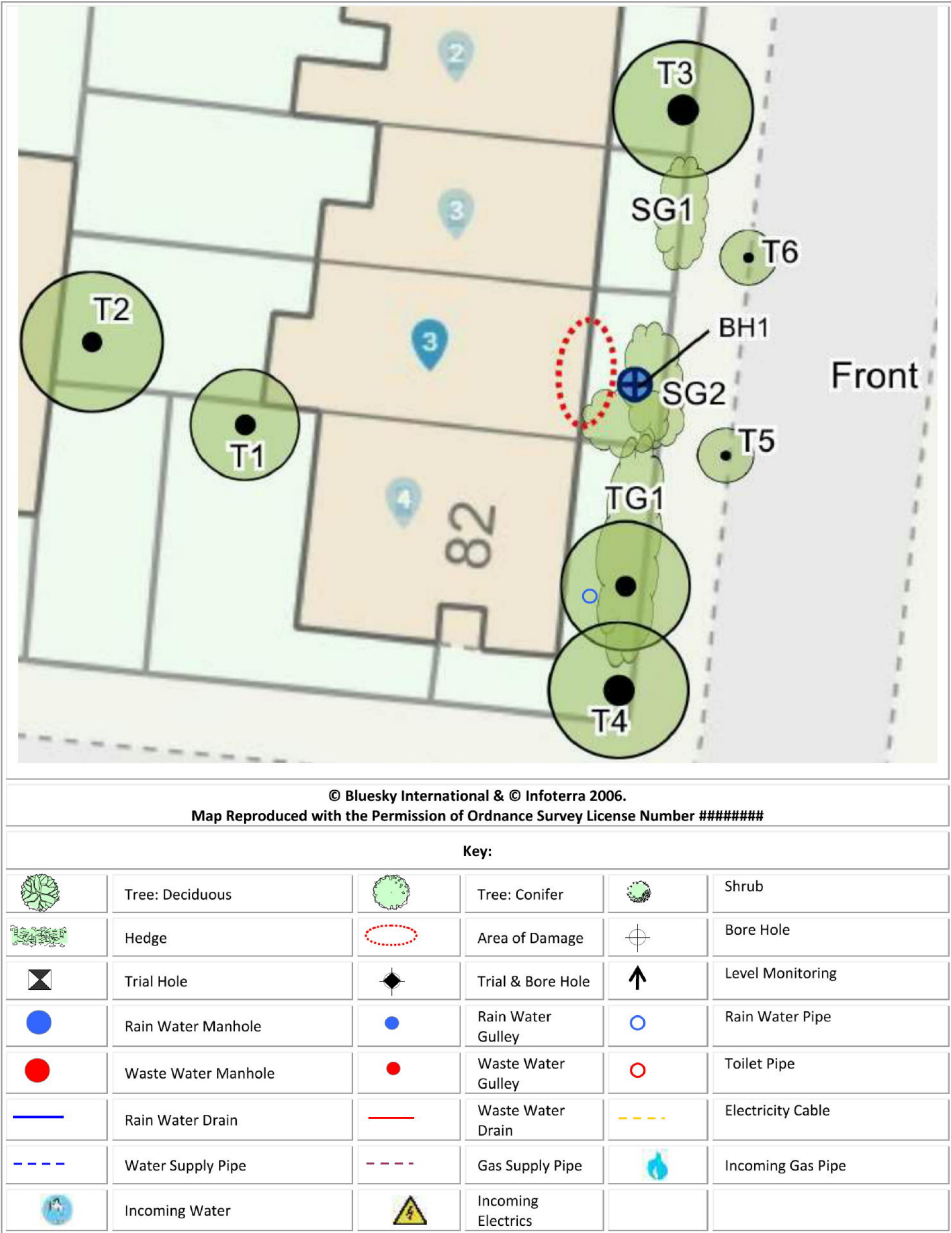
#### Site Plan

There are several trees and shrubs nearby, some with roots that may extend beneath the house foundations. The following are of particular interest:-

| Tree No. | Species | Ht (m) | Dia (mm) | Crown Spread (m) | Dist. to building (m) | Age Classification | Ownership |
|---|---|---|---|---|---|---|---|
| Recommendation | | Pollard at approx. 10.0m and re-pollard thereafter on a biennial cycle to maintain at reduced dimensions. | | | | | |
| Recommendation | | Re-pollard to previous points at approx. 10.0m and re-pollard thereafter on a biennial cycle to maintain at reduced dimensions. | | | | | |
| Recommendation | | Remove (fell) all to near ground level and treat shrub stumps to inhibit regrowth. | | | | | |
| Recommendation | | Remove (fell) all to near ground level and treat stumps to inhibit regrowth. | | | | | |
