**Pre-Redevelopment Options Review**

39a Fitzjohn's Avenue

20727-QODA-FJA-XX-RP-YS-3003

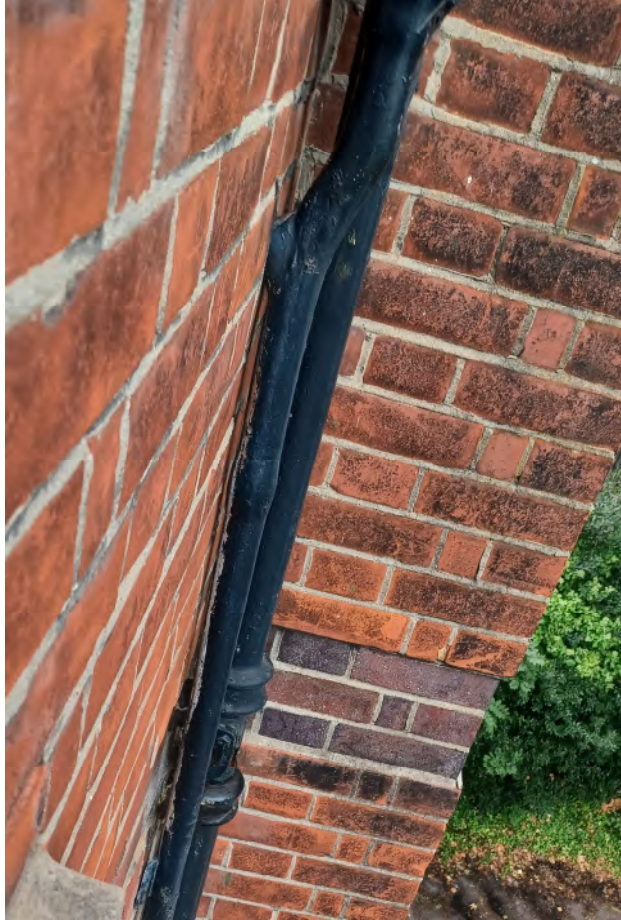
| | 2) | Lead Drain<br>Stack,<br>outside the<br>building. |

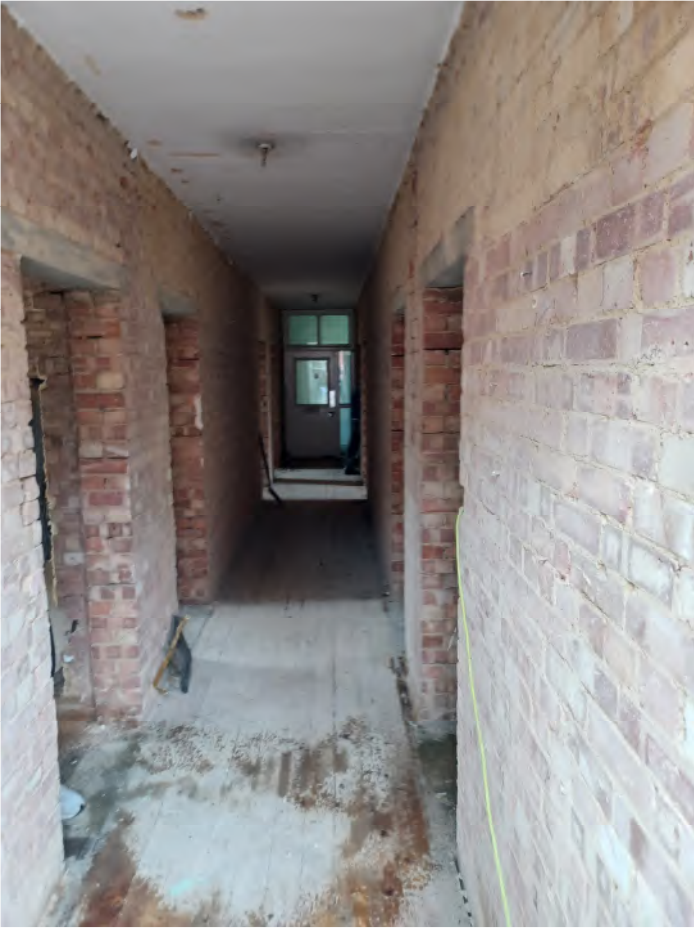
| | 3) | 2 <sup>nd</sup> floor, services has been stripped out. |

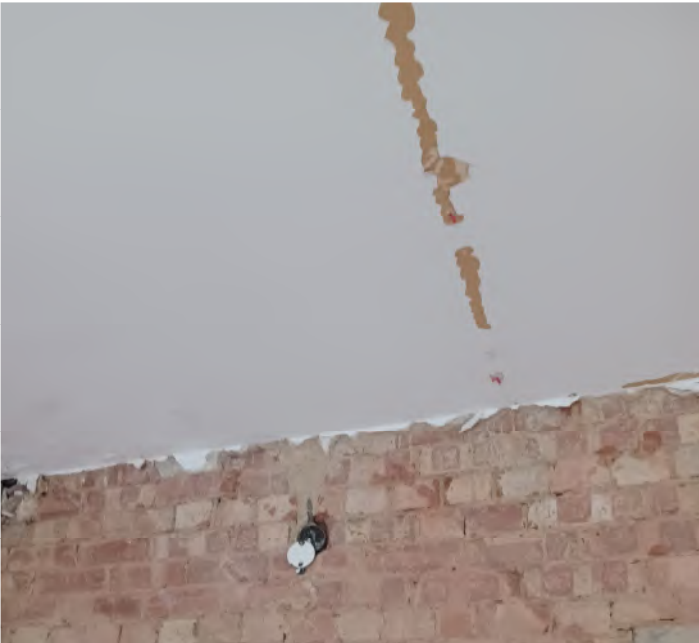
| | 4) | Stripped out electrical feeding to the lighting. |

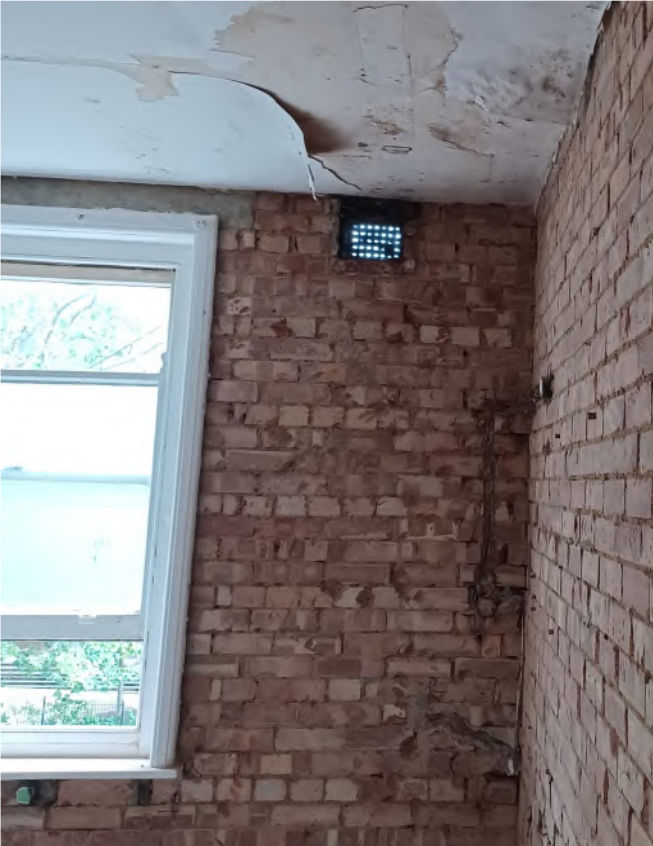
| A photograph showing a corner of a room. On the left is a white-framed window looking out onto greenery. The wall is made of red bricks. Above the window, there is a small, square, perforated metal air brick. The ceiling is white and shows signs of peeling paint or plaster. | 5) | Openable Windows and air bricks are main means of ventilation |

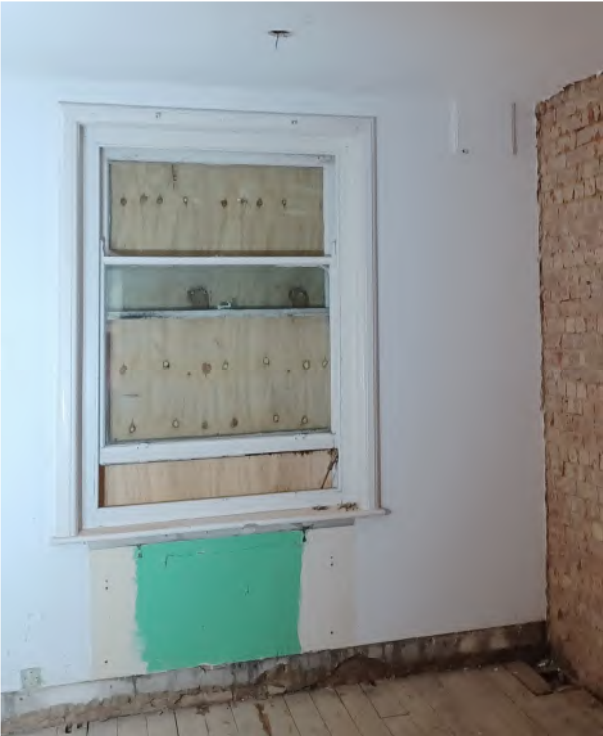
| A photograph of a window with white trim. The window is covered with light-colored wooden shutters that have several small, round knobs or handles. Below the window, there is a patch of green paint on the white wall. To the right of the window, a section of the red brick wall is visible. | 6) | Window and air brick are closed off occasionally. |

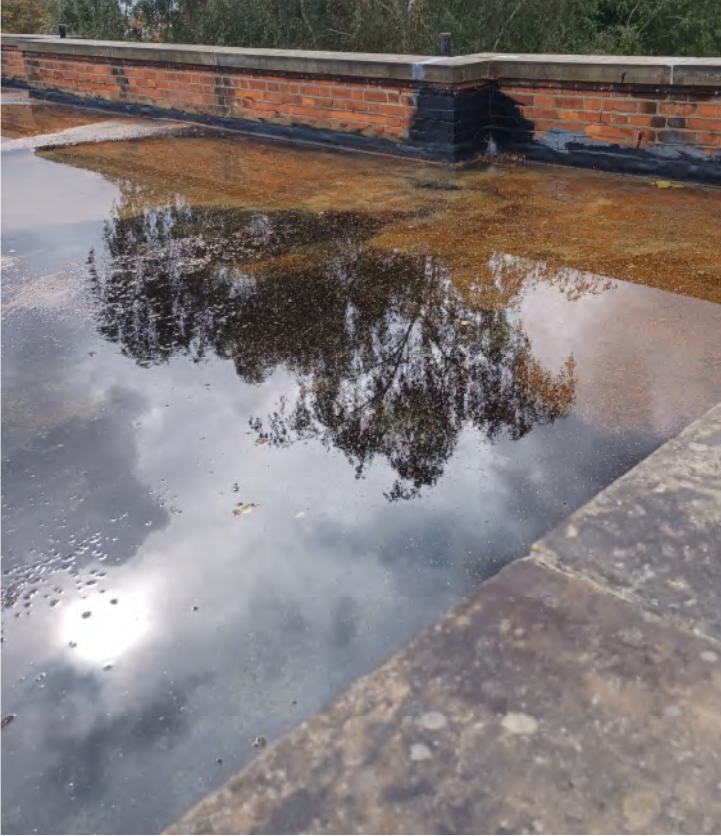
| | 8) | Storm Drain is blocked and needs servicing. |

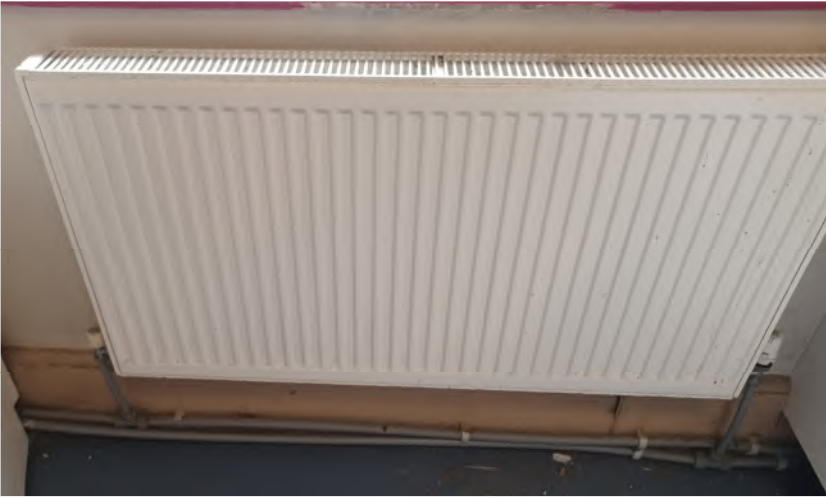
| | 12) | Retrofit UPVC pipework to radiator. |

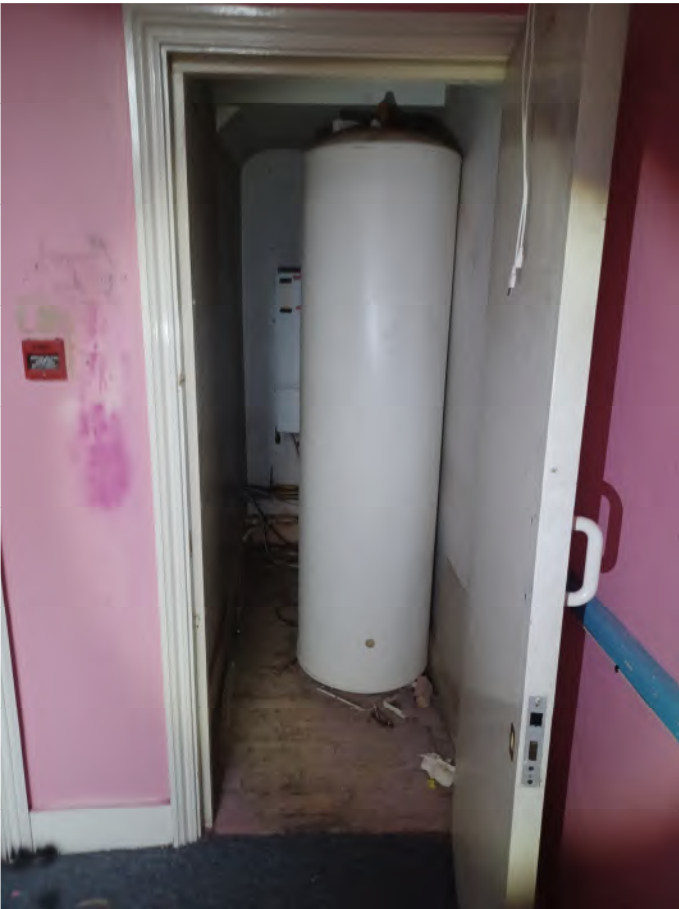
| | 19) | Heating and hot water plant room with boiler at the back and the calorifier in the front. |

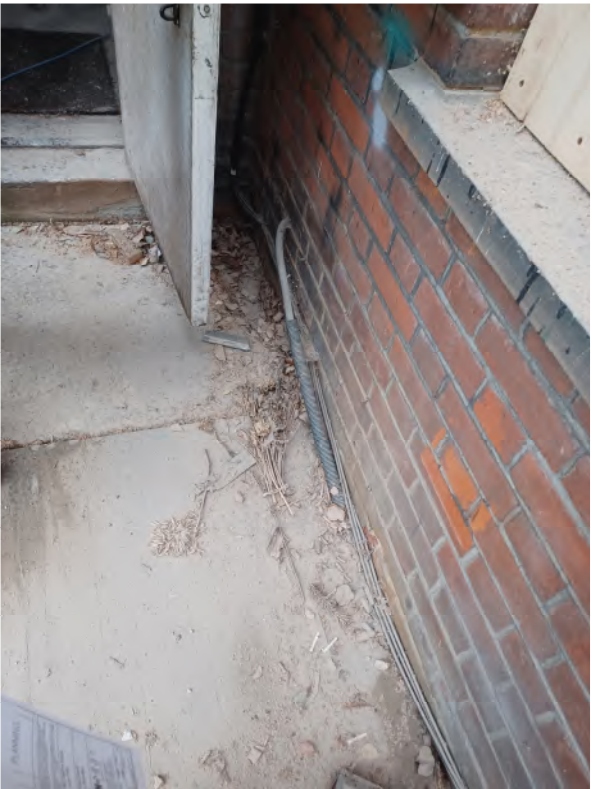
| <p>A photograph showing external wiring running along a brick wall. The wiring is bundled together and runs horizontally. The ground is covered with dirt, debris, and some dry leaves. The brick wall is made of red bricks with grey mortar. The wiring appears to be in a trench or a shallow channel. The overall condition of the wiring and its containment looks poor.</p> | 27) | External wiring not run in correct or adequate containment |

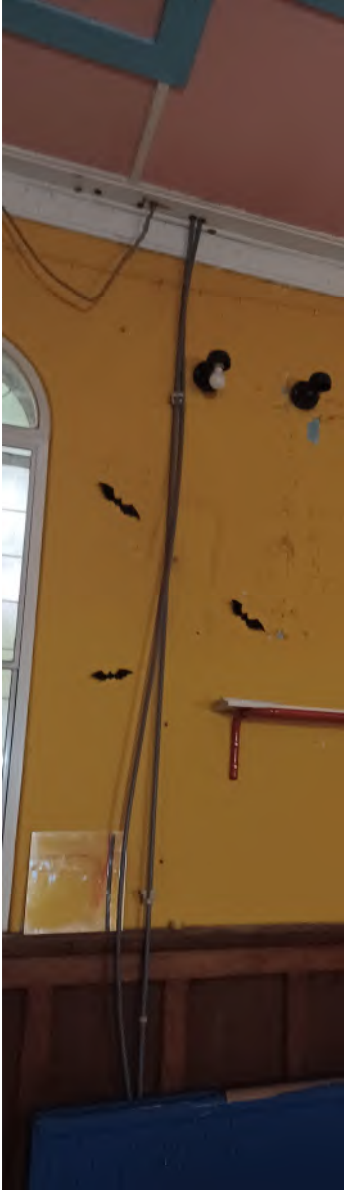
| | 29) | Heating pipework is in disarray and needs insulation. |

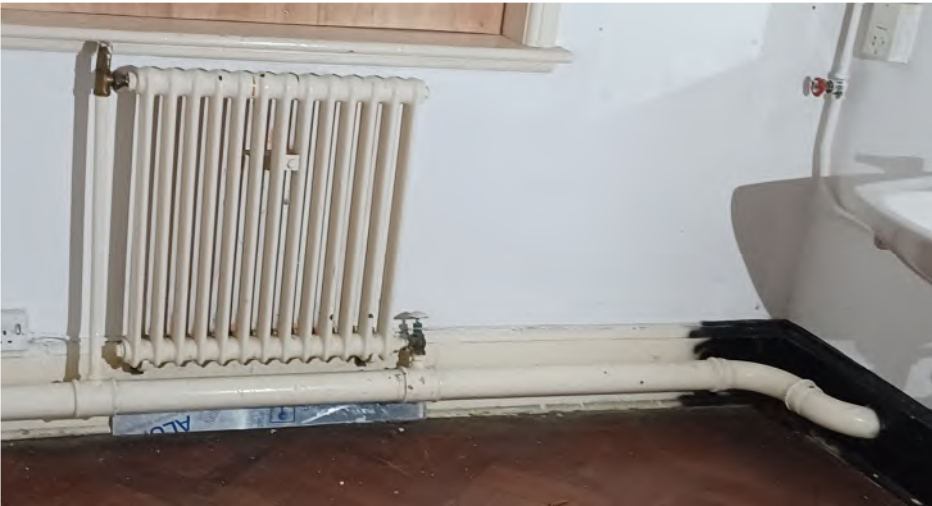
| | 31) | Old fashioned cast iron radiator and valves with one pipe arrangement |

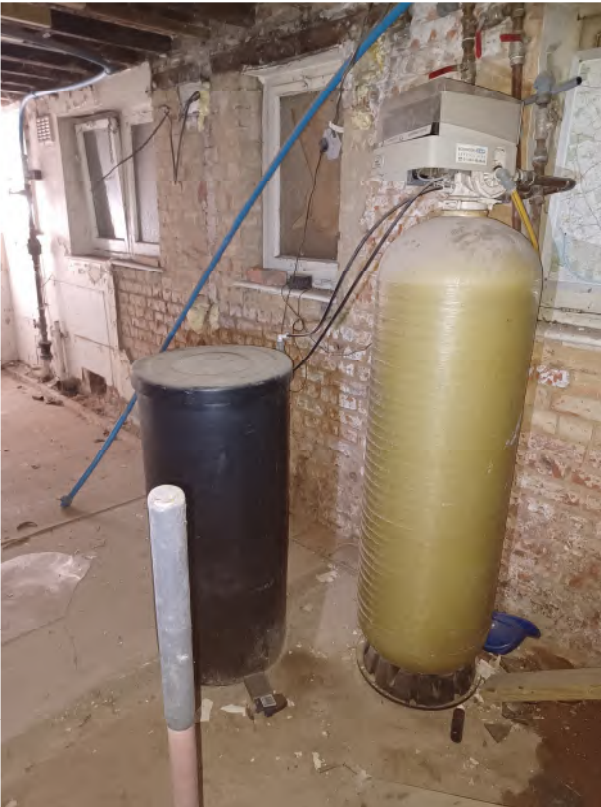
| A photograph of a large, yellow, cylindrical water softener tank standing in a room. The tank has a control valve on top with various pipes connected to it. To the left of the tank is a black cylindrical object, possibly a drum or another tank. The background shows a brick wall and a window. | 39) | Redundant softener |

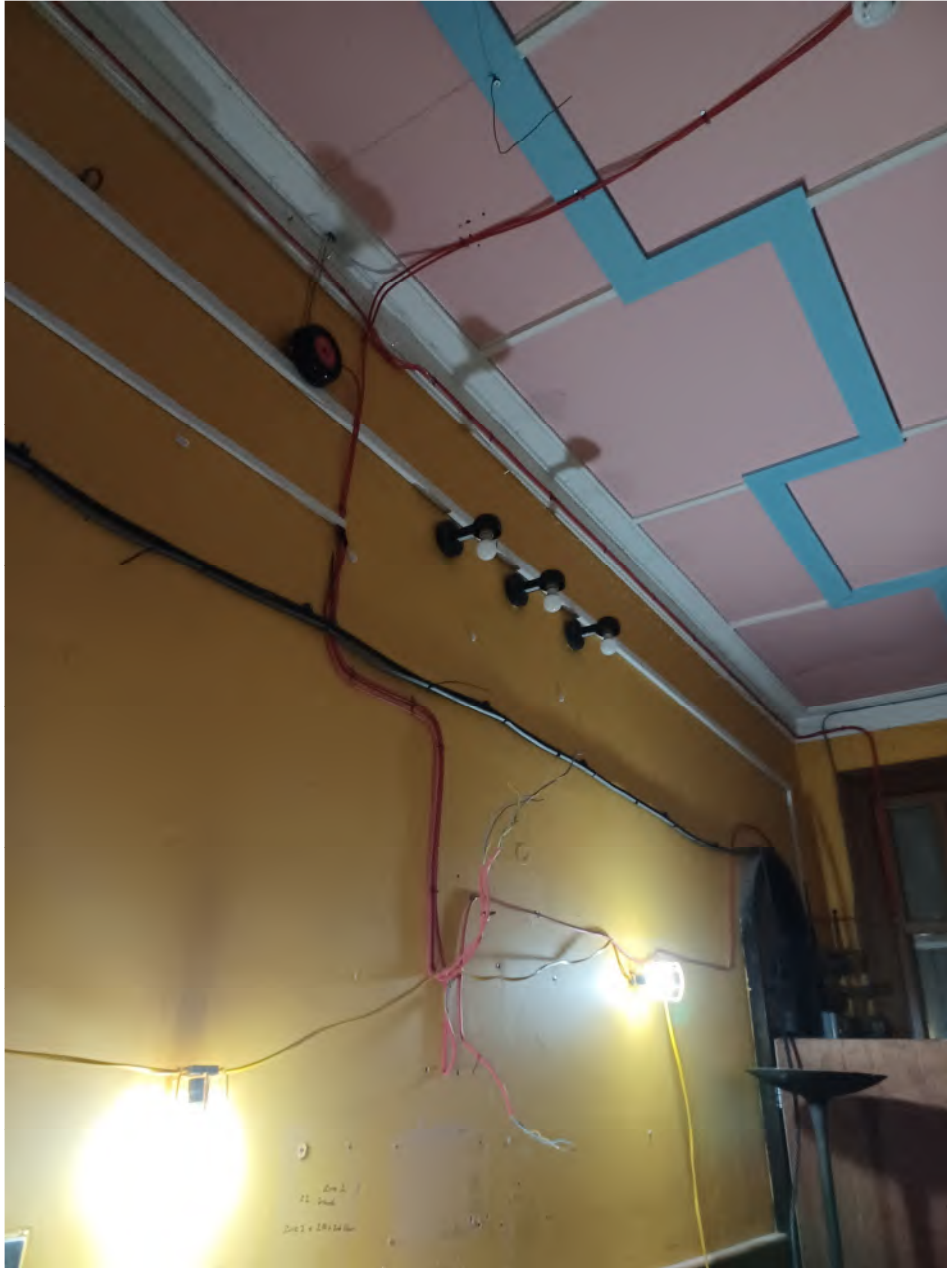
42)

Fire alarm panel has been stripped out.
