**ARBORICULTURAL ASSESSMENT OF TREES
IN RELATION TO ALLEGED SUBSIDENCE**

PROPERTY ADDRESS: 30 ELSWORTHY ROAD
LONDON
NW3 3DL

DATE OF REPORT: 3rd NOVEMBER 2023

OUR REFERENCE: J63.64

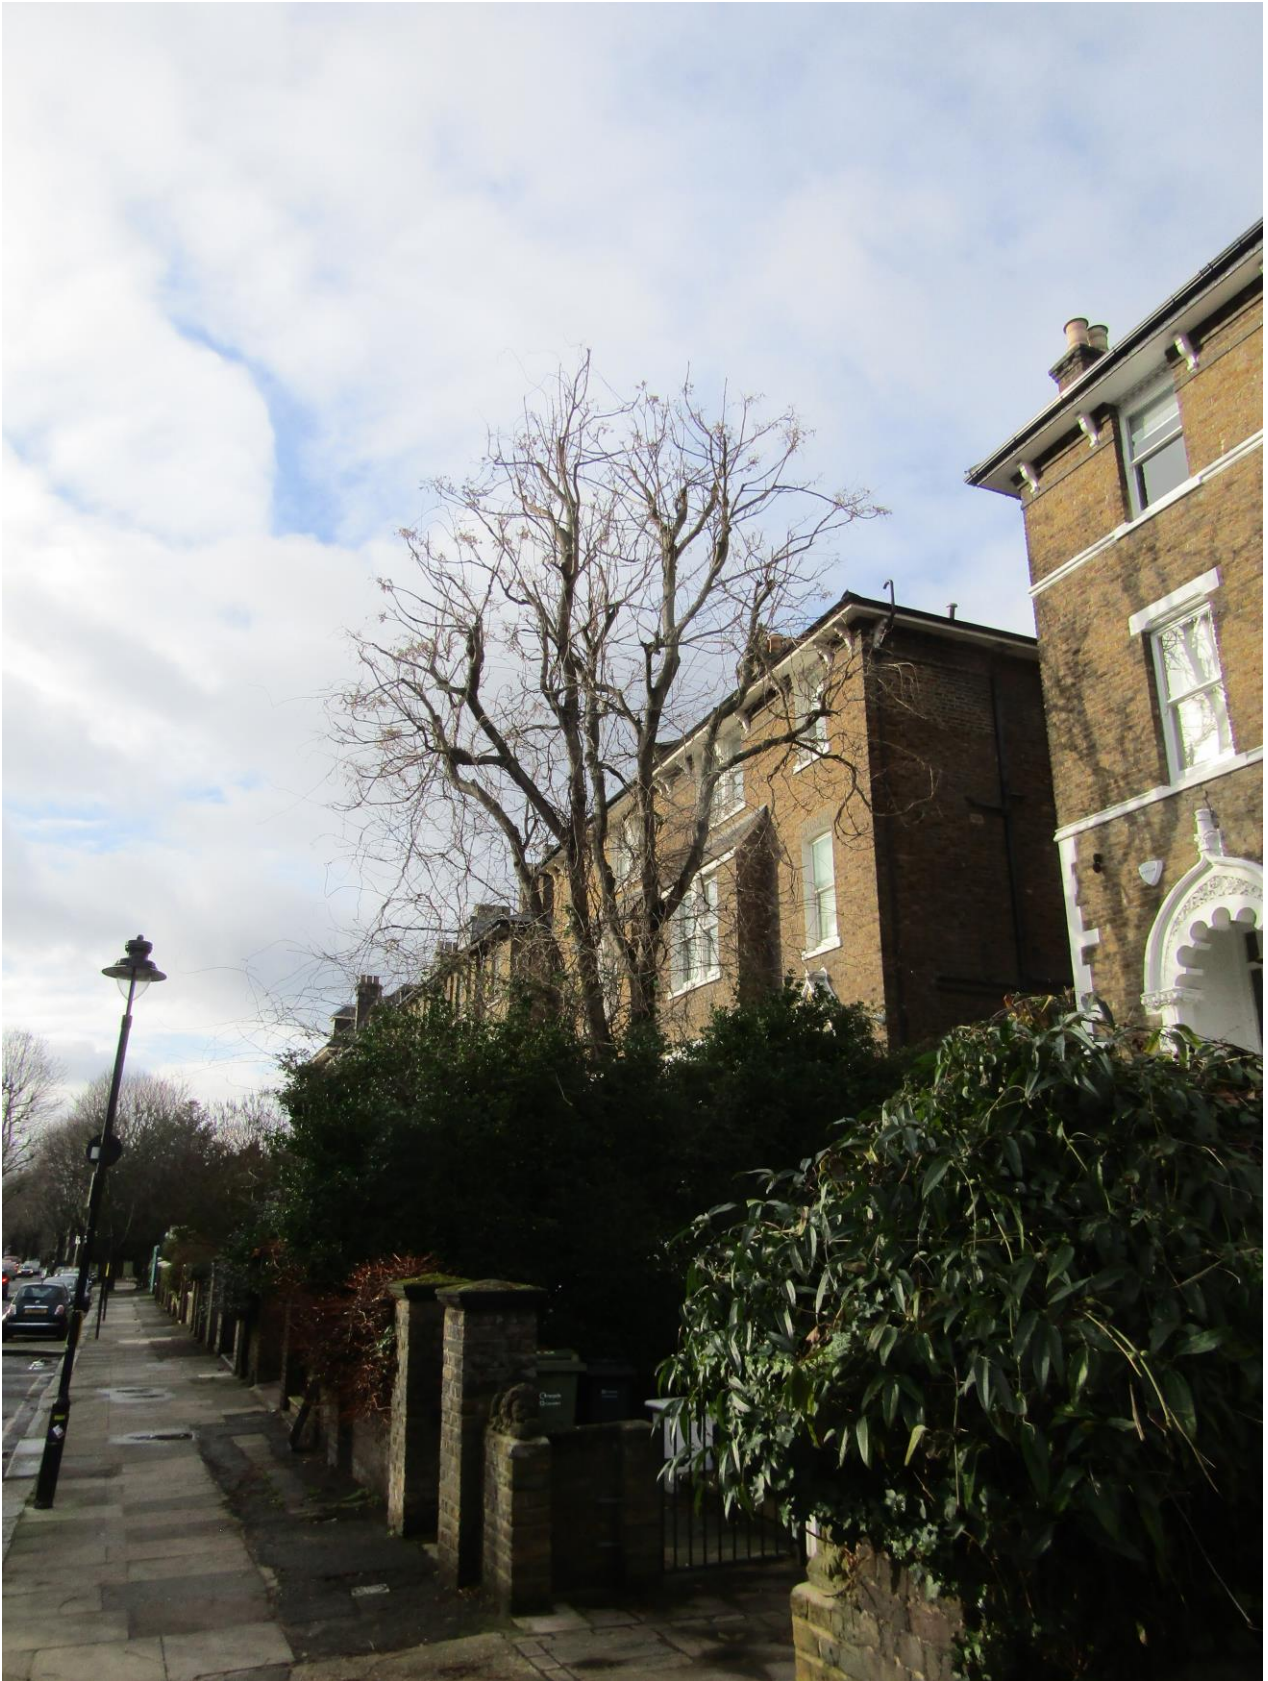
- 5.3 The site investigations identified highly shrinkable Clay based soils with desiccation present to depth. Roots were also noted in all locations up to 3m depth with samples from TP1 and TP2 indicating T2 Tree of Heaven to have roots present well below foundation depths. This is the largest tree present and the most likely source of soil drying, contributed to by the surrounding large shrubs. Their proximity to the steps will represent significant localised soil drying, sufficient to cause a subsidence event.

- 5.4 The Tree of Heaven has been crown raised in the past and canopy reduced on at least several occasions. This will have controlled overall moisture demands to an extent but the restricted growing conditions and proximity of the steps in particular mean that it is inappropriately large for the situation. The surrounding shrubs have developed considerably over the years and the Himalayan Cotoneaster (T1) in particular is over dominant of the relatively small planting bed. It is assumed this has been allowed to develop to such dimensions to provide year round screening.

T2 Tree of Heaven with T1 beneath to right and shrubs G3 to left, viewed from east. Note previous reduction points in canopy.

Tree No.	Species	Works recommended
T1	Himalayan Cotoneaster	Fell to ground level. Grind out or poison stumps to prevent regrowth.
T2	Tree of Heaven	Fell to ground level. Grind out or poison stump to prevent regrowth.
G3	Escallonia	Maintain at maximum 2m height and 2m radial spread.
-	Castor Oil	Maintain at current dimensions.
-	Large Climber	Fell to ground level and grind out or poison stumps to prevent regrowth.

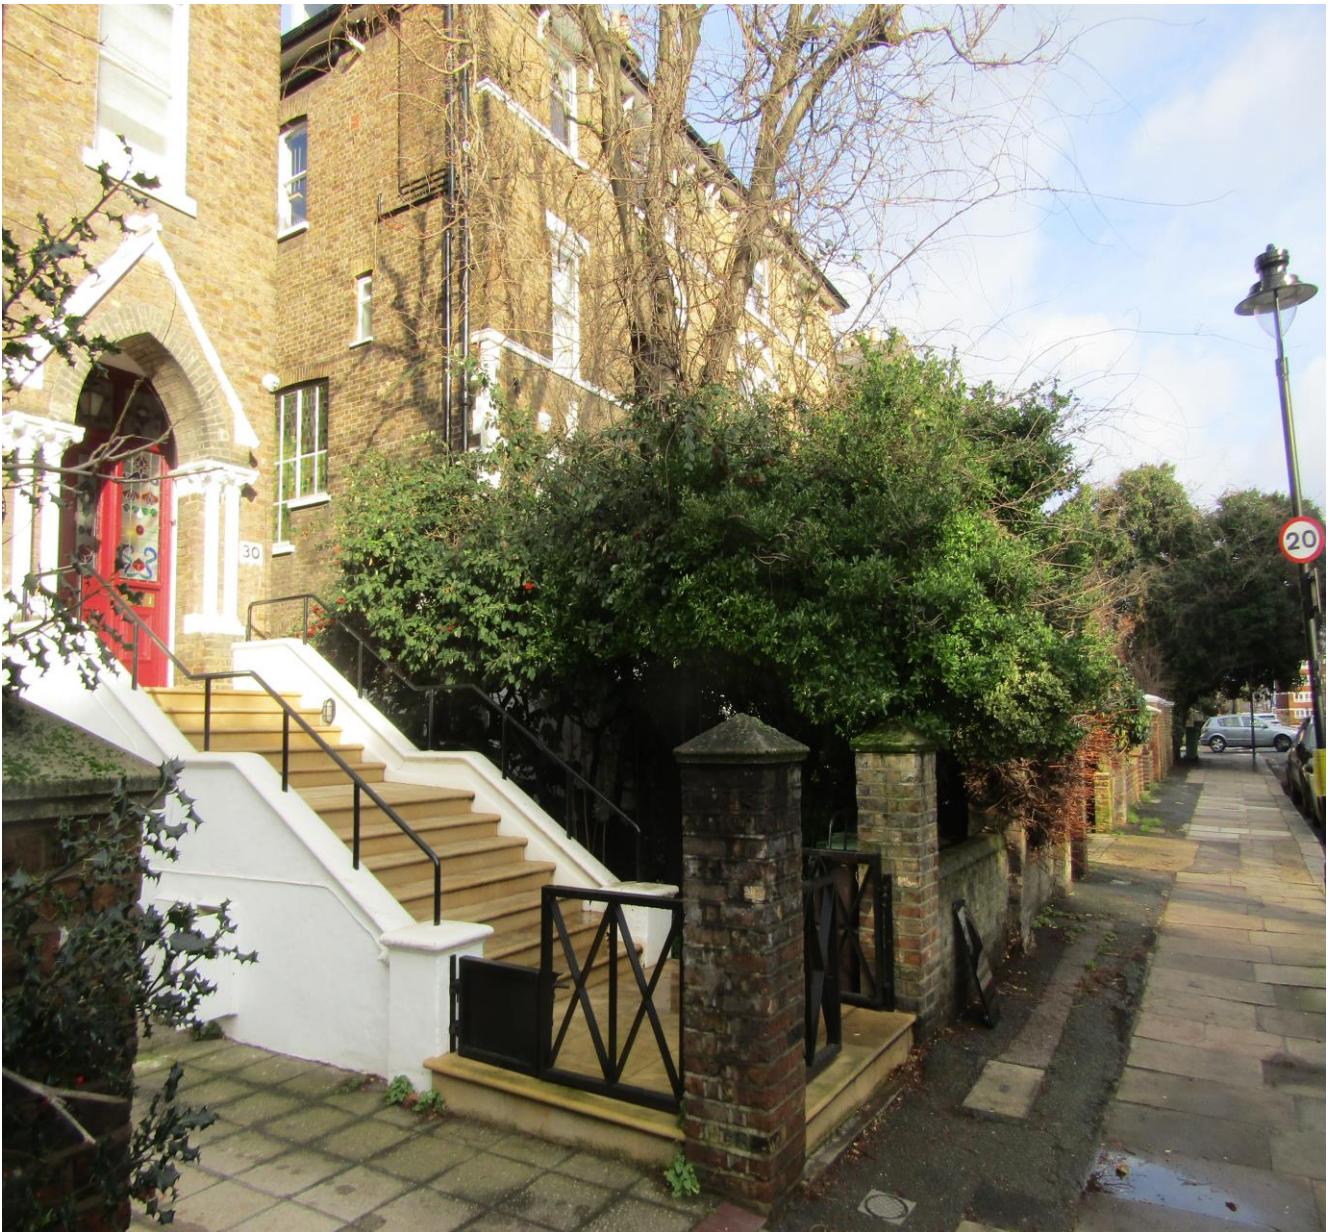
**View from west of T2 Tree of Heaven (centre)
with T1 to left and G3 to right.**

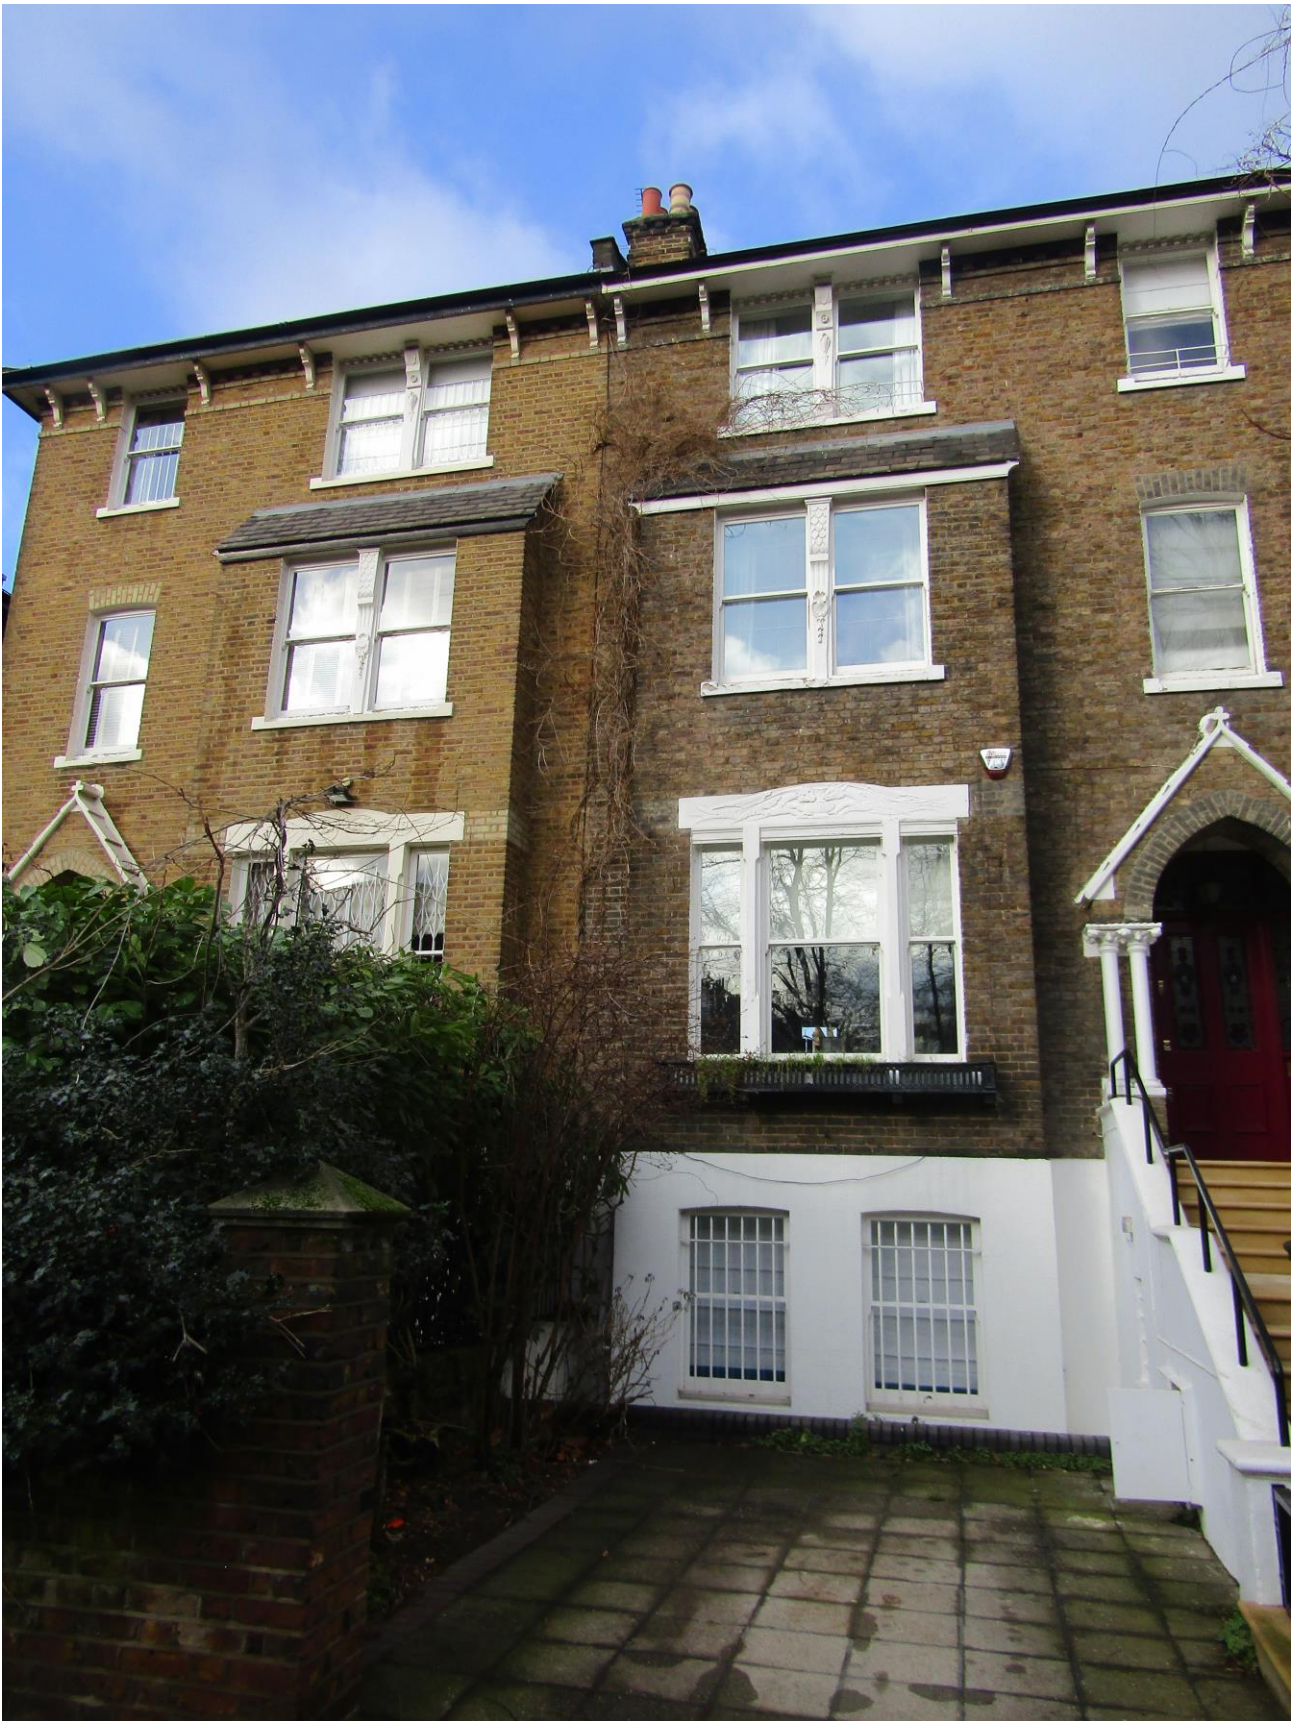
- 5.5 To the west side the shrub/tree presence is more limited with the dominant vegetation located in the garden of No. 32. Cracking to the boundary wall is likely a combination effect of the shrubs and various Laurels, together with the root system of the large climber on the front of the building. This will have a considerable moisture demand not just due to its foliar area but due to additional evapotranspiration occurring due to the solar heating of the brickwork. This represents a concentrated drying influence close to the wall and front of No. 30 and 32 with associated subsidence risks.

View of western boundary between No's 30 and 32 to show extent of climber on house.

- 5.10 For the large climber on the building no notification to the Council would be necessary as this would not be covered by the Conservation Area Regulations.

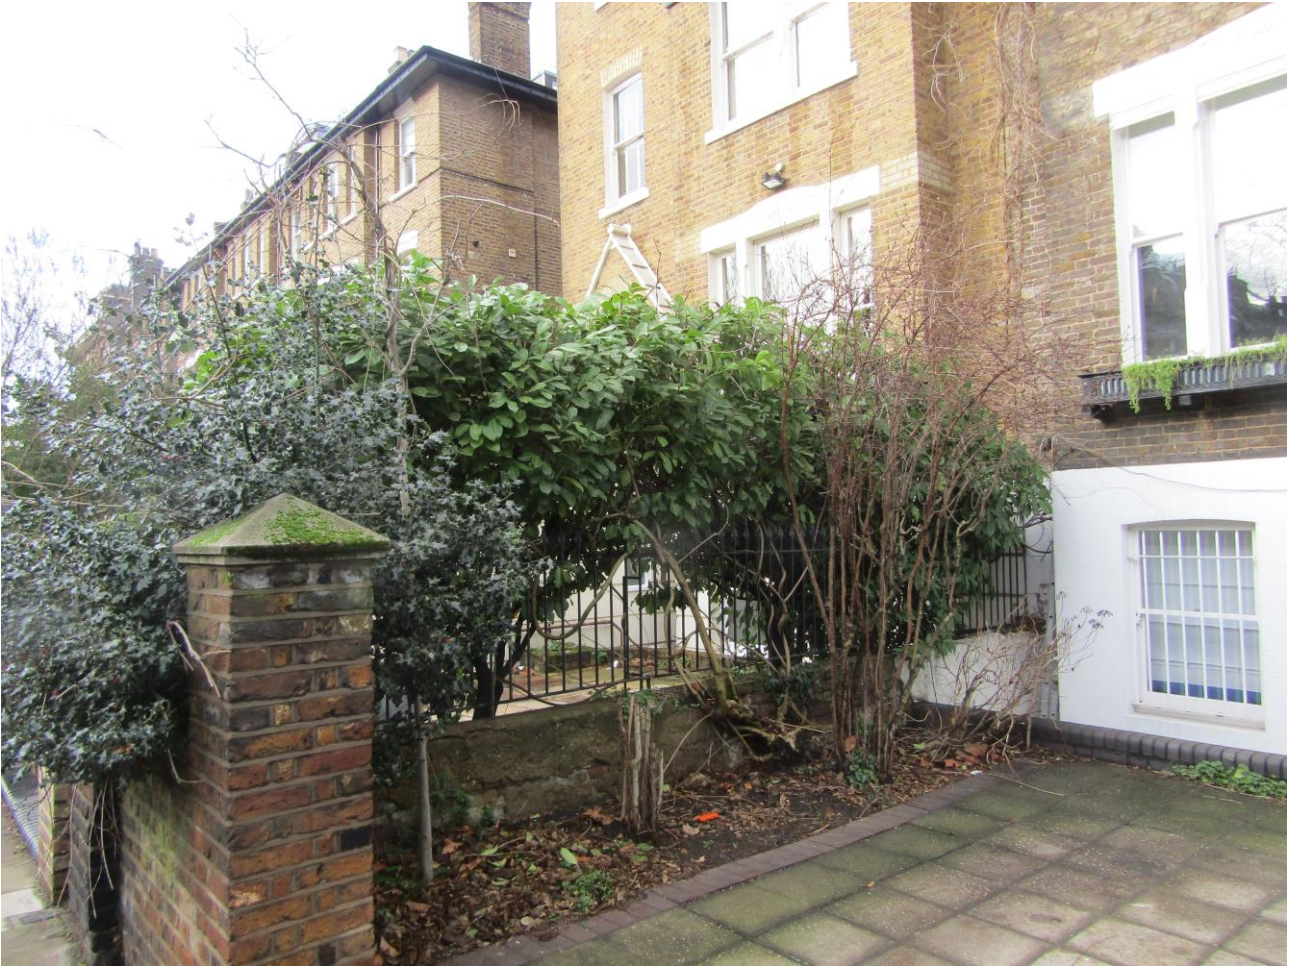
View of vegetation along western boundary with G4 Cherry Laurel in adjoining garden.

Tree No.	Species	Works recommended
G4	Cherry Laurel	Fell to ground level. Grind out or poison stumps to prevent regrowth.
-	Spotted Laurel	Fell to ground level. Grind out or poison stumps to prevent regrowth.
-	3m Shrub	Fell to ground level. Grind out or poison stumps to prevent regrowth.
