Project 1952

Images to support retrospective application for listed building consent.

Minor interior alterations & changes to meeting rooms, reception and the basement Clerking office (including structural support upgrade).

Completed end 2022.

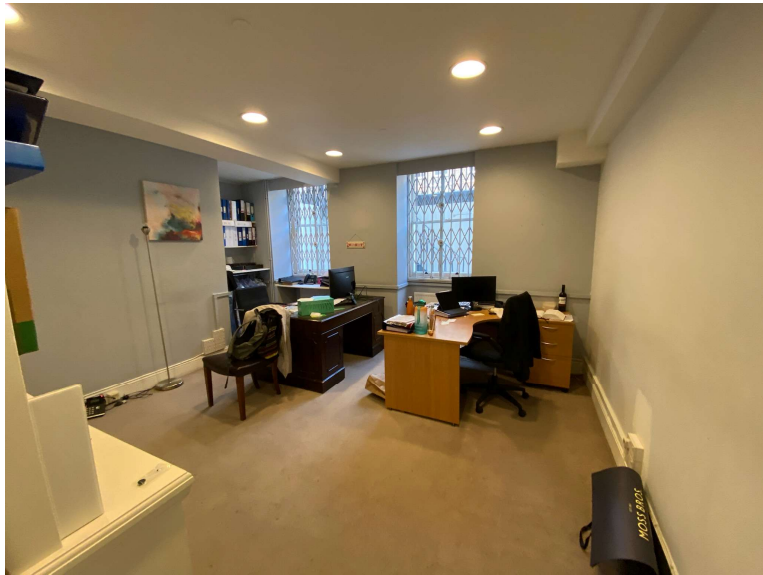
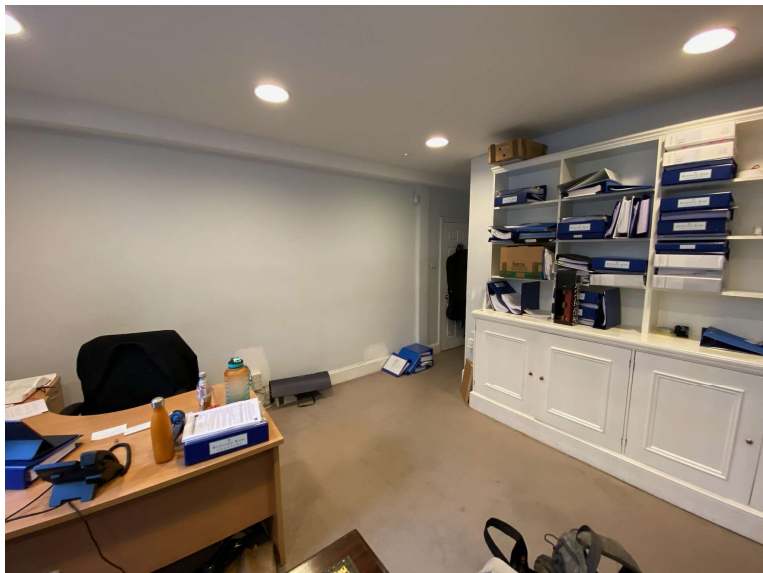
The photos 1 & 2 are pre works in the basement office / store room which was converted to a Clerk's office.

Images are of extract 5 on the drawings provided which was divided (prior to works) from extract 6 by a modern stud partition.

The space had been previously modernised with plasterboard cladding and a suspended plasterboard ceiling.

Joinery was low grade painted MDF and softwood, the majority being free standing.

Modern lighting and sheet carpeting.

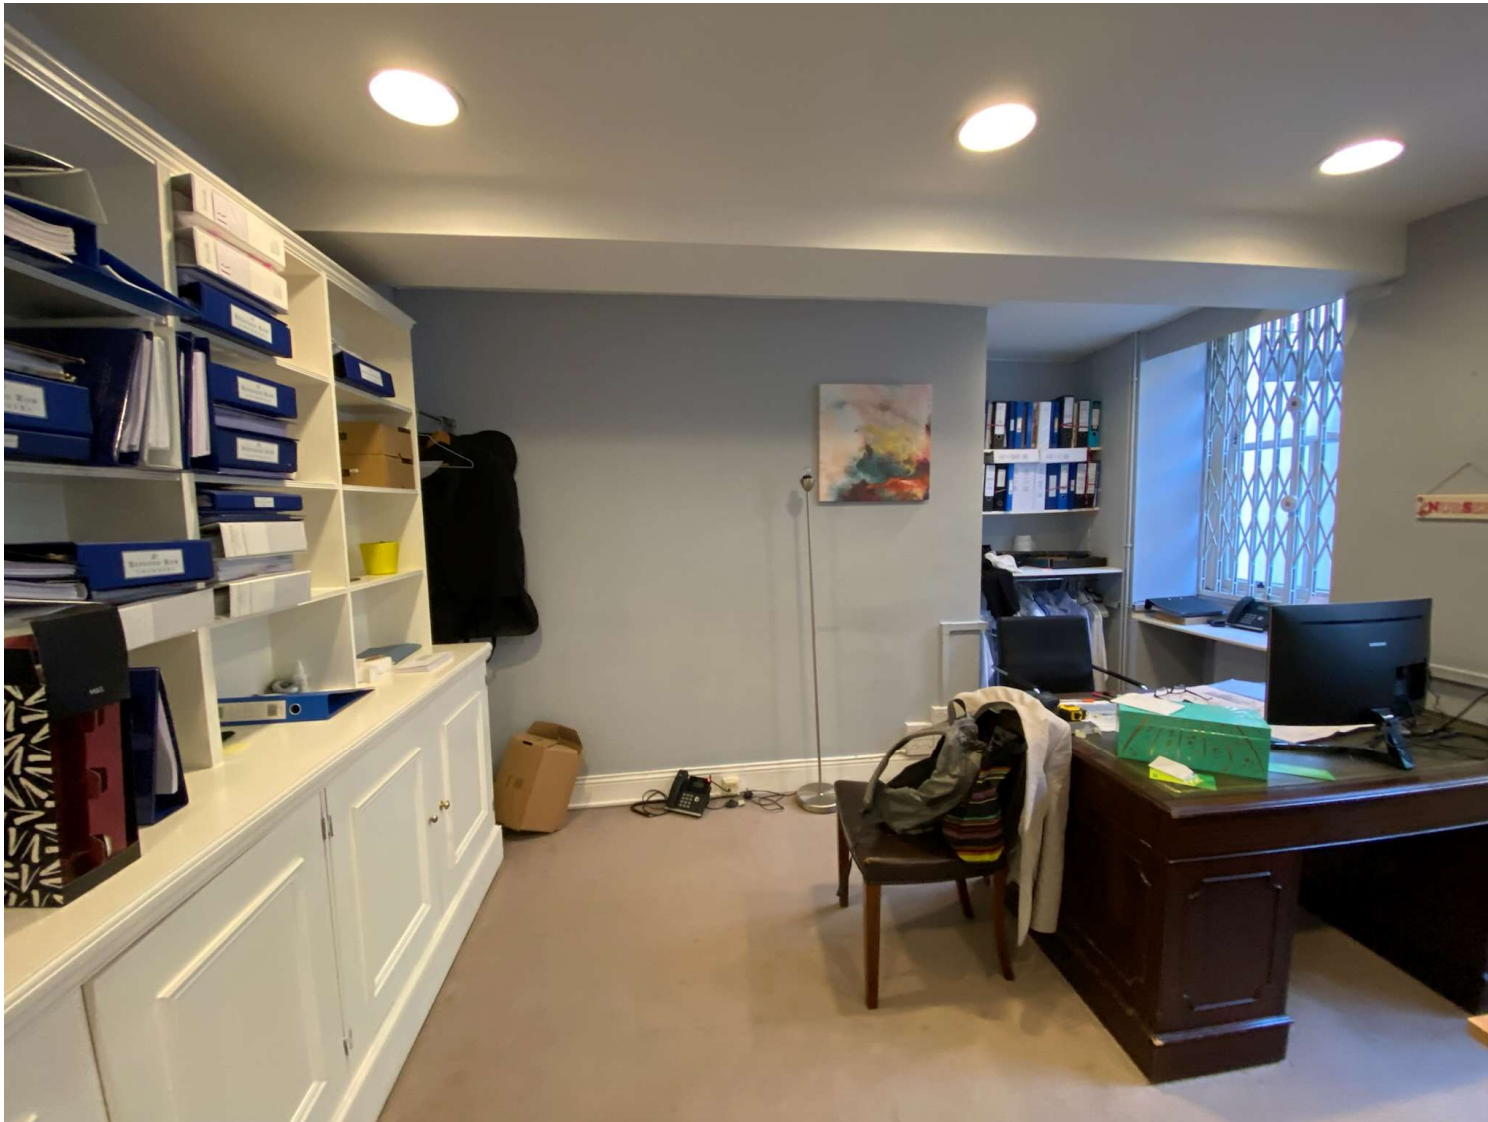
Image 3

Same area as images 1 / 2.

Note plasterboard ceiling with dropped plasterboard cladding of concealed oak beam above (supporting ground floor extract 10).

The oak beam was not altered and remains concealed.

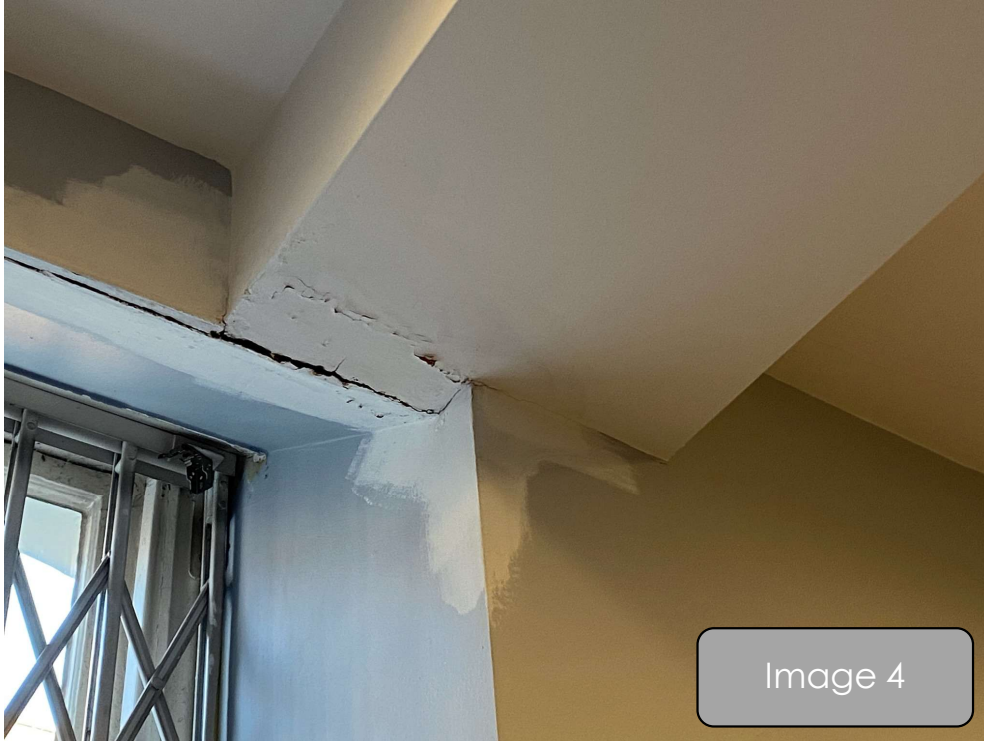
Image 4 shows general poor condition of spaces prior to our decoration / upgrade works.

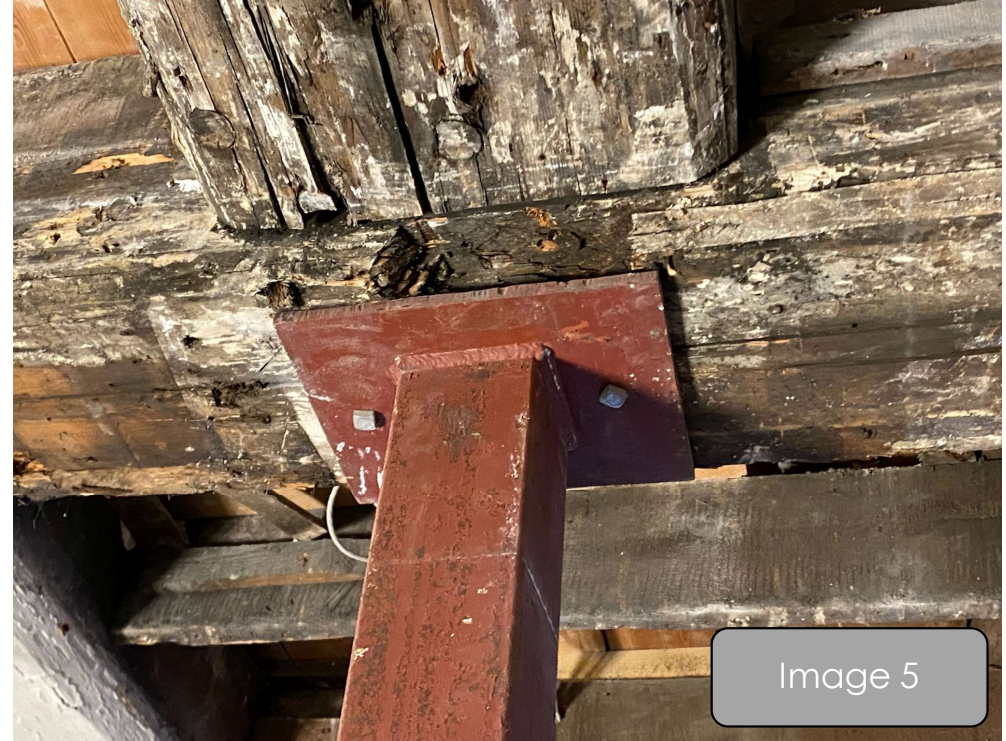
Same area as images 1 / 2 / 3

Image 5 shows the concealed modern 80 x 80 mm SHS post found during strip out which was supporting the concealed oak beam within area 6 supporting the ground floor. This was found to be inadequate and in need of upgrading in order to properly support the ground floor. The oak beam was not altered during the installation of a steel beam below and properly sized support post beneath. The steel beam now fully supports the retained oak beam.

Please refer to structural calculations and design for detail

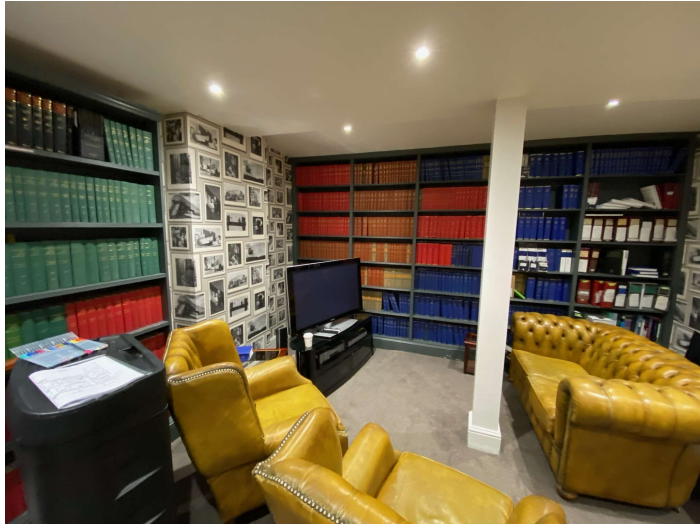
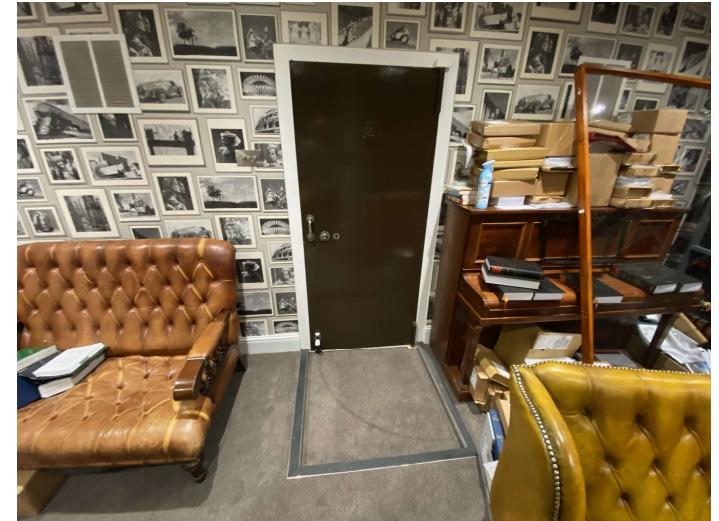
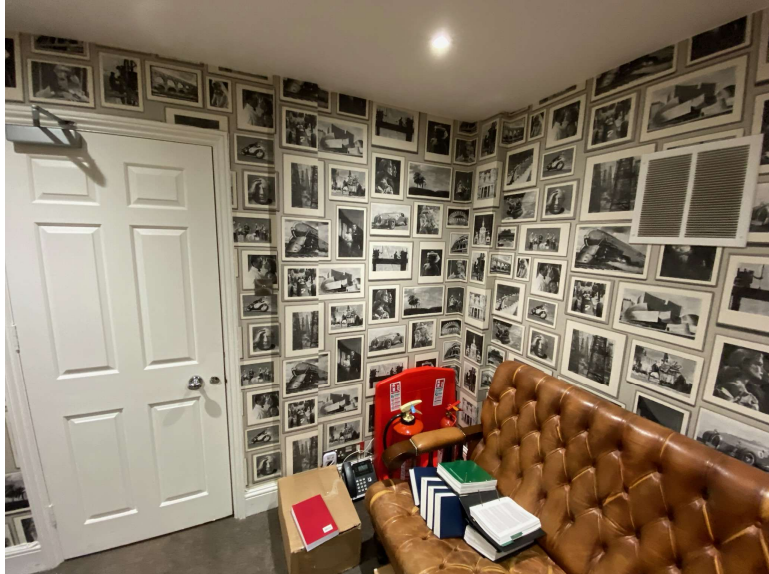
Area Extract 6

The area had been previously modernised with plasterboard cladding, spot lights, sheet carpet and modern decoration.

The column shown in image 6 is the 80 x 80 SHS modern steel post in image 5 but clad in plasterboard.

The area was designated as a small staff room prior to being converted to the Clerk's office.

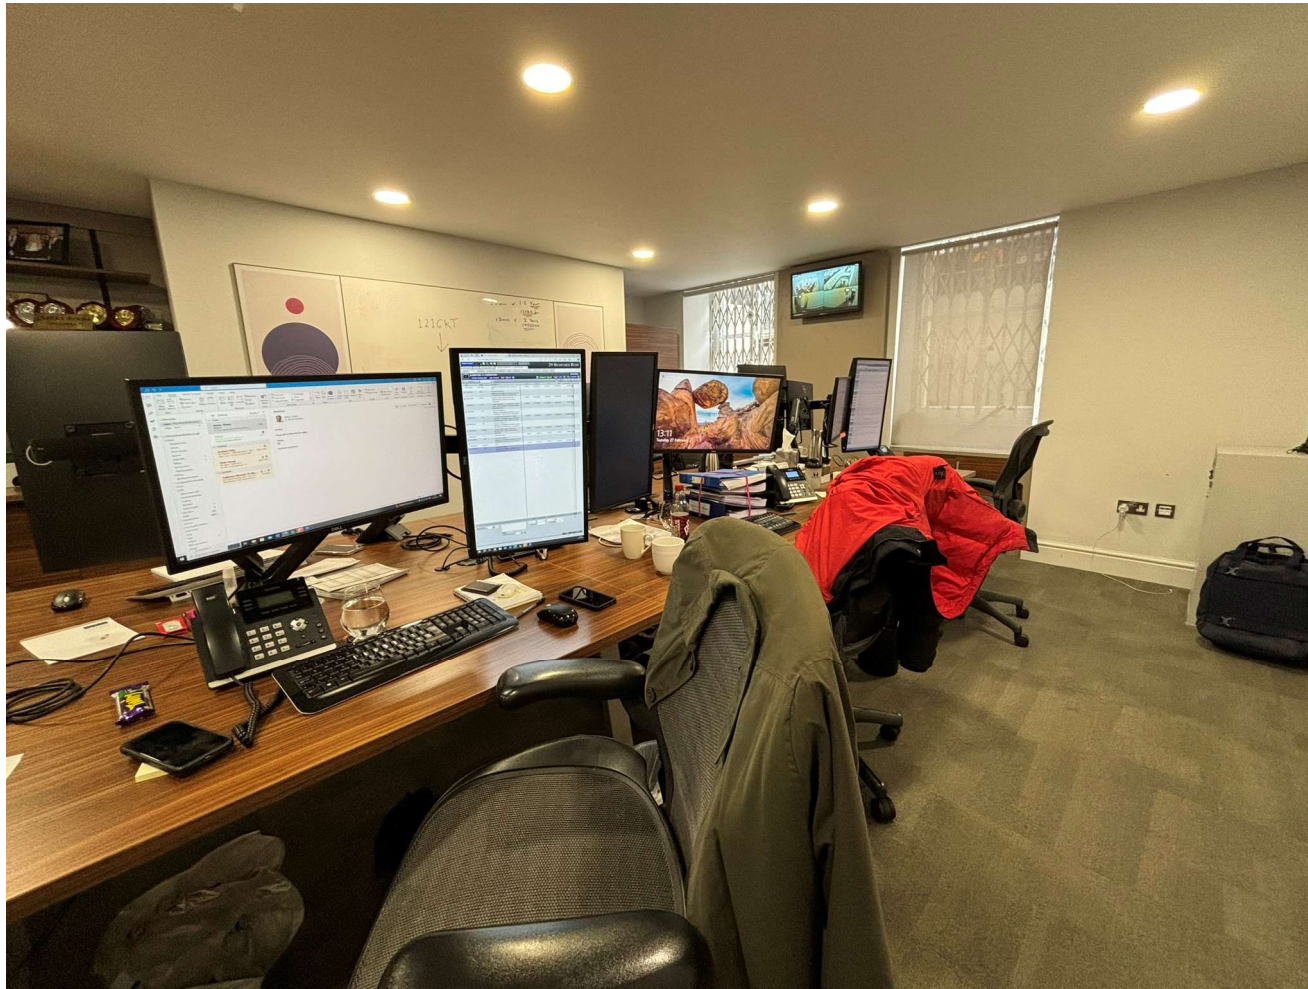
Image 9

Area Extract 6 after works completed.

The office was decorated and recarpeted, it's use converted from store / Pupil's office to Clerking team office.

New plasterboard ceiling, decoration & flooring.

New steel beam and support post concealed within plasterboard cladding.

New lighting.

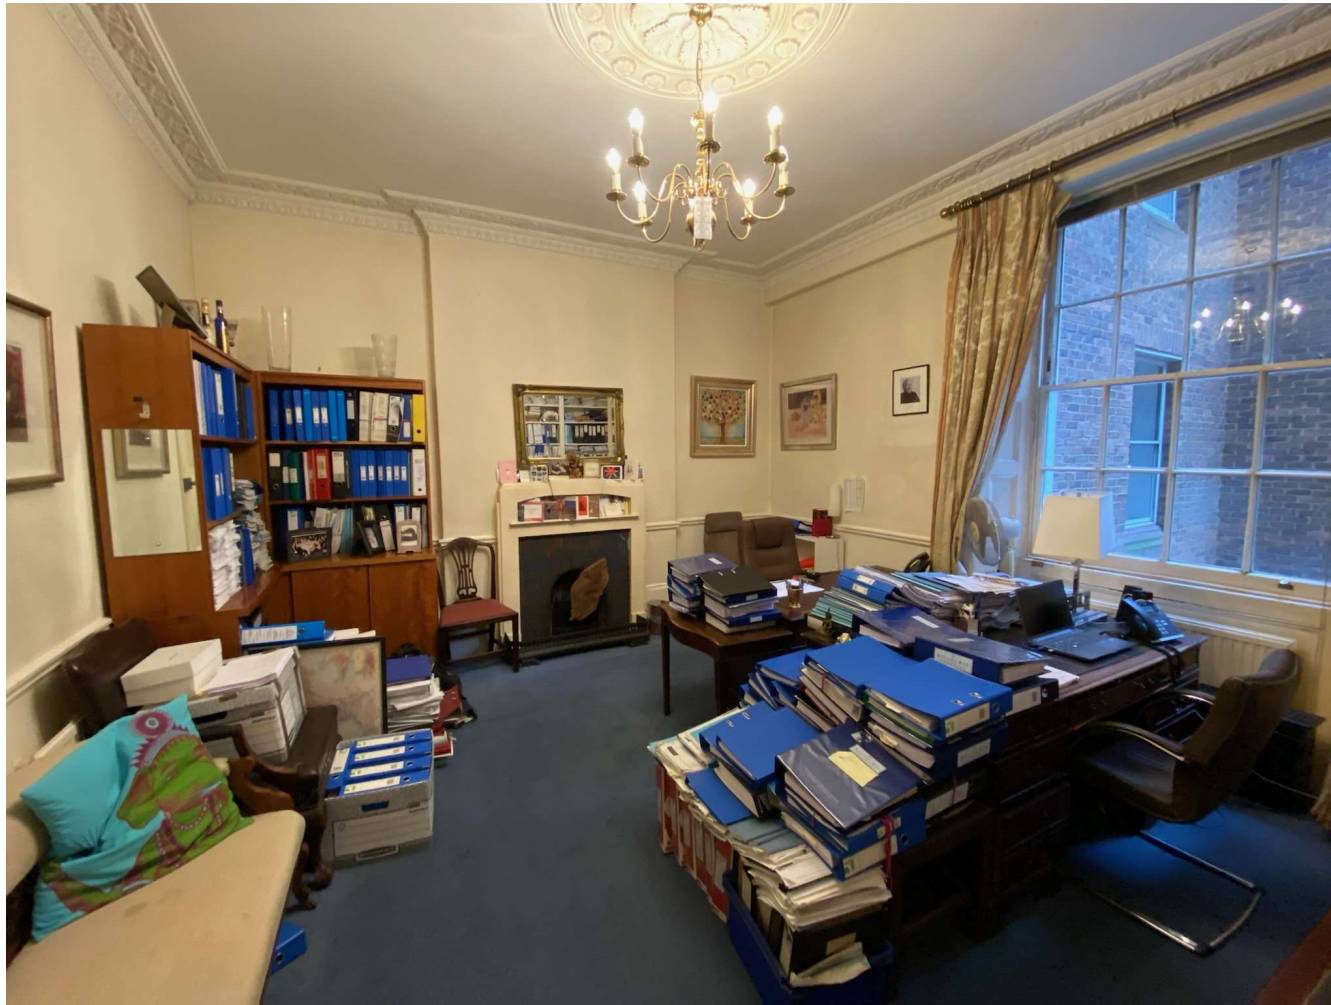
Image 10

Area Extract 9 Before
decoration works

The office was decorated and
recarpeted, it's use as
barrister's chamber was
maintained.

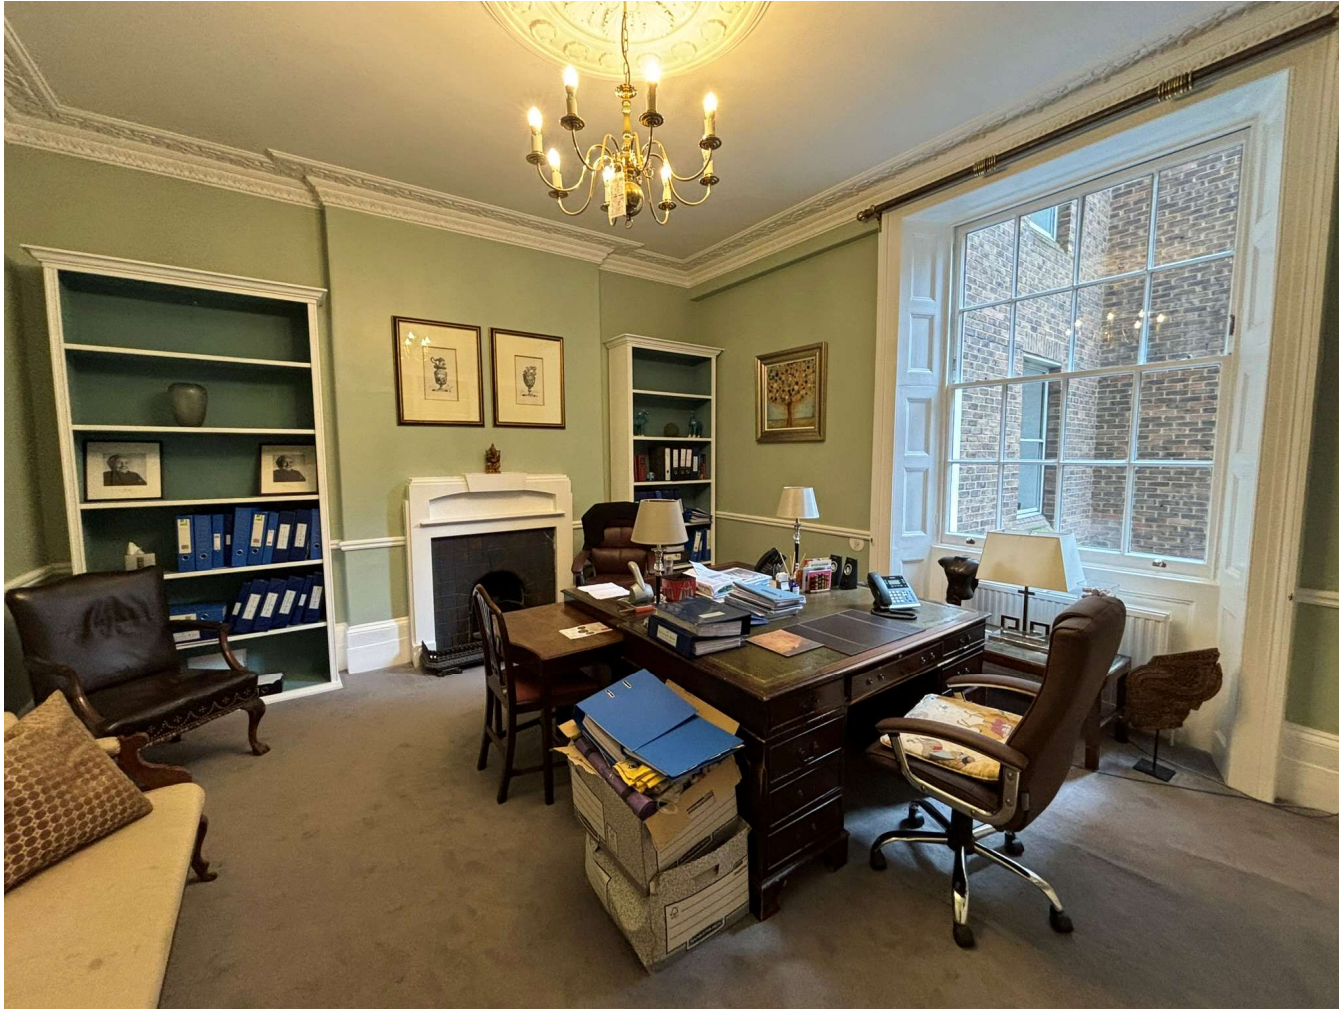
Image 11

Area Extract 9 After
decoration works

The office was decorated and
recarpeted, it's use as
barrister's chamber was
maintained.

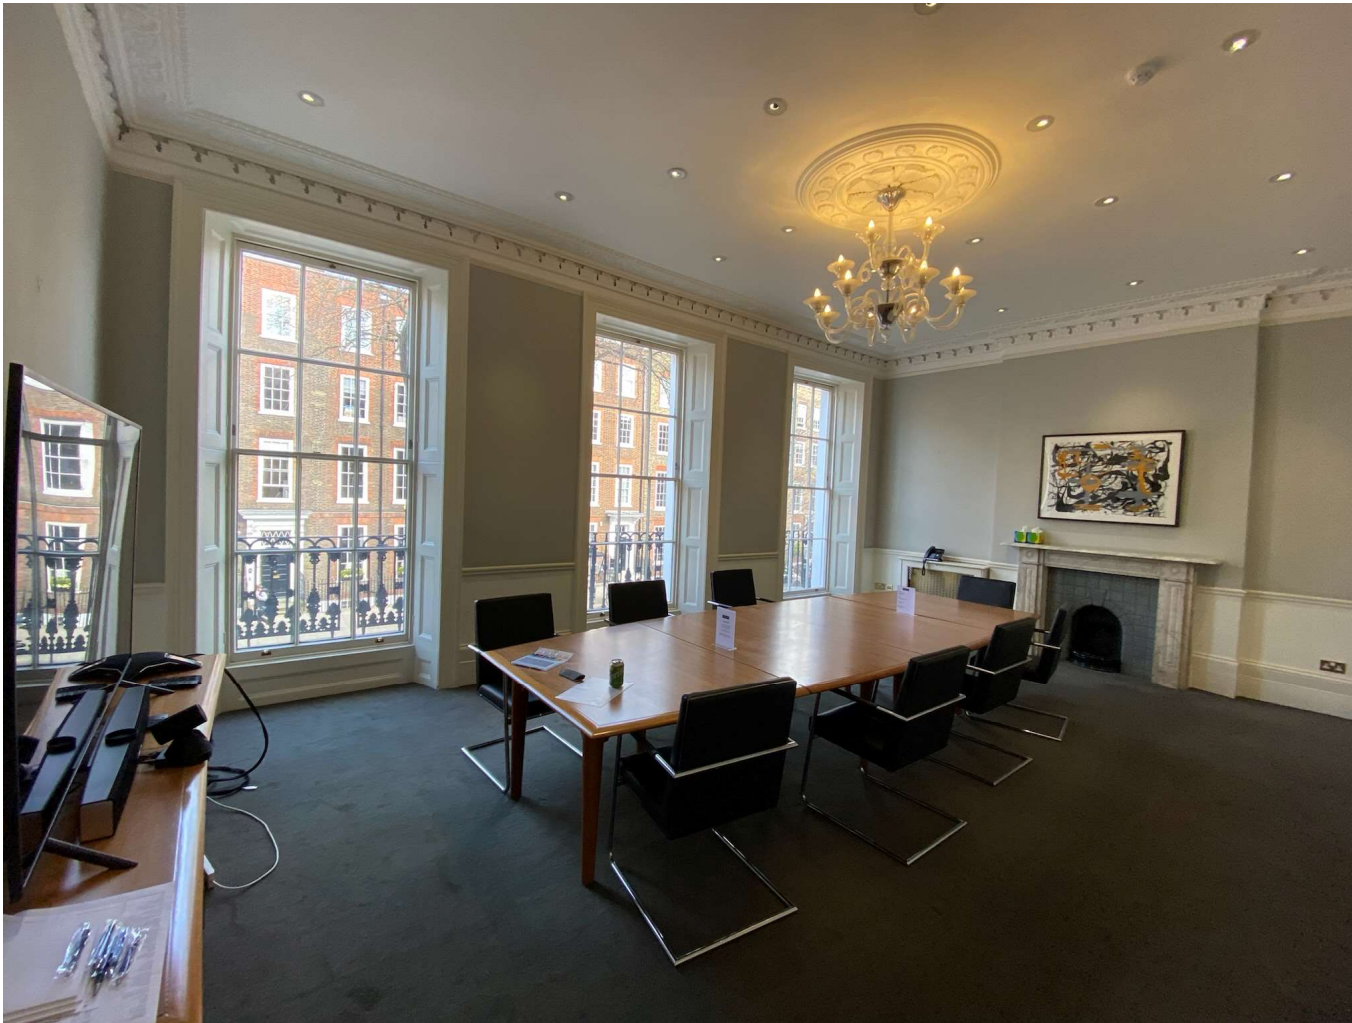
Image 12

Area Extract 1 Before decoration

This meeting room on the 1st floor has a number of historical details, all of which were maintained and unaltered.

The modern spot lights were changed for LED versions, the flooring was upgraded and the room decorated.

Care was taken to carefully decorate the ornate plaster work on the ceiling.

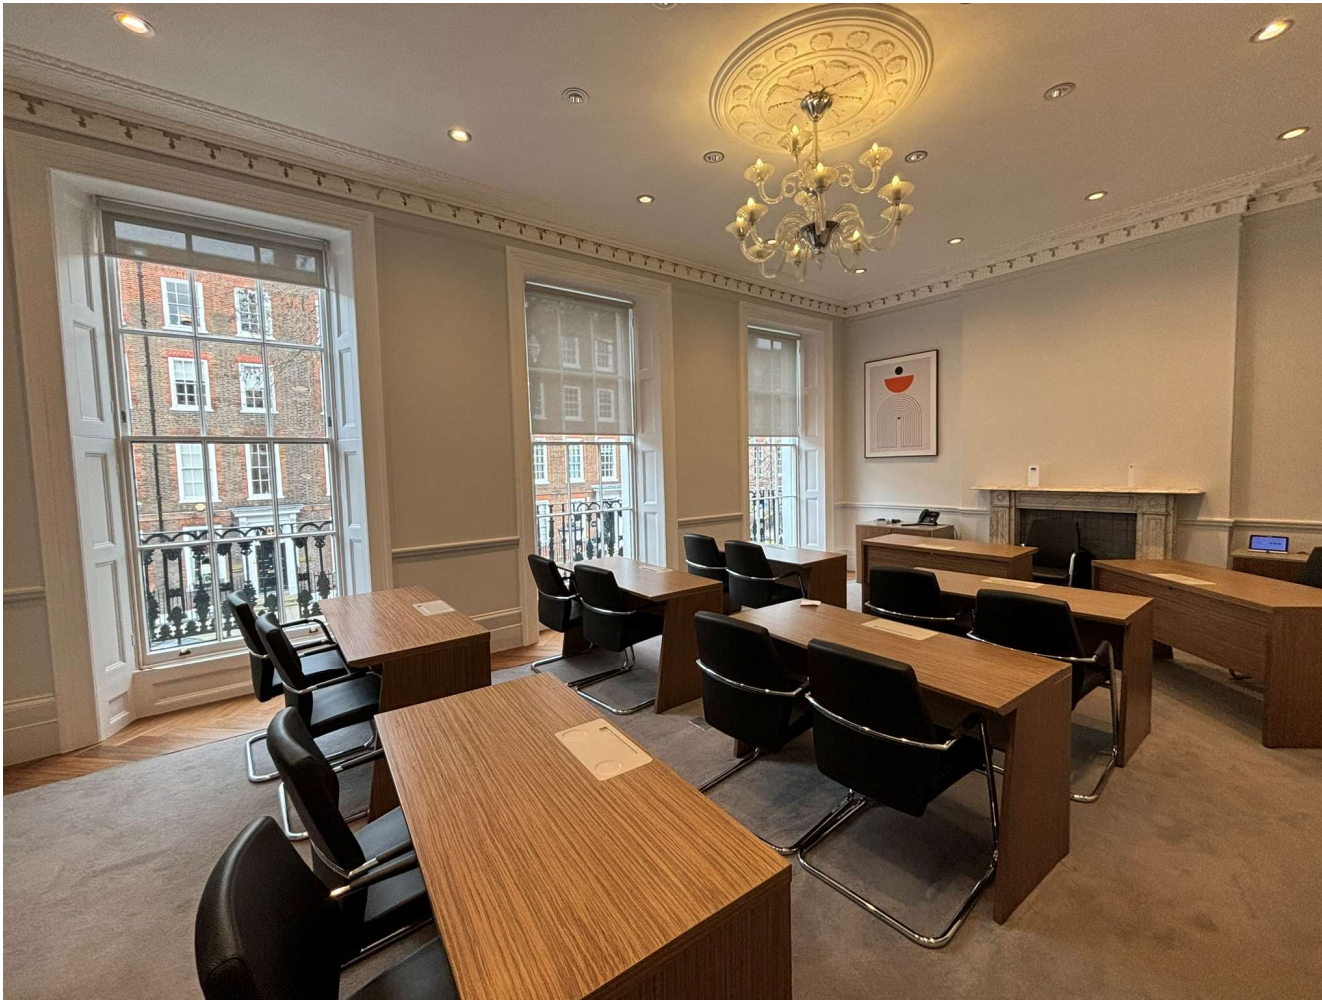
Image 13

Area Extract 1 After decoration

This meeting room on the 1st floor has a number of historical details, all of which were maintained and unaltered.

The modern spot lights were changed for LED versions, the flooring was upgraded and the room decorated.

Care was taken to carefully decorate the ornate plaster work on the ceiling.

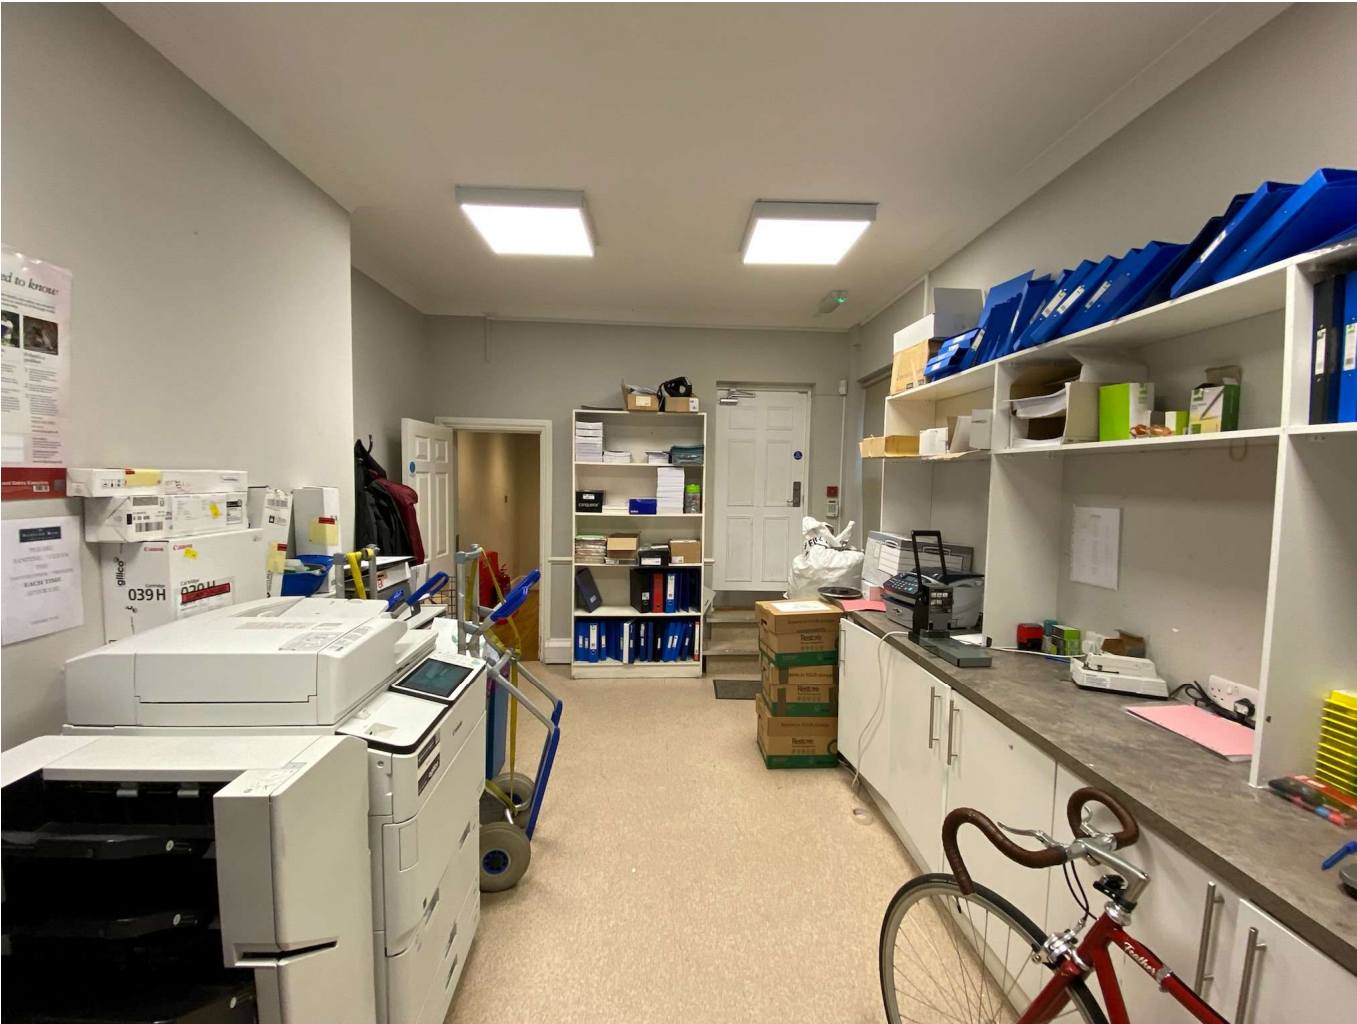
Image 14

Area Extract 11 Before works

This meeting room on the ground floor had been previously modernised with plasterboard cladding and a suspended ceiling.

The area was used as a post room.

Our project involved the upgrade of the space ready for use as a client facing meeting room.

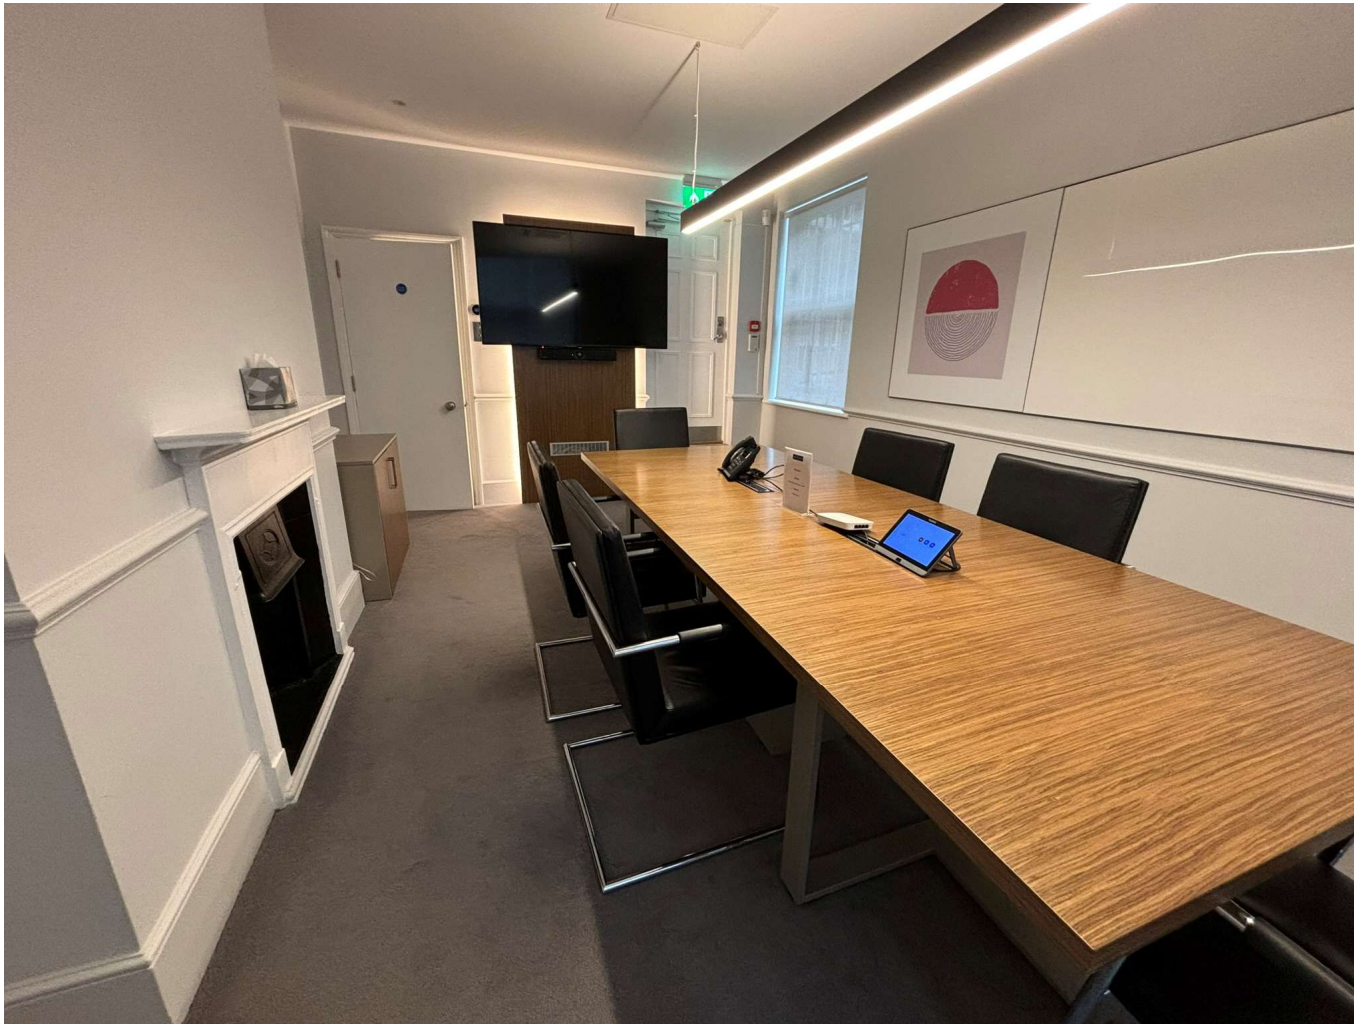
Image 15

Area Extract 11 After works

This meeting room on the ground floor had been previously modernised with plasterboard cladding and a suspended ceiling.

Our project involved the upgrade of the space ready for use as a client facing meeting room.
