**Arboricultural Implications  
Assessment  
for a proposed development  
at  
Mount Tyndal  
The Cottage  
Spaniards Road  
London  
NW3 7JH**

**Client: HP Architects  
4 Wiggshall Road  
Watford  
Herts  
WD18 0AL**

**Prepared by  
Simon Hawkins Dip Arb L6 (ABC) N.D Arbor M. Arbor. A.**

**Date  
04/03/2024**

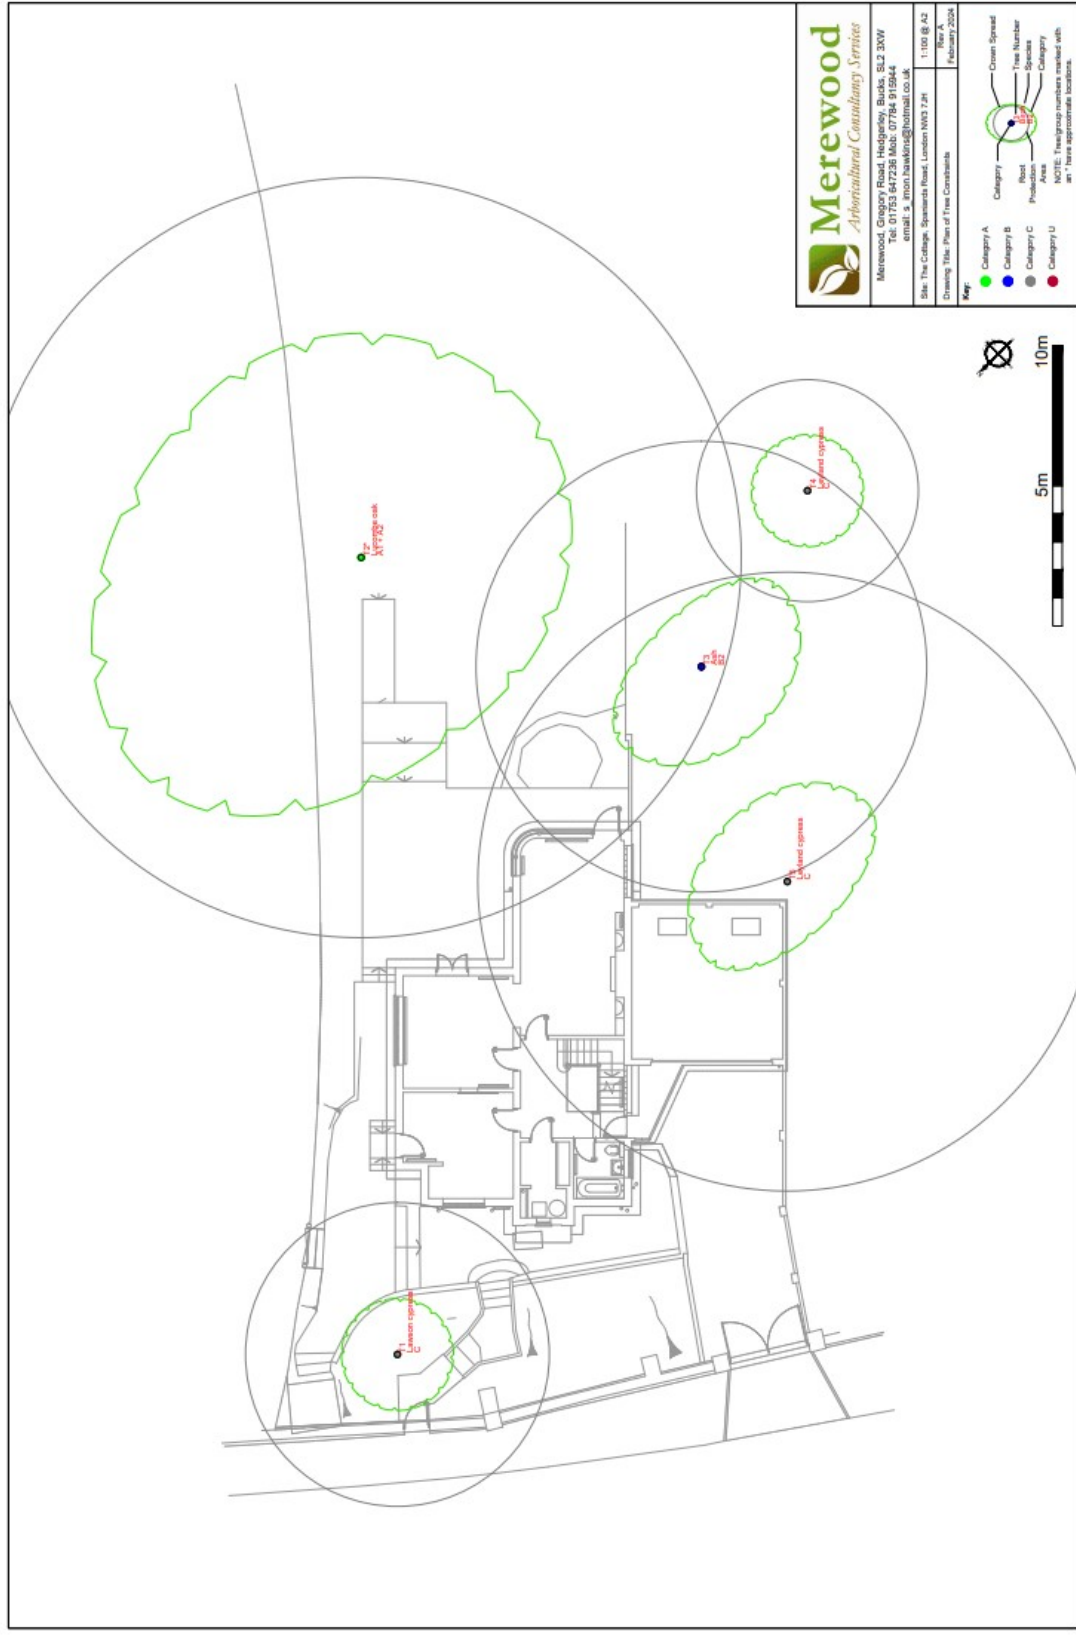
# Appendix 3 Plan of Tree Constraints

Tree no	Species	Height	Stem diameter	Crown spread				Height to 1st main branch	Height of canopy	Age	General observations	Life expectancy	Category
				North	South	East	West						
T1	Lawson cypress	18	400 210	2	2	2	2	F	F	M		20 - 40	C
T2	Lucombe oak	20	1130	11	8	8	7	G	G	M	Crown spread biased towards north. Some ivy on the main stem	40+	A1 + A2
T3	Ash	18	670 (est)	4	4	2	3	G	F	M	No sign of Chalara die back noted	40+	B2
T4	Leyland cypress	19	330 (est)	2	2	2	2	G	G	M	Part of a row of screening trees	40+	C
T5	Leyland cypress	18	920 (est)	4	4	3	2	G	G	M		40+	C

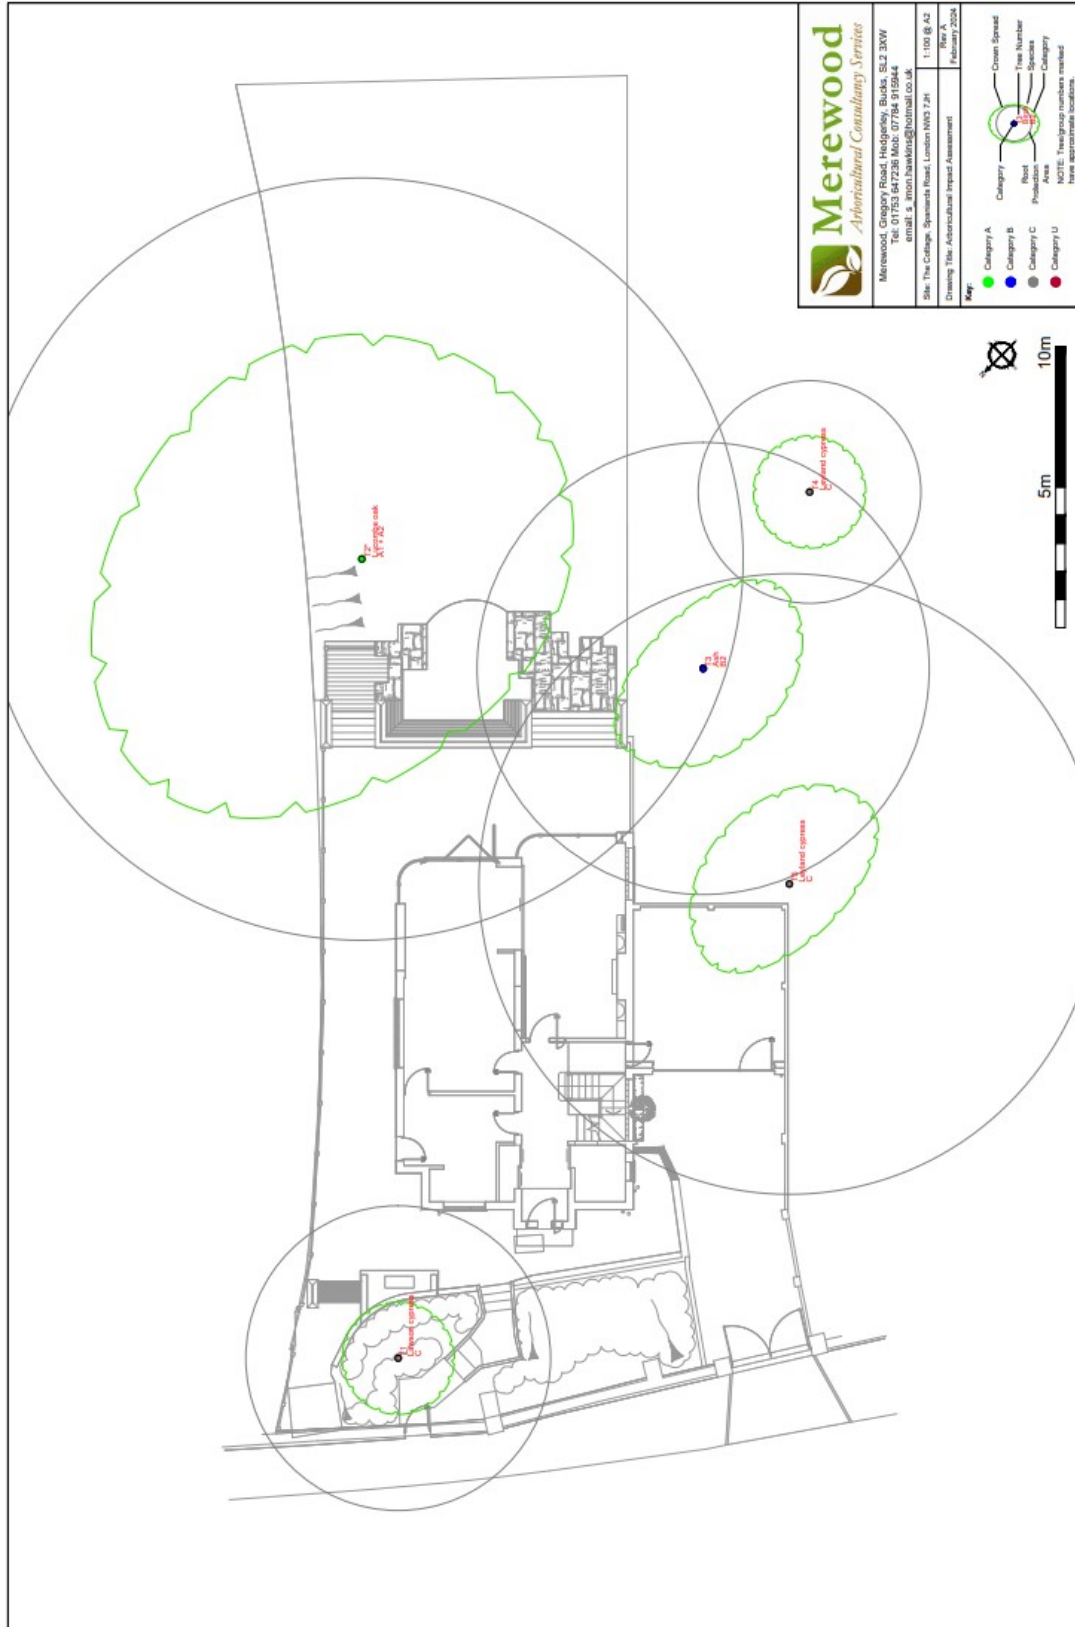
# Appendix 4 Impact Assessment Plan

- 3.5.1 The footprint of the proposed extension lies within the RPA of the Lucombe oak (T2). There will therefore be some potential impact arising from the construction of the extension (and the installation of the decking).
- 3.5.2 The extension therefore is to be built onto screw piles (supporting a ring beam) to minimise any impact from providing a foundation for the extension. British Standard 5837:2012 offers guidance as to the use of specialised foundations. The Standard states at 7.5.1 that

- 3.5.4 The ring beam itself will also be used in part to help support the proposed decking. On the outer edges, the decking will also be supported by mini piles.
- 3.5.5 The retaining brick wall to the rear of the decking has the potential to impact on the Lucombe oak (T2), as the foundation lies within its' RPA. Again, the use of precast screw piles is proposed to overcome this, using a lintel across the top of the piles to create a suitable layer for the brickwork to be laid onto.

- 3.5.7 The air source heat pump at the front of the building will be placed adjacent to the existing retaining wall within the RPA of the Lawson cypress (T1). The enclosure for this has the potential to impact onto the roots of the cypress, as the structure would sit within the RPA of this tree.

- 3.5.8 However, it is considered that this impact will not be so great as the tree is positioned on a higher level than the foundations of the structure would be and there is already a retaining wall here. Root growth where the foundations for the enclosure would be dug is likely to be quite limited therefore, and the tree will not be significantly harmed by excavating the foundations here.

- 3.6.1 The installation of plies using a piling rig will require the ground to be protected during the operation. It is recommended therefore that the existing patio remains in situ whilst the piles are inserted.

- 3.6.2 Once the piles are ready, the existing patio slabs are to be removed by hand to allow for the installation of the timber decking. Scaffolding for the construction of the extension is to be placed onto the new decking. In order to prevent loose mortar, etc. falling onto the soil between decking slats, the decking is to be covered by an impermeable sheet (PVC or similar) for the duration of the construction work.
