Arboricultural Report for Tree Condition & Insurance Purposes

35B Fairhazel Gardens
London
NW6 3QN

MWA CONSULTANT: Andy Clark
REPORT DATE: 24/11/2023

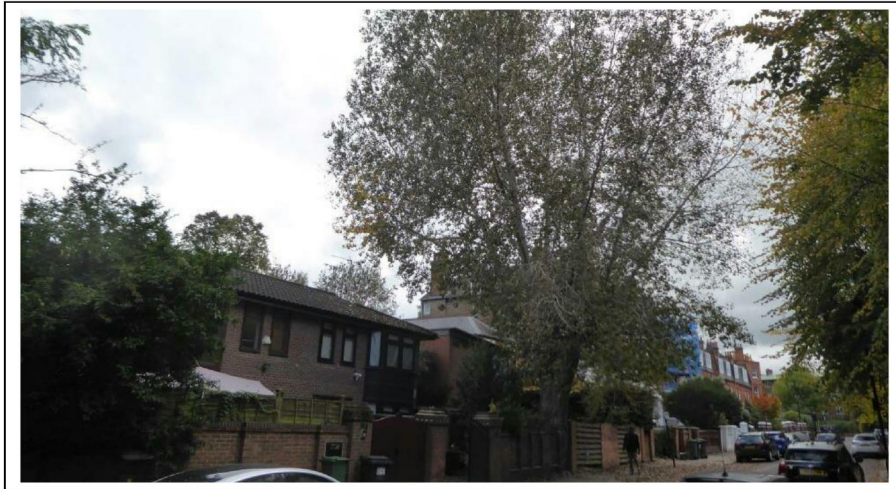
- 6.1 The focus of this report is T1 Poplar, a large fully mature tree located on the property boundary to the front and standing adjacent to the Fairhazel Gardens highway and significantly overhanging the road and surrounding third party gardens.

Overview from south of T1 Poplar

- 6.10 However in this instance, given the evident structural deficiencies in the tree and the resulting foreseeable risk of failure/collapse, in our opinion the tree no longer provides a suitable amenity asset worthy of statutory protection and as such the tree should be removed on H&S grounds – irrespective of the damage to the front boundary wall.

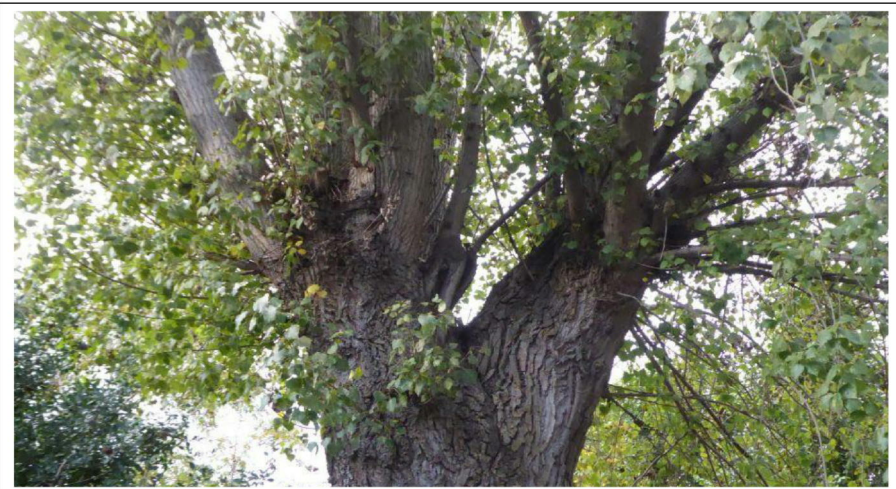
- 6.3 In terms of the risk of direct damage and possible injury from whole or part tree failure this is currently assessed as high. The lapsed aging nature of the pollard regrowth, and the inherent weak stem to trunk unions which occur as a result of pollarding, means there is a foreseeable risk for regrowth-stem breakout to occur. The significant decay of the main stem also greatly compromises the main stem integrity with the potential for main stem failure.

View from south of pollard points at approx. 5.5m

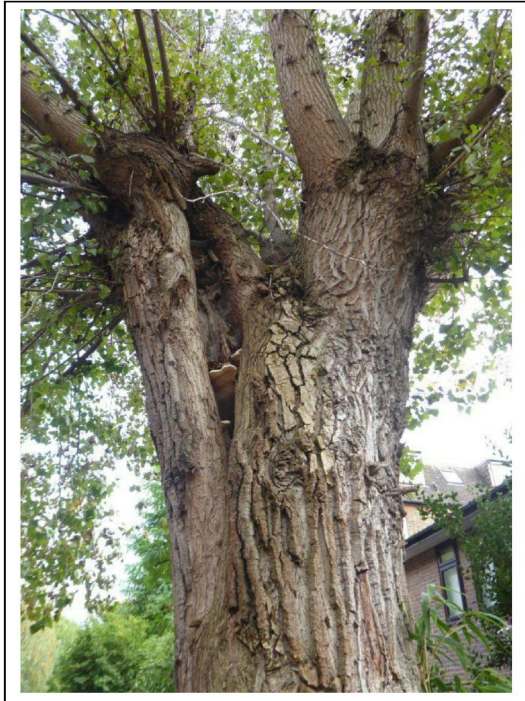
- 6.2 The tree appears of fair physiological health, however structurally the tree is compromised and suffering from significant main stem decay with a visible open decaying wound to the main stem from approx. 2.0m to approx. 4.5m above ground level on the north-eastern aspect of the main stem. The tree has also been previously pollarded at approx. 5.0m with the crown and scaffold limb structure of the tree now formed of lapsed aging pollard regrowth emanating from the main stem.

View from north of significant main stem decay to NE side from approx. 2.0 to 4.5m

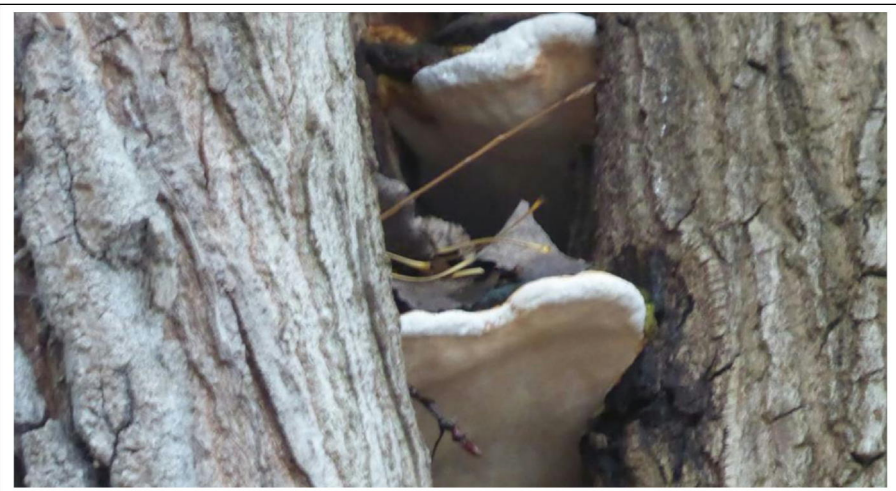
View of active fungal brackets in decay column

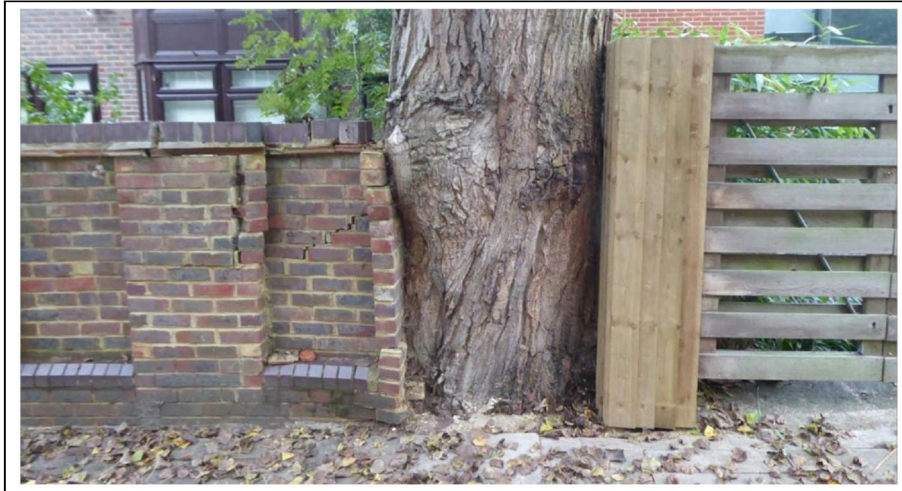
- 6.4 The tree also stands in close proximity to the front boundary wall and is currently causing significant displacement damage to the wall due to pressure from the main-stem and root-buttress expansion growth. In future years as the tree grows larger with age, this displacement will likely increase leading to potential failure of the wall onto the public footpath. Of note is that the adjacent property No 35C Fairhazel gardens, has recently replaced a section of their own front boundary wall with a section of fencing, which we understand was also damaged by the tree.

View of main stem in relation to adjacent boundary wall / fencing

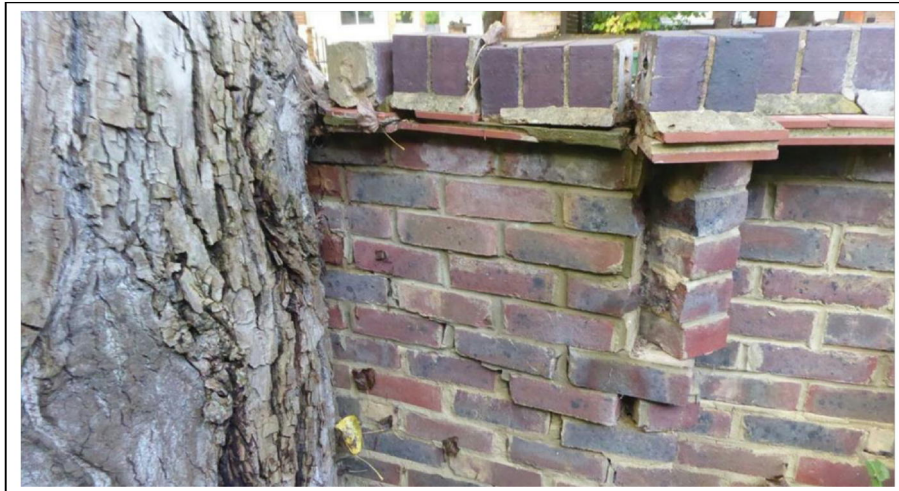
- 1.12 The tree is however currently causing direct damage to the front boundary wall, with concerns recently raised relating to the wall structural integrity and the potential H&S implications in the event the wall collapses on to the adjacent public footpath.

View of wall damage with main stem reaction wood encompassing wall structure
