REPORT ON THE CONDITION OF

TEMPORARY WORKS AT

163 SUMATRA ROAD, WEST HAMPSTEAD

Reference: R/22003/1

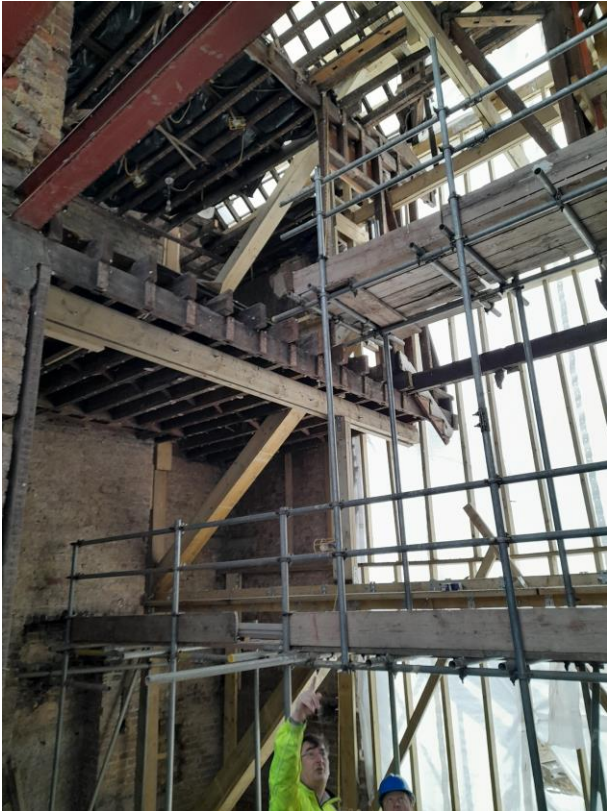
The braced timber frame as installed during November and December 2021 remains in place with no sign of any distress, movement, or degradation of the structure.

Figure 1 - Left hand side of Braced Frame

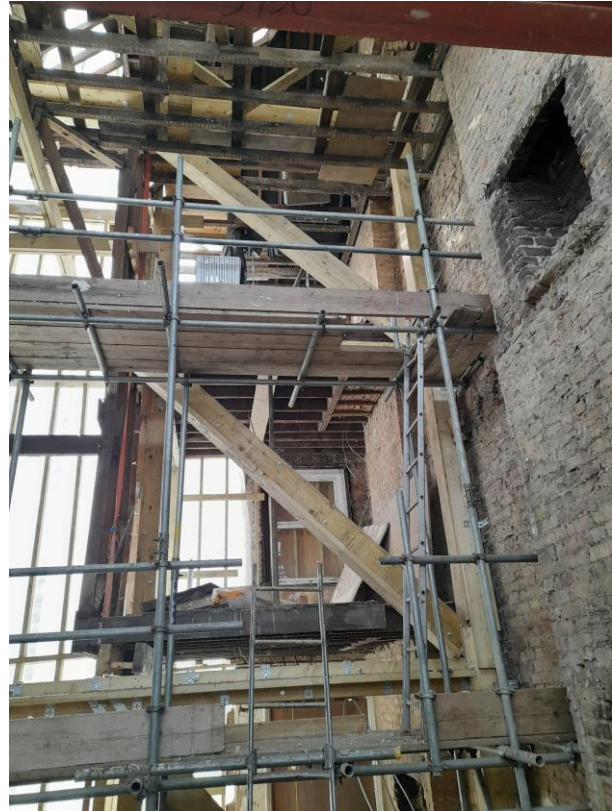
Figure 2 - Right hand side of Braced Frame

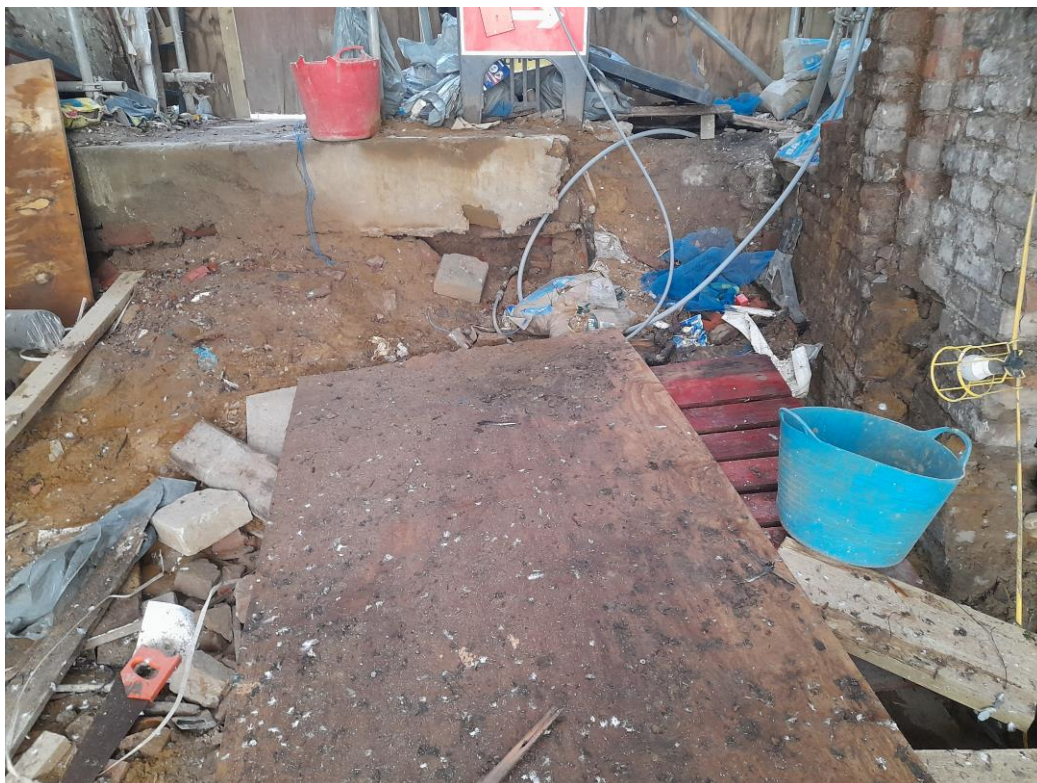
Internally the site is relatively dry, though with some evidence of water penetration through the roof coverings adjacent to the front elevation on the right-hand side of the property. Refer to Figure 3 below.

Figure 3 - Damp to debris on ground at front of property

The presence of leakage through the roof suggests that the temporary sheeting has not been entirely waterproof; however it should be noted that the leakage as noted has not resulted in any distress to the structure.
