13 Weech Road  
London  
NW6 1DL

**INSURANCE CLAIM**

**CONCERNING SUBSIDENCE DAMAGE**

**ENGINEERING APPRAISAL REPORT**

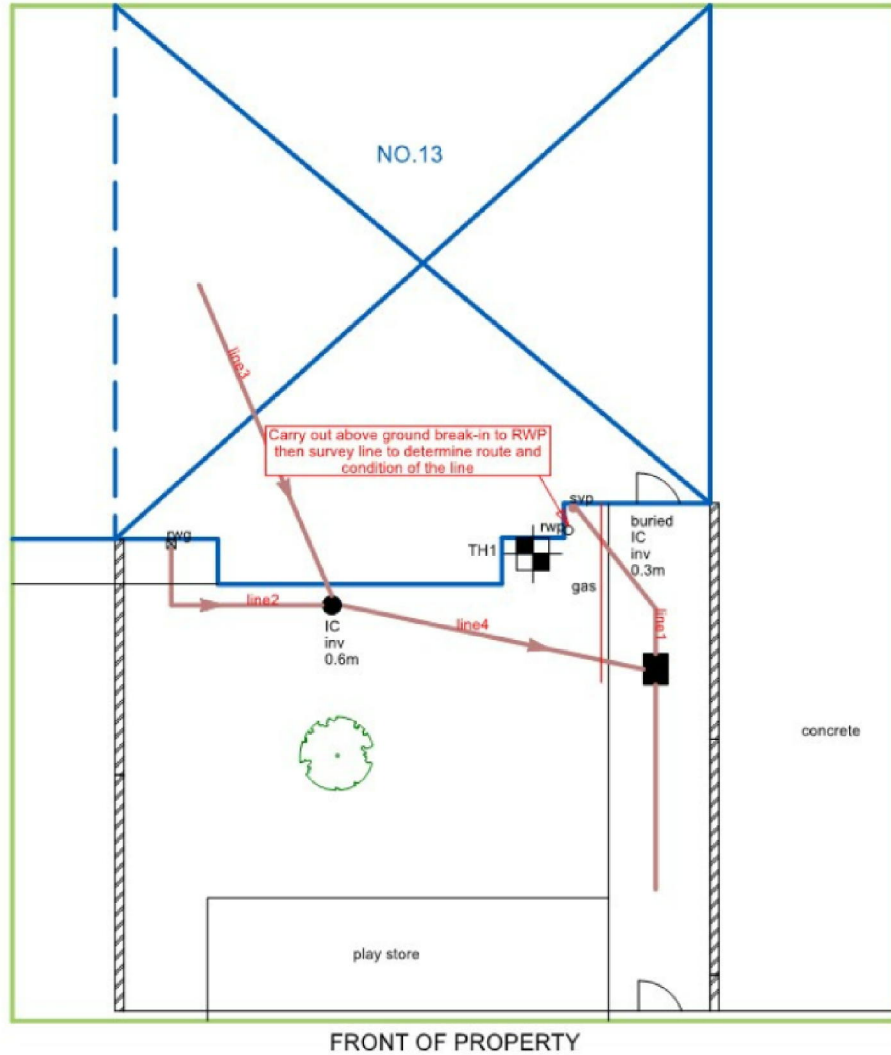
The general layout of the site is shown on our sketch plan below.

There are trees within influencing distance of the property.  
The drainage system is a combined system which is shown on the plan.

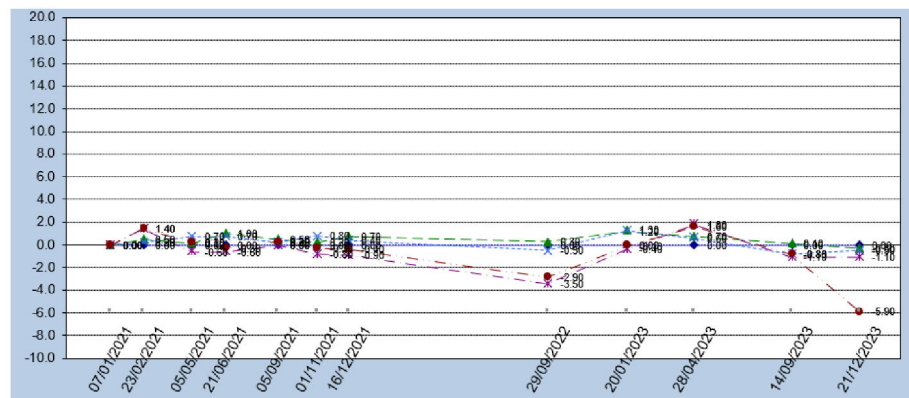
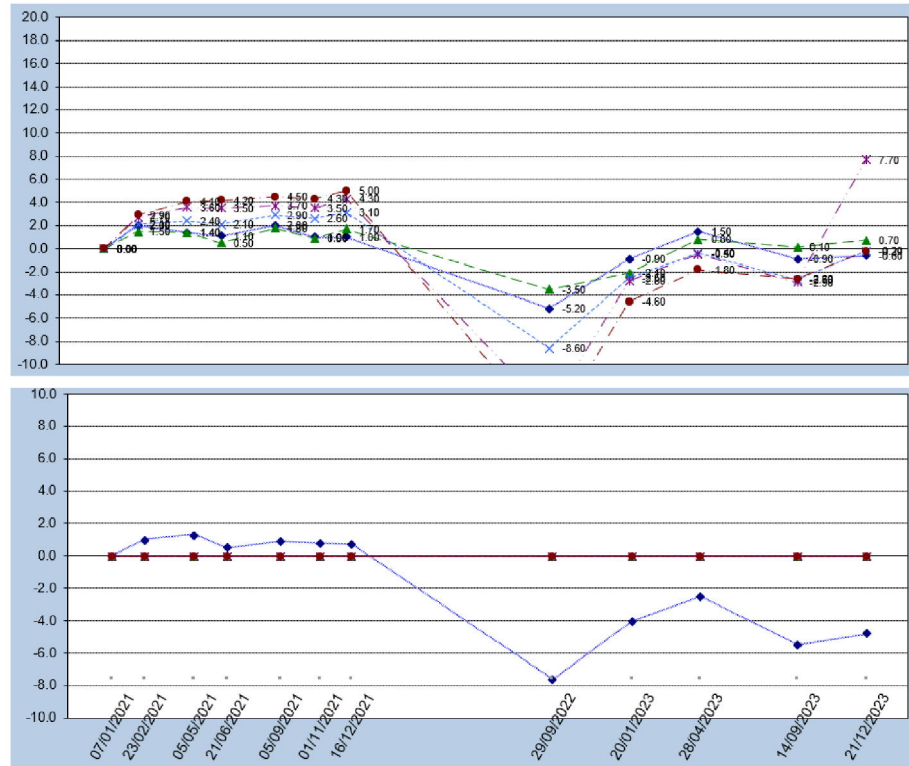
Level monitoring has been underway since 7 January 2021 and will be concluded in February 2024. The level monitoring was carried out around the property and shows cyclical pattern of downwards movement during the drier summer months when the trees are in leaf and subsequent upward movement during the wetter winter months when the trees have dropped leaf and are dormant. This pattern of movement is consistent with clay shrinkage subsidence. The maximum movement was noted at the front right hand quoin and indicates downward movement of 16.00mm during the summer 2022.

It's worth noting that a combination of drainage repairs being completed, the policyholder carrying out his own privately undertaken ground stabilisation works and above average rainfall in the summer 2023 has influenced the level readings during this period. It is anticipated that movement would have been more severe during a hot summer drought.
