Auger House, Cross Lane,
Wallasey, Wirral, CH45 8RH

Site Investigation Report

Client	Sedgwick
Client ref	
Visit date	21/08/2020
Report date	24/08/2020

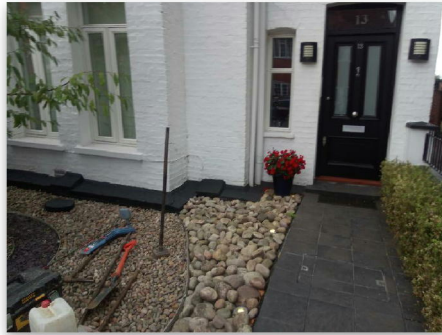
Fig 1.1: Trial Hole 1 Location

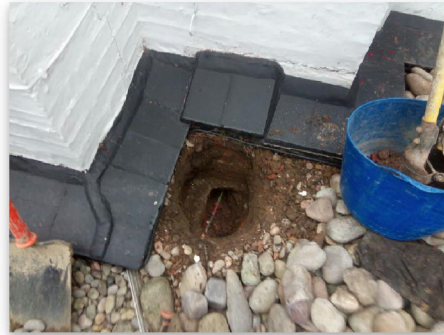
Fig 1.2: Trial Hole 1 Footing

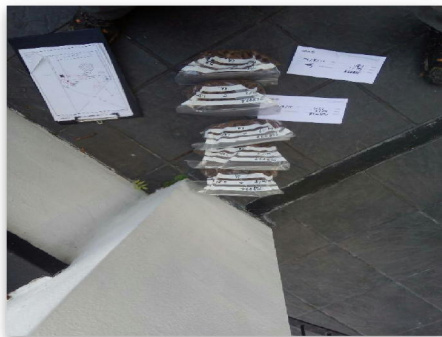
Fig 1.3: Trial Hole 1 root and soil samples

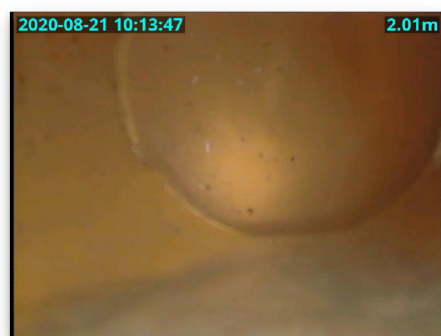
Fig 2.1: Line 1 no defects to the pipework

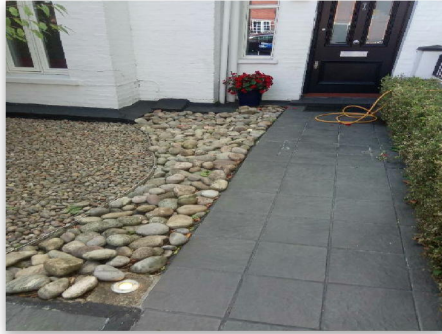
Fig 3.1: Buried manhole location in path

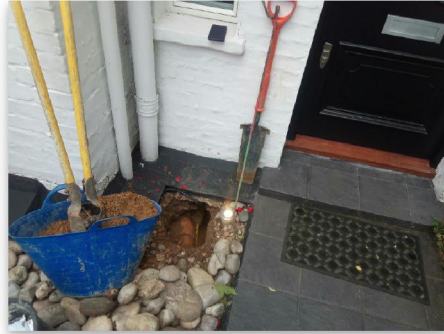
Fig 3.2: RWP & SVP

Recommendations	Auger recommend to carry out further investigations on the RWP to determine the route and condition of the RWP line.

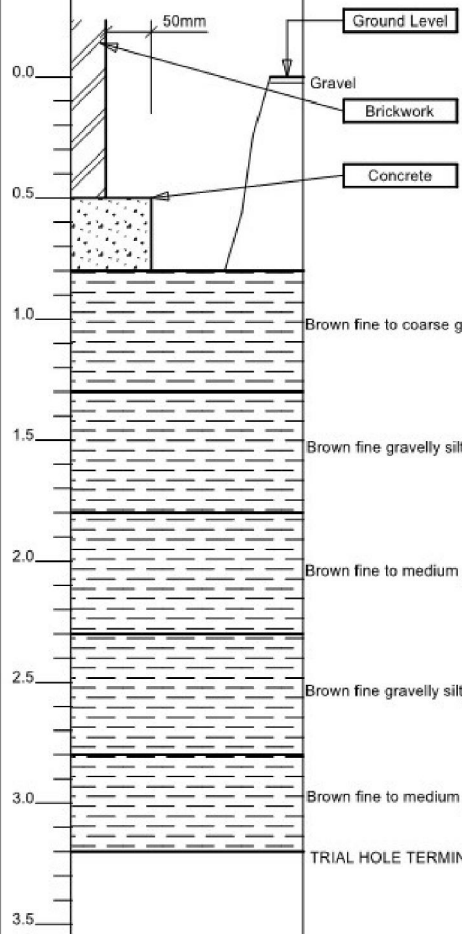
Trial Hole Log No.1

Ground Level				
		Gravel				
		Brickwork				
		Concrete				
0.5						
1.0		Brown fine to coarse gravelly silty CLAY	100kpa		Soil @ 0.8m	Root @ 0.8m
1.5		Brown fine gravelly silty CLAY	100kpa		Soil @ 1.3m	Root @ 1.3m
2.0		Brown fine to medium gravelly silty CLAY	104kpa		Soil @ 1.8m	
2.5		Brown fine gravelly silty CLAY	108kpa		Soil @ 2.3m	
3.0		Brown fine to medium gravelly silty CLAY	112kpa		Soil @ 2.8m	
3.5		TRIAL HOLE TERMINATED	120kpa

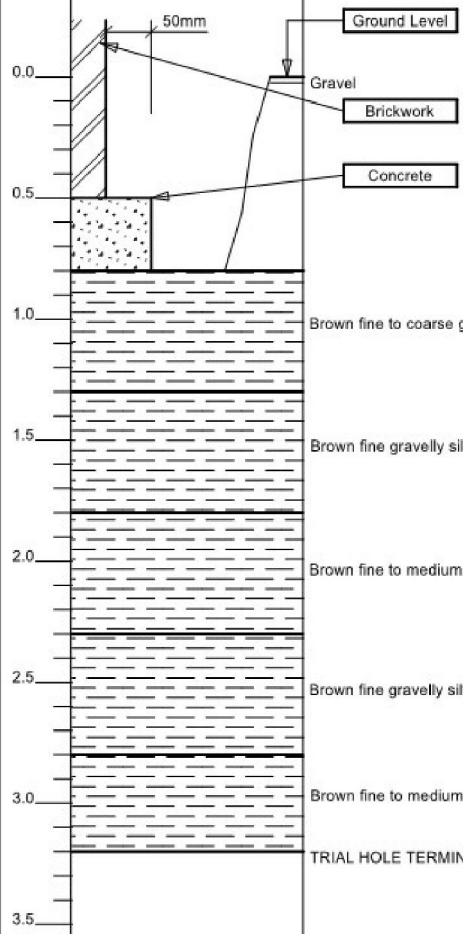
Trial Hole Log No.1b

0.5						
1.0		Brown fine to coarse gravelly silty CLAY	100kpa			
1.5		Brown fine gravelly silty CLAY	100kpa			
2.0		Brown fine to medium gravelly silty CLAY	104kpa			
2.5		Brown fine gravelly silty CLAY	108kpa			
3.0		Brown fine to medium gravelly silty CLAY	112kpa			
3.5		TRIAL HOLE TERMINATED	120kpa
