## ARBORICULTURAL ASSESSMENT REPORT

**Risk Address:** 13 Weech Road, London, NW6 1DL

Survey Date: 22/06/2023

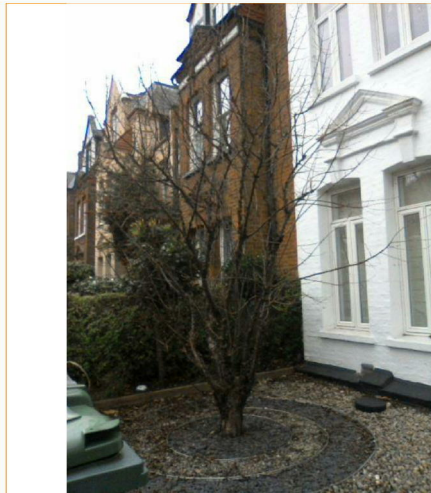
ST1 – Cherry (December 2020)

| Tree No | Common Name | Age Class | Condition | Height (m) | Crown Spread (m) | Stem diam. (mm) | Dist to bldg. (m) | Roots Implicated | Pruning history | Recommendation | Tree work constraints | Notes | Owner address | Owner |
|---|---|---|---|---|---|---|---|---|---|---|---|---|---|---|
| ST1 | Cherry | N/A | DD | 0 | 0 | 0 | 2.5 | N | Felled as per recommendations. | No work required. | | | 13 Weech Road<br>London<br>NW6 1DL | PH |

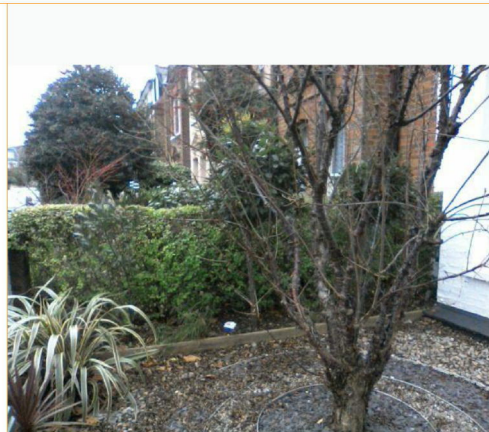
HG1 – Privet and Laurel (December 2020)

| Tree No | Common Name | Age Class | Condition | Height (m) | Crown Spread (m) | Stem diam. (mm) | Dist to bldg. (m) | Roots Implicated | Pruning history | Recommendation | Tree work constraints | Notes | Owner address | Owner |
|---|---|---|---|---|---|---|---|---|---|---|---|---|---|---|
| HG1 | Privet and Laurel | Young | Good | 2 | 1.0 | 70 | 0.2 | N | Subject to past management. | No work required. | | | 13 Weech Road<br>London<br>NW6 1DL | PH |

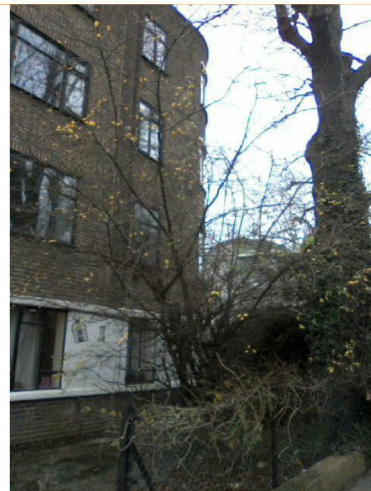
T2 - Plum (December 2020)

| Tree No | Common Name | Age Class | Condition | Height (m) | Crown Spread (m) | Stem diam. (mm) | Dist to bldg. (m) | Roots Implicated | Pruning history | Recommendation | Tree work constraints | Notes | Owner address | Owner |
|---|---|---|---|---|---|---|---|---|---|---|---|---|---|---|
| T2 | Plum | Semi-Mature | Good | 6 | 6 | 100 | 8 | N | Subject to past management. | No work required. | | | Weech Hall<br>Fortune Green Road<br>London<br>NW6 1DJ | P3P |

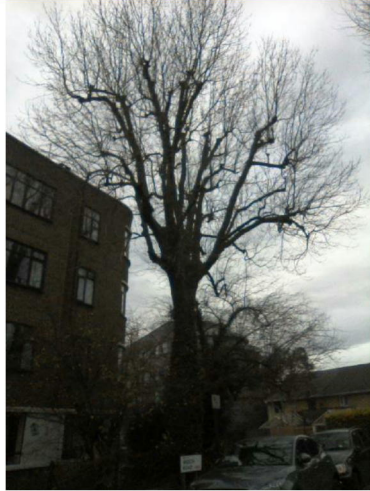
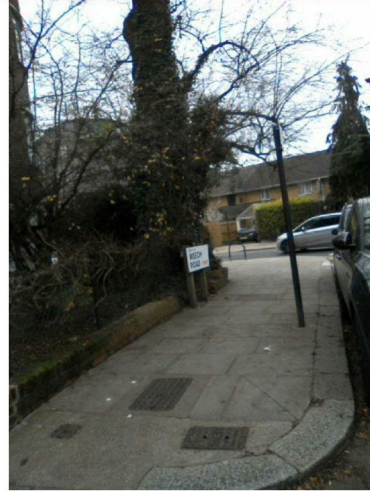
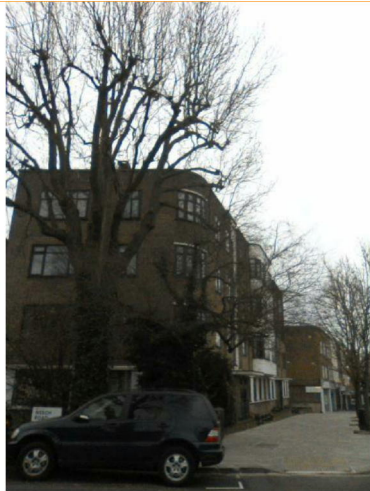
T3 - Ash (December 2020)

London Borough of Camden Council has confirmed that the implicated Ash vegetation is subject to a Tree Preservation Order. There are no Conservation Area controls.

| Tree No | Common Name | Age Class | Condition | Height (m) | Crown Spread (m) | Stem diam. (mm) | Dist to bldg. (m) | Roots Implicated | Pruning history | Recommendation | Tree work constraints | Notes | Owner address | Owner |
|---|---|---|---|---|---|---|---|---|---|---|---|---|---|---|
| T3 | Ash | Mature | Fair | 25* | 15.0 | 820 | 8.5 | Y | Subject to past reduction management (within last 3 years). | Fell and treat stump (deciduous). | Pre cone/signage/ barriers action required - footpaths/public access. Heavily parked. | | Weech Hall<br>Fortune Green Road<br>London<br>NW6 1DJ | P3P |

| Tree No: | Species | Works Required | CA | TPO | Ownership |
|---|---|---|---|---|---|
| T3 | Ash | Fell and treat stump (deciduous). | No | Yes | P3P |

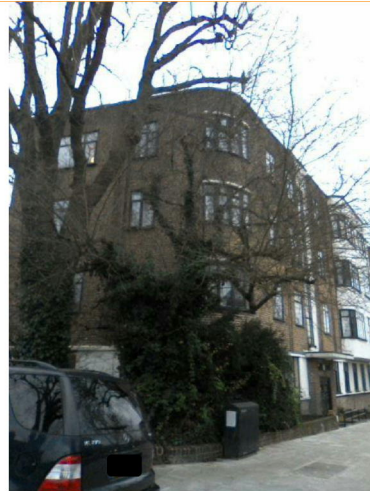
T4 - Plum (December 2020)

| Tree No | Common Name | Age Class | Condition | Height (m) | Crown Spread (m) | Stem diam. (mm) | Dist to bldg. (m) | Roots implicated | Pruning history | Recommendation | Tree work constraints | Notes | Owner address | Owner |
|---|---|---|---|---|---|---|---|---|---|---|---|---|---|---|
| T4 | Plum | Mature | Good | 9 | 6 | 329 | 11 | N | No significant past tree works. | No work required. | Potential/identified bat habitat. | | Weech Hall<br>Fortune Green Road<br>London<br>NW6 1DJ | P3P |

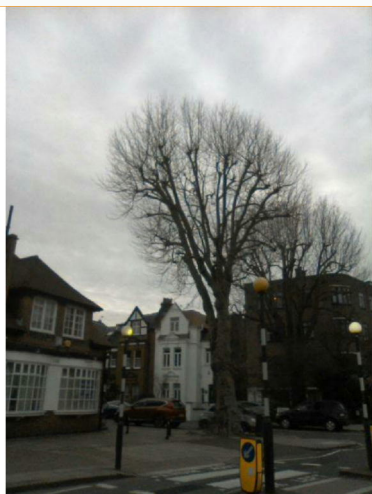
T5 - Plane (London) (December 2020)

| Tree No | Common Name | Age Class | Condition | Height (m) | Crown Spread (m) | Stem diam. (mm) | Dist to bldg. (m) | Roots implicated | Pruning history | Recommendation | Tree work constraints | Notes | Owner address | Owner |
|---|---|---|---|---|---|---|---|---|---|---|---|---|---|---|
| T5 | Plane (London) | Mature | Good | 27* | 11.0 | 1070 | 19 | N | Subject to past management. | No work required. | | | London Borough of Camden Council | LA |
