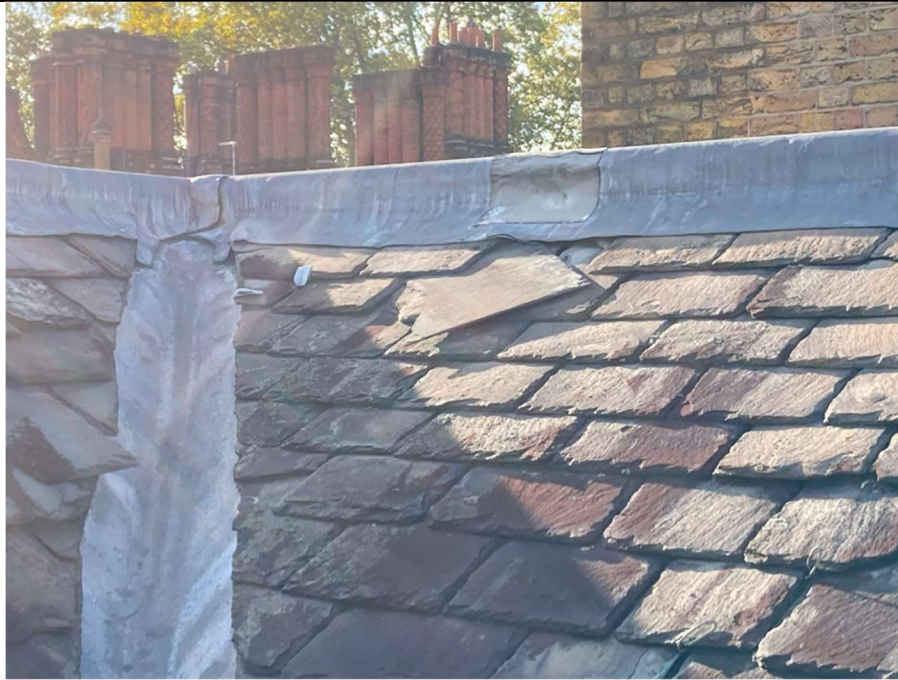
Plate 3 – Ridge tile broken and delaminated slates to E2A, nearest E1

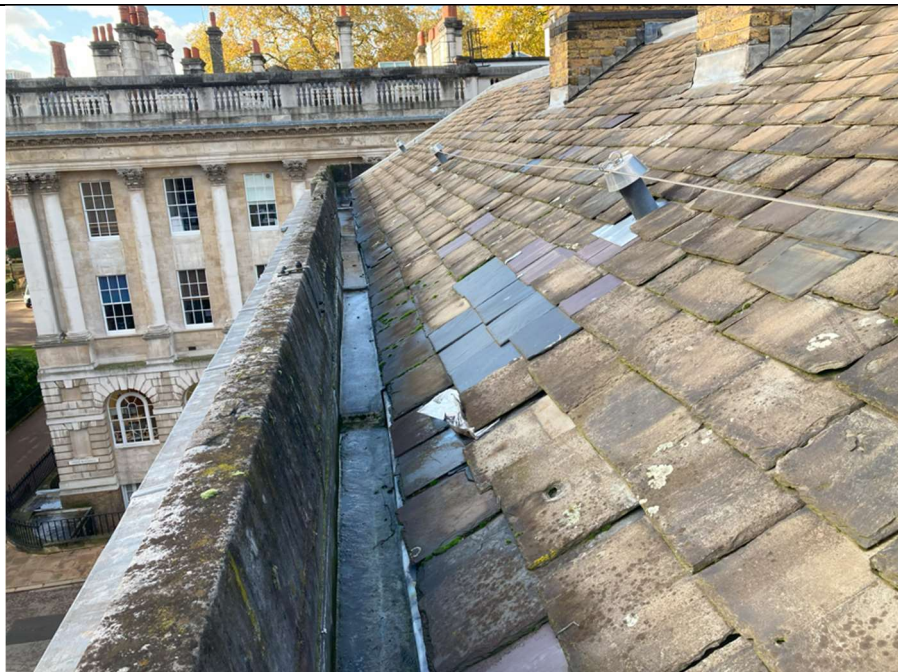
Plate 4 – Delaminated and broken slates to elevation E1

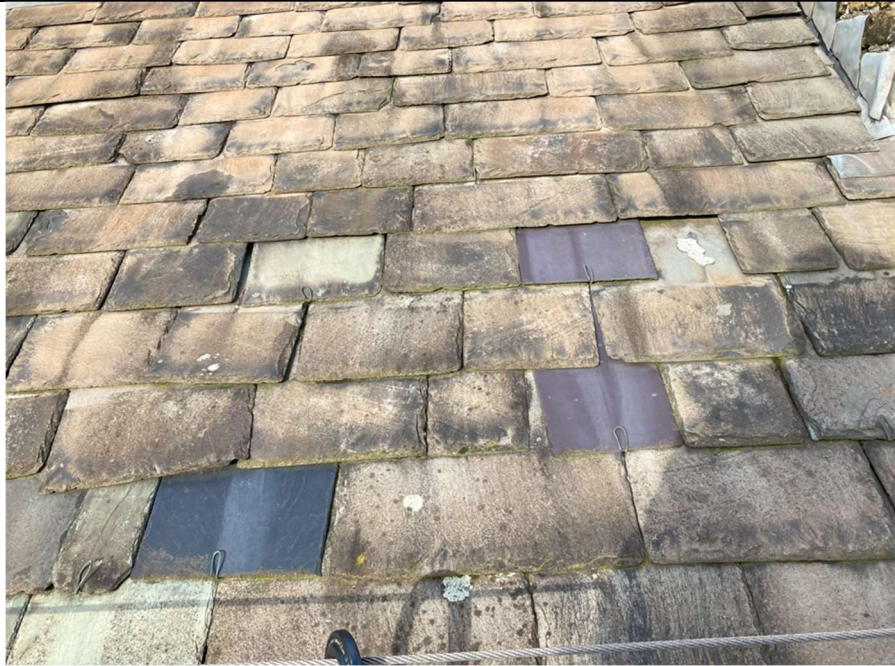
Plate 5 – Detail of delaminated / broken slates to elevation E1

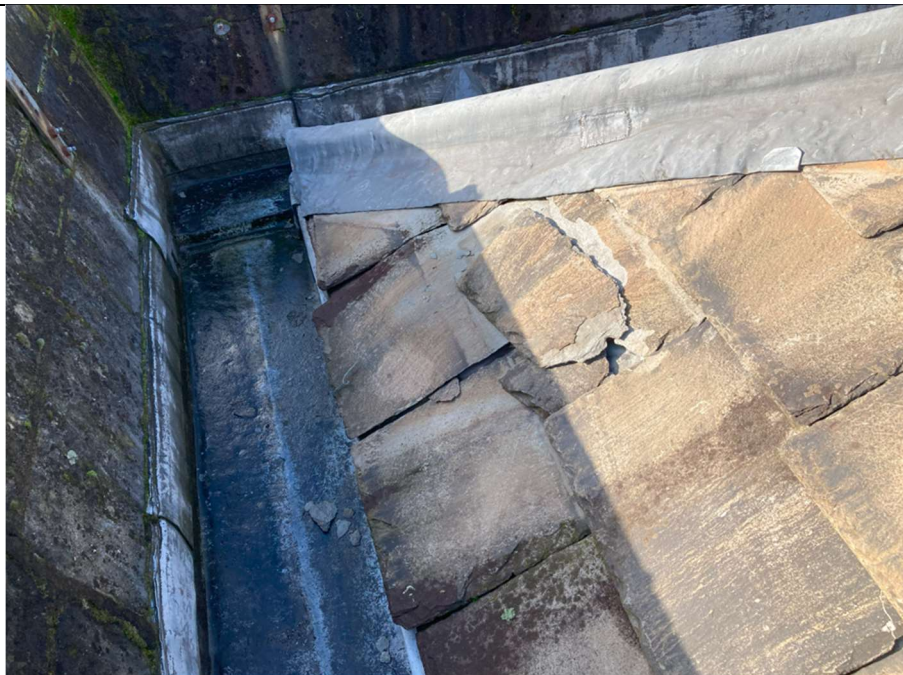
Plate 6 – Detail of delaminated / broken slates to Elevation E1 on junction with E3A.

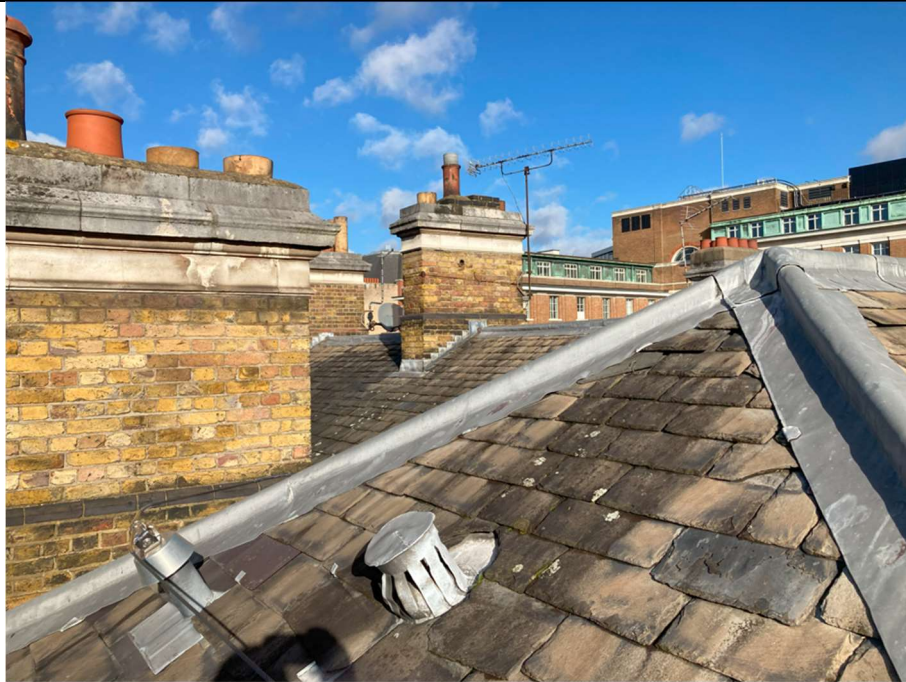
Plate 7 – Detail of delaminated / broken slates to Elevation E3A on junction with E1

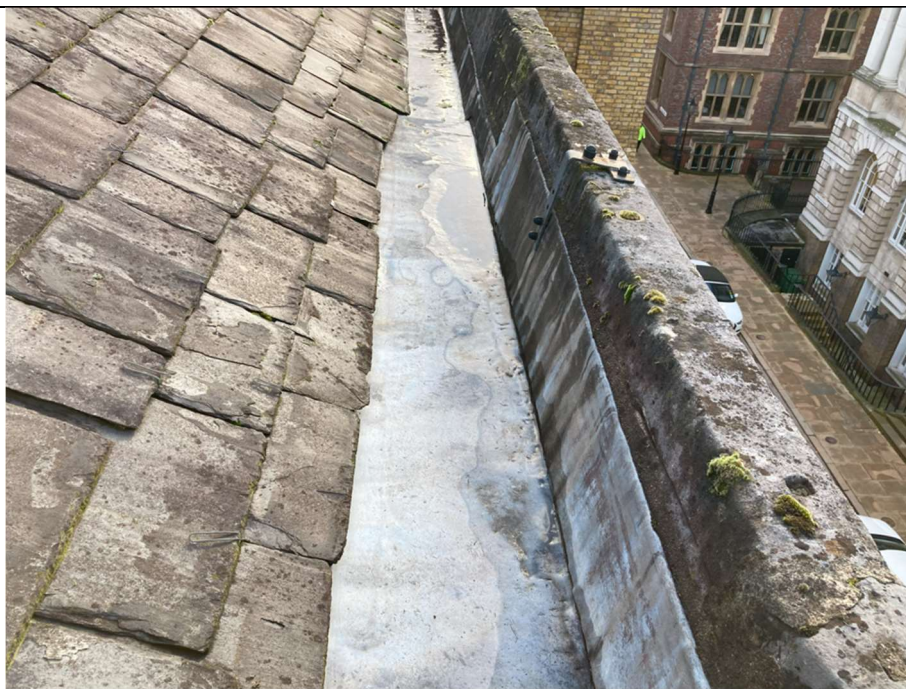
Plate 8 – Slipped / delaminated slates to E3A to gutter.

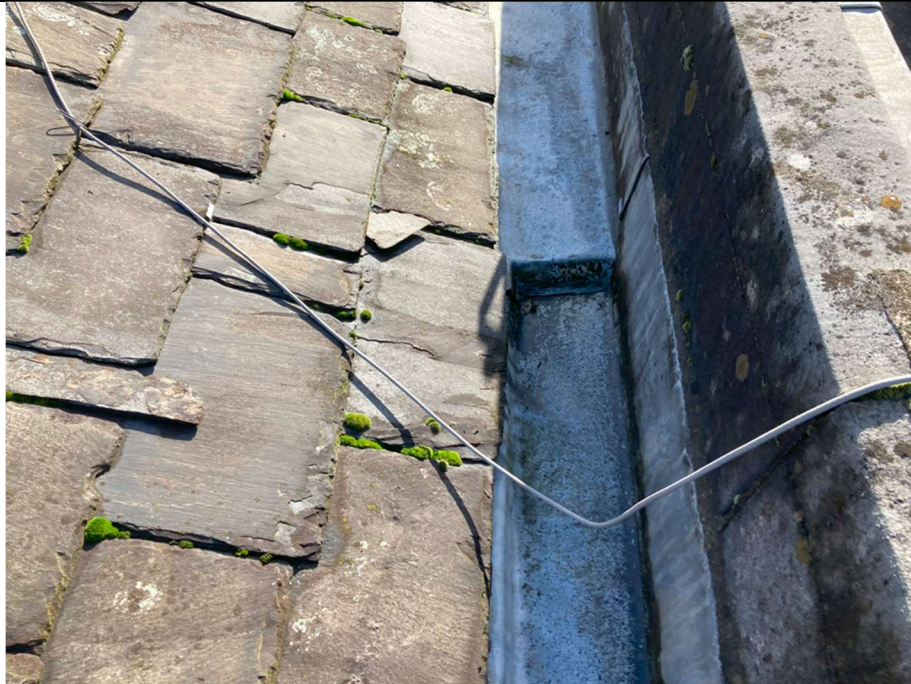
Plate 9 – Further slate damage to elevation E3A.

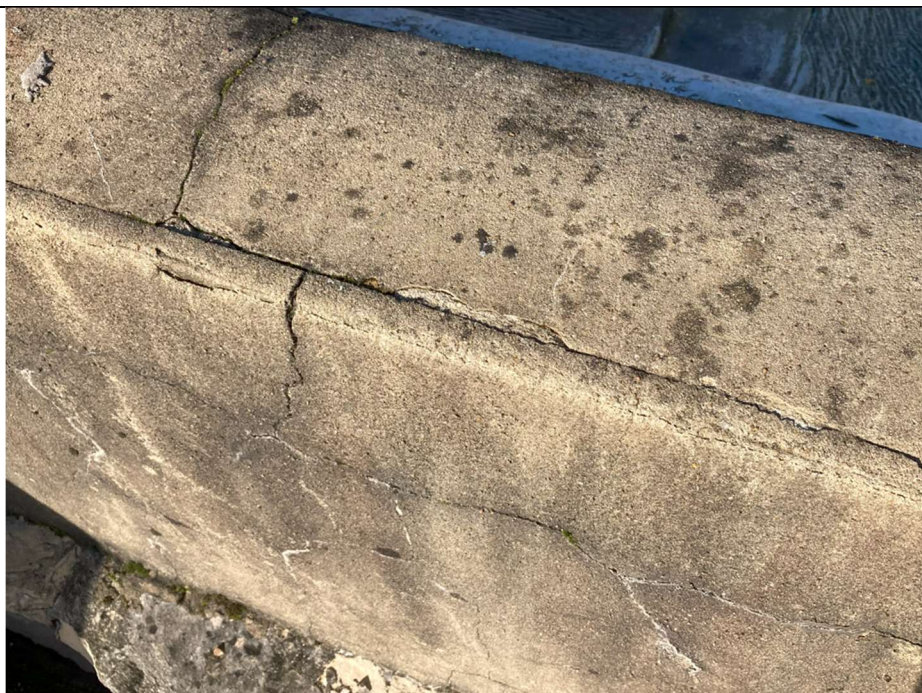
Plate 12 – Cracked render surrounding the base of the parapet wall to the lightwell nearest to Chancery lane elevation.

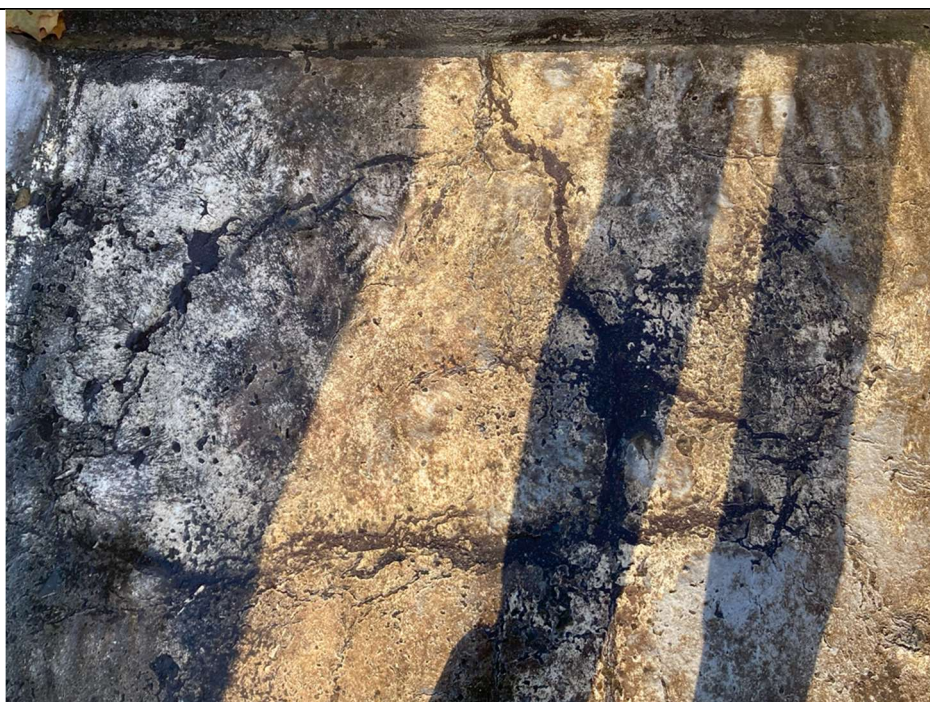
Plate 14 – Failed asphalt covering to the central roof area, showing blisters and splitting to this.
