Decay Detection Investigation

22 Frognall Way
London
NW3 6XE

March 2023

230227-DID-02

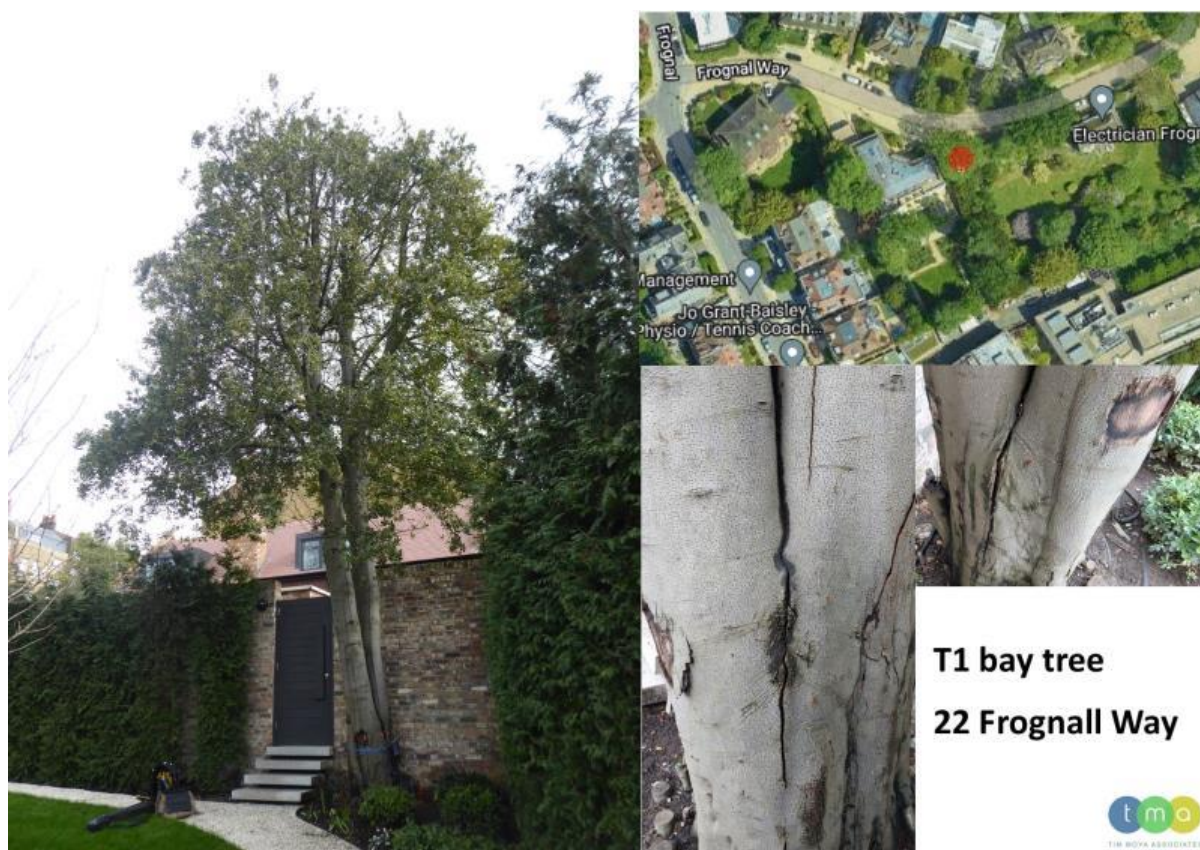
T1 Bay tree: with map showing approximate location highlighted in red, and views of the crack/bark inclusion between stems from the north (right) and south (left).

- 4.2 The tree has two co-dominant stems with adaptive growth around them. These stems present a structural weakness due to a crack and included bark between them. There is adaptive growth around the lower trunk. A flexible brace has been installed to prevent/arrest stem failure.

- 4.3 Some bark wounding has occurred around the lower trunk, though tap testing with a sounding mallet did not indicate any decay. Visual inspection of the crack on the northern and southern sides indicates that it may extend down approximately 30cm between the stems.

4.16 For the above reasons tree removal and replacement are recommended.

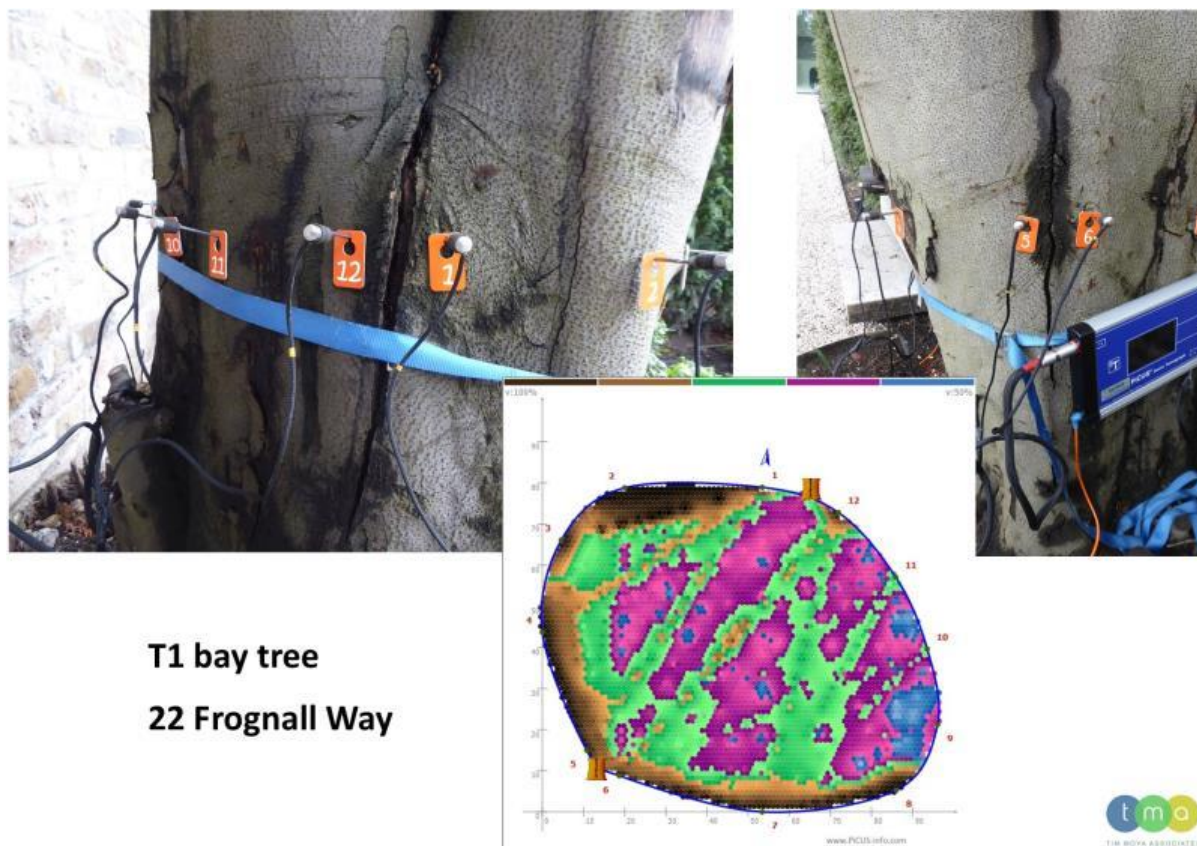
T1 bay tree PiCUS: sonic tomograph setup around the crack/bark inclusion and initial tomogram.

- 4.6 The initial tomogram produced shows extensive slow velocities (blue, pink) across the stems at the test height, which is very likely due to the crack and bark inclusion between the stems interrupting those sound waves, making the results unhelpful.
- 4.7 Revision of the data allows the separation of readings for each stem to provide more realistic results, as shown below.

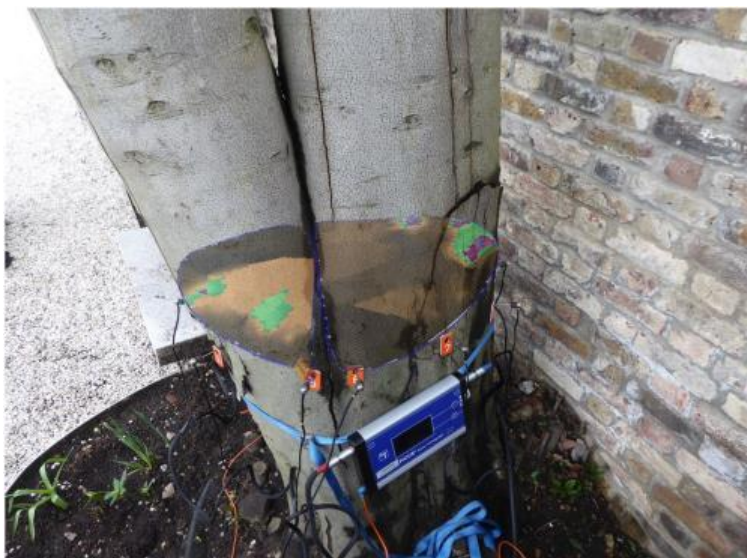
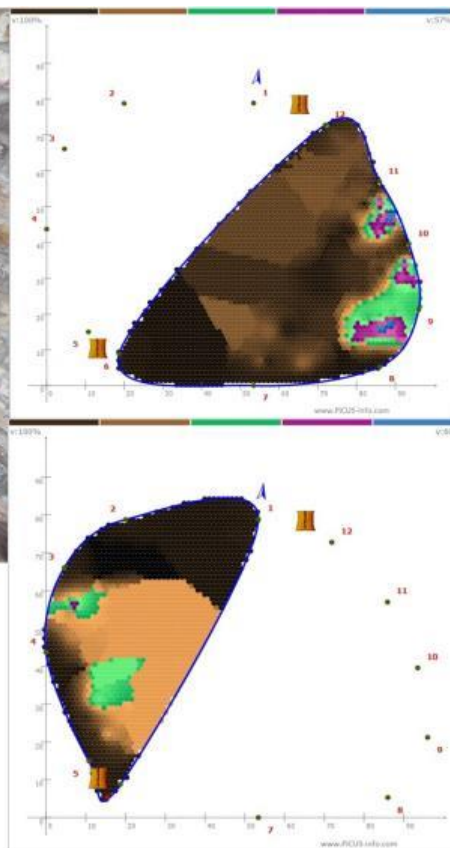
T1 bay tree
22 Frognall Way

T1 bay tree PicUS: sonic tomograms of each stem, superimposed in approximate position over the stems.

- 4.8 The results for each stem show high velocities indicating intact wood - black, dark brown, brown - with slower areas within each tomogram shown in green, pink and blue. The velocities in these areas are slower in comparison to other areas but are not considered to represent structurally significant damage in the stems.
- 4.9 These results indicate that each stem is largely intact, however the crack and included bark between the stems presents a significant structural weakness. Further investigation was carried out using the RESI PD at the height of the tomogram and below.

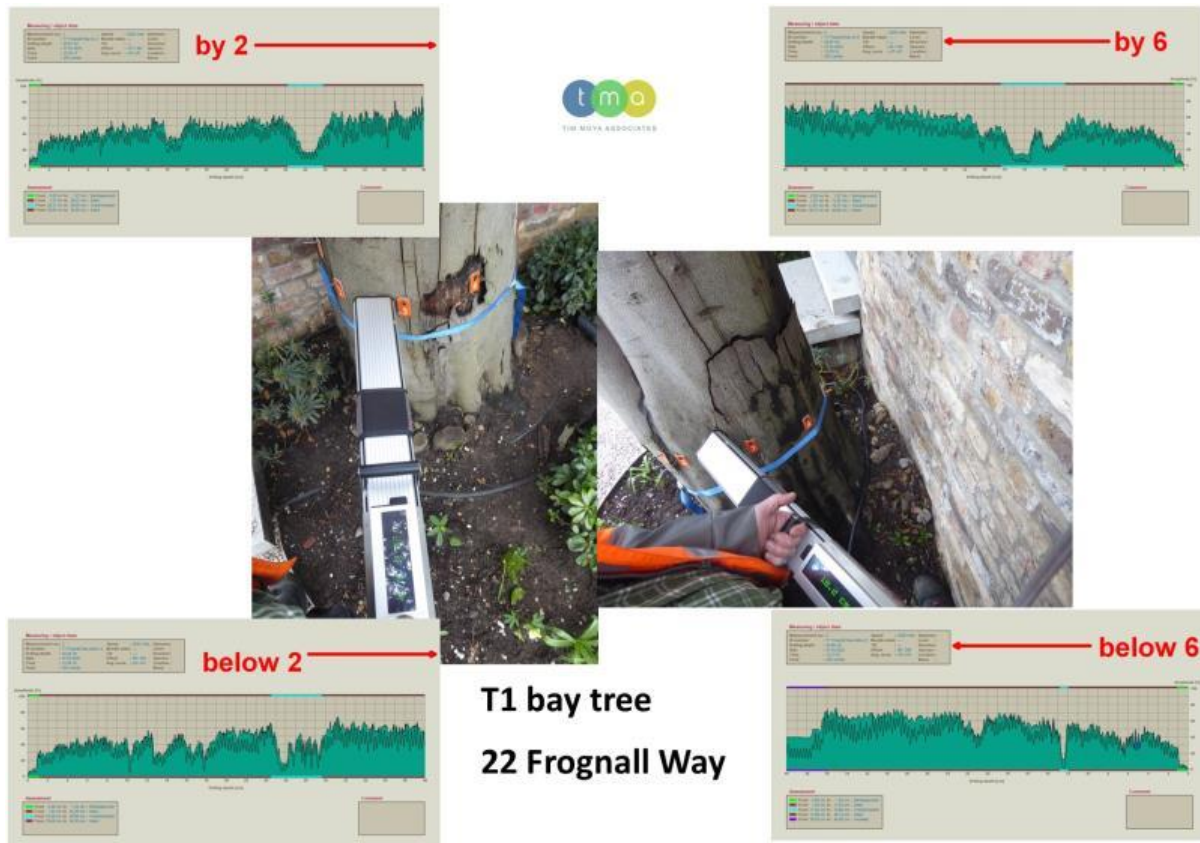
T1 bay tree RESI PD: graphs with direction and position indicated, and images of tests being undertaken.

- 4.10 The graphs confirm high resistance indicating intact wood until the crack/bark inclusion as shown by the drop in resistance in each graph, with intact wood beyond the crack.

- 4.11 The graphs by and below mp 2 confirm a drop in resistance of approximately 4cm & 5.5cm respectively, indicating that the crack/bark inclusion is more significant lower down the stem.

- 4.12 The graphs by and below mp 6 confirm a drop in resistance of approximately 6cm & 1cm respectively, indicating that the crack/bark inclusion is more significant at the visually apparent opening higher on the stem.

5.1 T1 bay tree - **fell tree - appropriate**

5.2 **plant replacement tree - landscape improvement**
