ARBORICULTURAL ASSESSMENT REPORT

69 Canfield Gardens, London, NW6 3EA

Survey Date: 05/05/2023

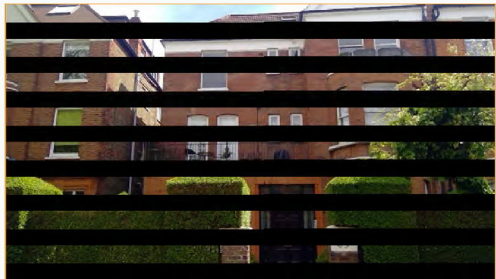
Front elevation
