INSURANCE CLAIM: ENGINEERING APPRAISAL REPORT

FOLLOWING FURTHER SITE INVESTIGATION

Address of Insured: 69 Canfield Gardens, LONDON, NW6 3EA

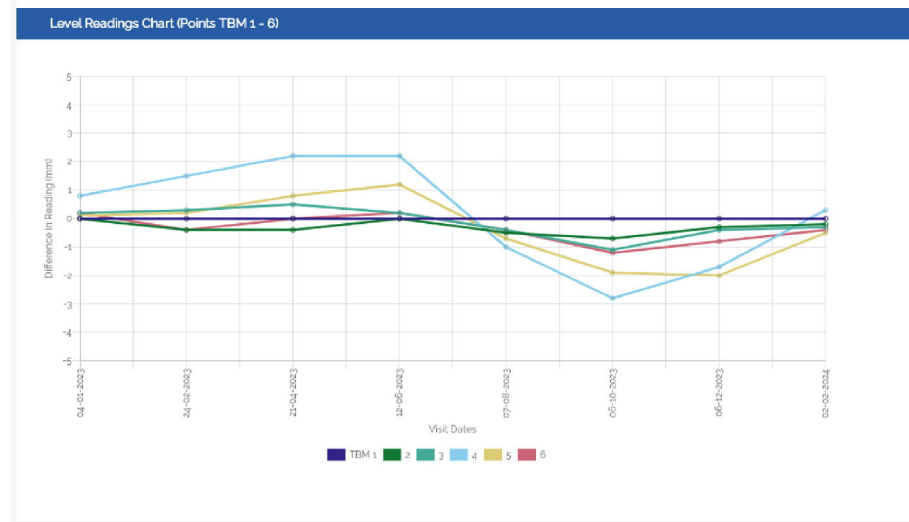
Crack and level monitoring have been established and readings have been taken at regular intervals between January 2023 and February 2024. The graph showing the level readings taken to date is shown below. The readings demonstrate a general pattern of seasonal movement associated with a clay shrinkage mechanism.

If the Lime tree is removed then I consider that works including structural crack repair and redecoration at an [REDACTED] will be appropriate in order to repair the damage in this case.

If the Lime tree is not removed then it may be necessary to consider underpinning of the foundations of the property in the area of damage, in addition to structural crack repair and redecoration needed to repair the damage. The total cost of this option is estimated [REDACTED]
