Asbestos Refurbishment / Demolition Survey Report

248-250 Camden Road
London
NW1 9HE

Survey Date: 18th November 2021

Report Number: 2118

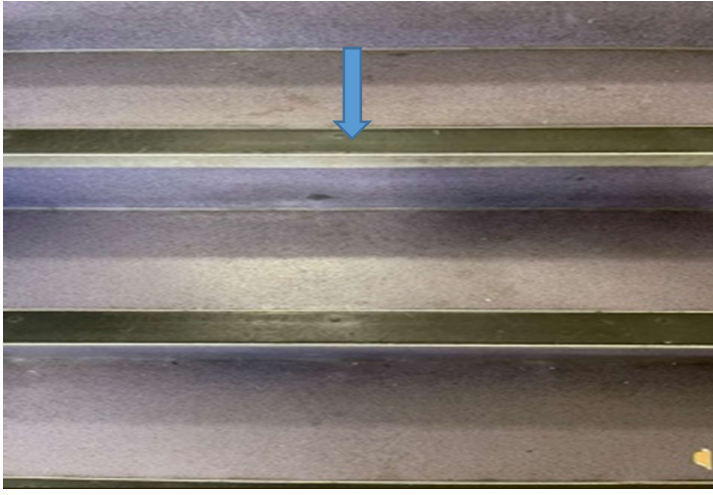
Site Name	248-250 Camden Road
Floor	Ground Floor
Area	G1 & G15
Location	Stairs
Material Details

Status: No Asbestos Present	
Position: Stairs	
Product: Stair Nosing N.A.D.I.S	
Sample Number: 1 & 2	
Extent: Approx Total Throughout Stairwell x2	
Recommendation: N/A. Please note the stair nosing is throughout both stairwell areas from ground to third floor.

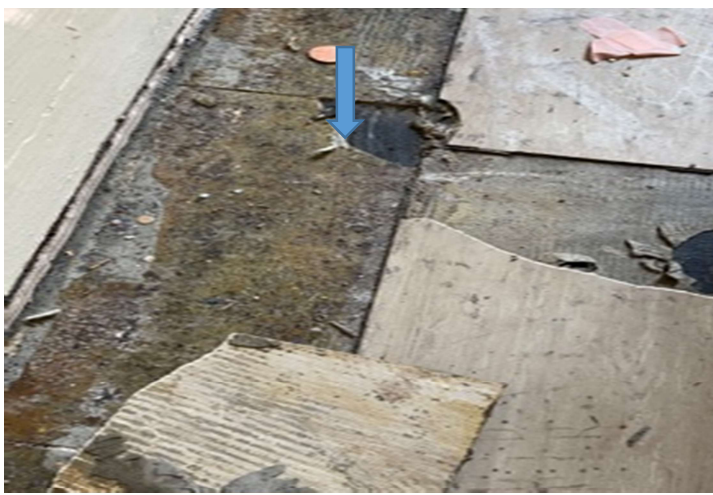
Site Name	248-250 Camden Road
Floor	Ground Floor
Area	G1,G2,G3,G4,G5,G6,G7,G8,G9,G10,G11,G15,G16,G17, G18
Location	Floor Beneath modern coverings
Material Details

Status: Asbestos Present	
Position: Floor Beneath Modern Coverings	
Product: Floor Tiles & Bitumen Adhesive Chrysotile	
Sample Number: 3	
Extent: Approx Total 167m ²	
Recommendation: Remove.

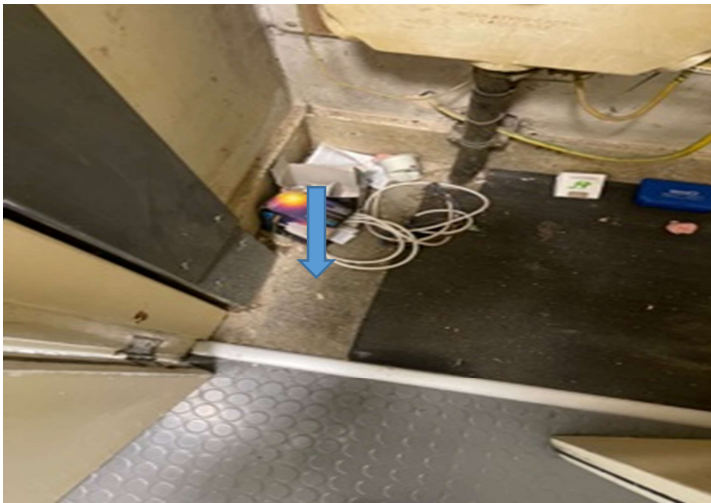
Site Name	248-250 Camden Road
Floor	Ground Floor
Area	G13&G14
Location	Floor
Material Details Status: Asbestos Present Position: Floor Product: Floor Tiles & Bitumen Adhesive Chrysotile Sample Number: 4 Extent: Approx Total 2m ²

Recommendation: Remove.

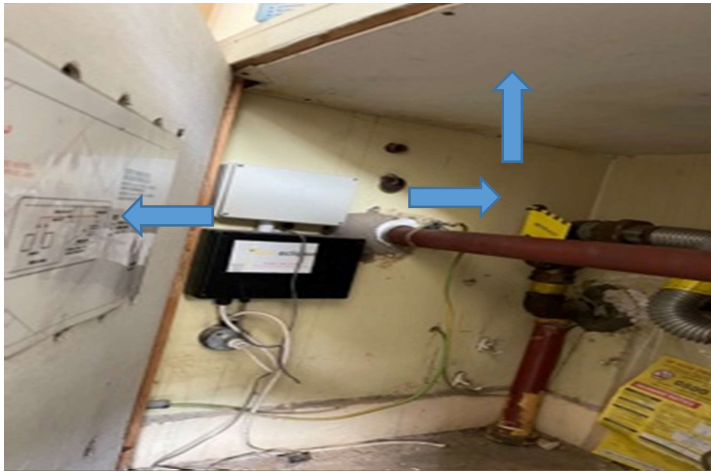
Site Name	248-250 Camden Road
Floor	Ground Floor
Area	G11
Location	Wall, Ceiling & Door
Material Details Status: No Asbestos Present Position: Wall, Ceiling & Door Product: Insulating Board N.A.D.I.S Sample Number: 5 Extent: Approx Total 2m ²

Recommendation: N/A.

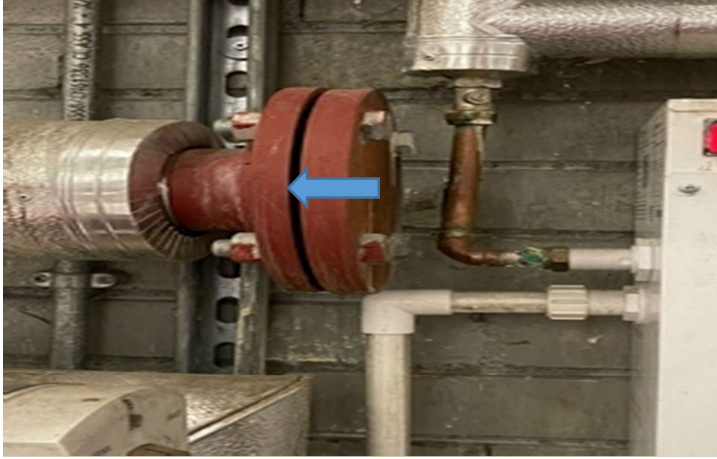
Site Name	248-250 Camden Road
Floor	Ground Floor
Area	G12
Location	Pipe Flanges
Material Details

Status: No Asbestos Present	
Position: Pipe Flanges	
Product: Gaskets N.A.D.I.S	
Sample Number: 6	
Extent: Approx Total x12	
Recommendation: N/A.

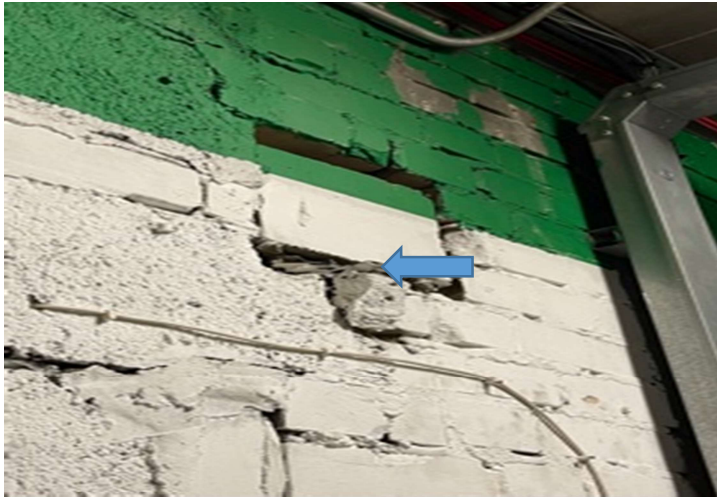
Site Name	248-250 Camden Road
Floor	Ground Floor
Area	G12
Location	Wall
Material Details

Status: No Asbestos Present	
Position: Wall	
Product: Cement Shuttering N.A.D.I.S	
Sample Number: 7	
Extent: Approx Total small amount	
Recommendation: N/A.

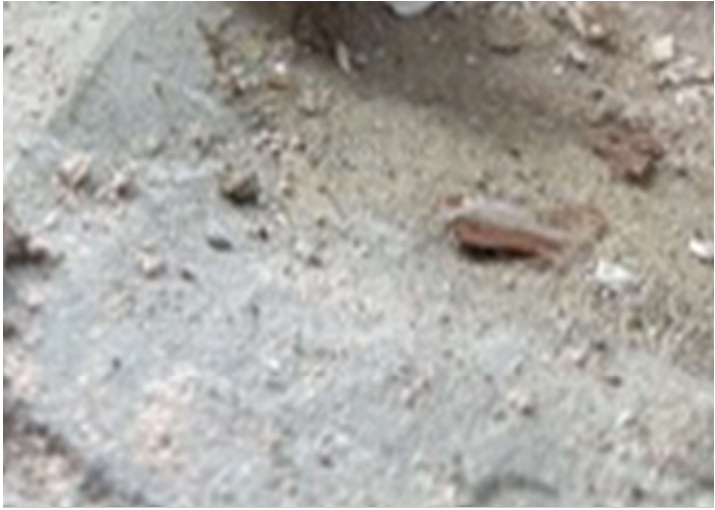
Site Name	248-250 Camden Road
Floor	Ground Floor
Area	G12
Location	Floor Beneath Stairs
Material Details Status: No Asbestos Present Position: Floor Beneath Stairs Product: Debris N.A.D.I.S Sample Number: 8 Extent: Approx Total 1m ²

Recommendation: N/A.

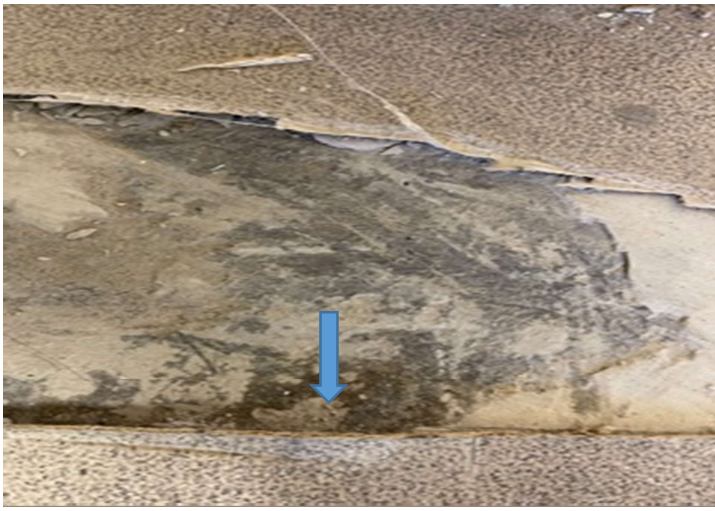
Site Name	248-250 Camden Road
Floor	First Floor
Area	0101,0105,0110,0113&0116
Location	Floor Beneath modern coverings
Material Details Status: Asbestos Present Position: Floor Beneath Modern Coverings Product: Bitumen Adhesive Chrysotile Sample Number: 9 Extent: Approx Total 32m ²

Recommendation: Remove.

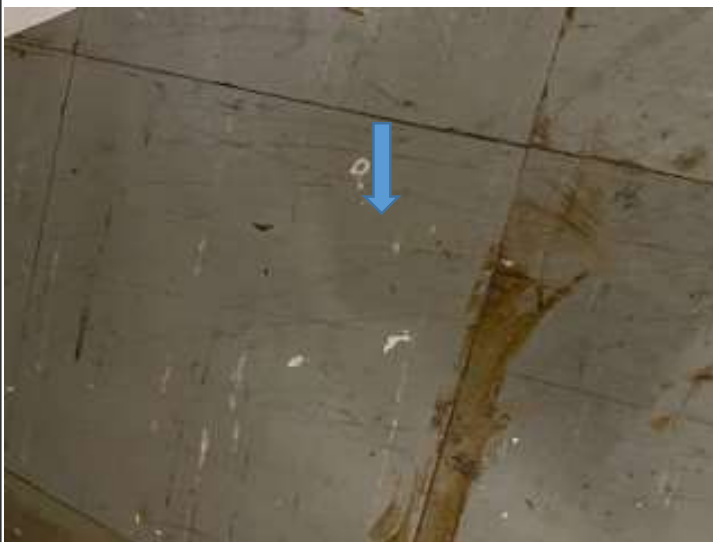
Site Name	248-250 Camden Road
Floor	Third Floor
Area	0314,0317&0319
Location	Floor Beneath modern coverings
Material Details Status: Asbestos Present Position: Floor Beneath Modern Coverings Product: Floor Tiles & Bitumen Adhesive Chrysotile Sample Number: 11 Extent: Approx Total 3m ²

Recommendation: Remove.

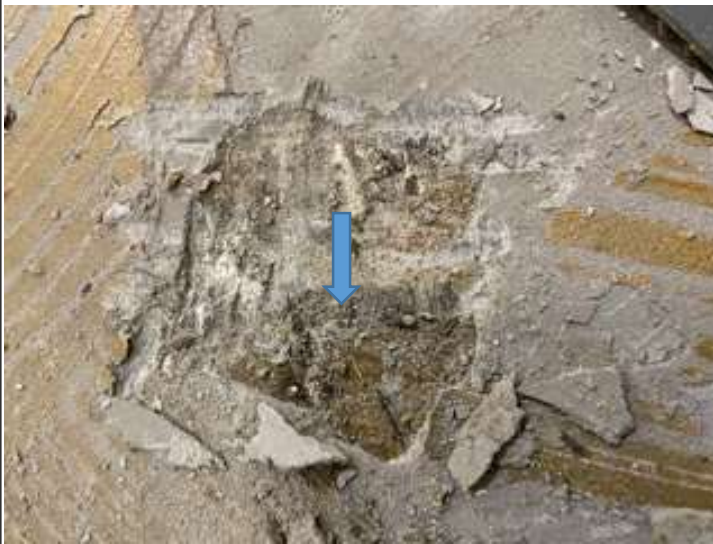
Site Name	248-250 Camden Road
Floor	Third Floor
Area	0301,0305,0306,0310,0312,0315&0320
Location	Floor Beneath modern coverings
Material Details Status: Asbestos Present Position: Floor Beneath Modern Coverings Product: Bitumen Adhesive Chrysotile Sample Number: 12 Extent: Approx Total 52m ²

Recommendation: Remove.

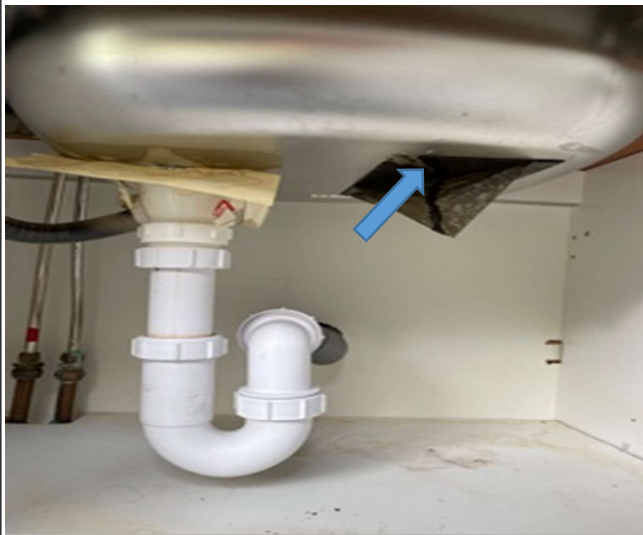
Site Name	248-250 Camden Road
Floor	Third Floor
Area	0307&0308
Location	Base Of Sink
Material Details Status: No Asbestos Present Position: Base Of Sink Product: Bitumen Sink Pad N.A.D.I.S Sample Number: 13&14 Extent: Approx Total 2 Items

Recommendation: N/A. All sink pads were of a modern type.

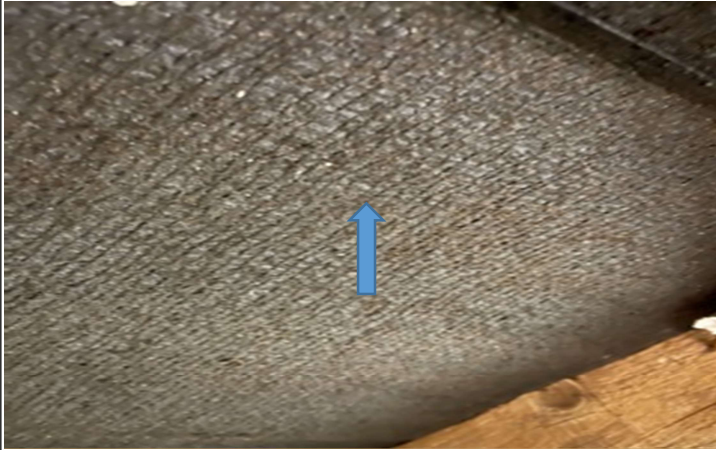
Site Name	248-250 Camden Road
Floor	Roof Space
Area	R01
Location	Underside Of Roof
Material Details Status: No Asbestos Present Position: Underside Of Roof Product: Roof Felt N.A.D.I.S Sample Number: 15 Extent: Approx Total 300m ²

Recommendation: N/A.

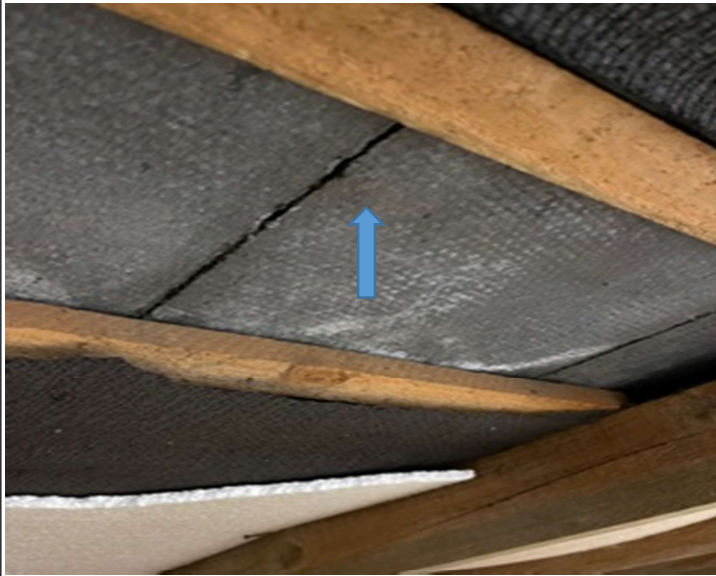
Site Name	248-250 Camden Road
Floor	Roof Space & External
Area	R01 & EX01
Location	Roof
Material Details Status: Asbestos Present Position: Roof Product: Roof Tiles Chrysotile Sample Number: 16 Extent: Approx Total 300m ²

Recommendation: Remove.

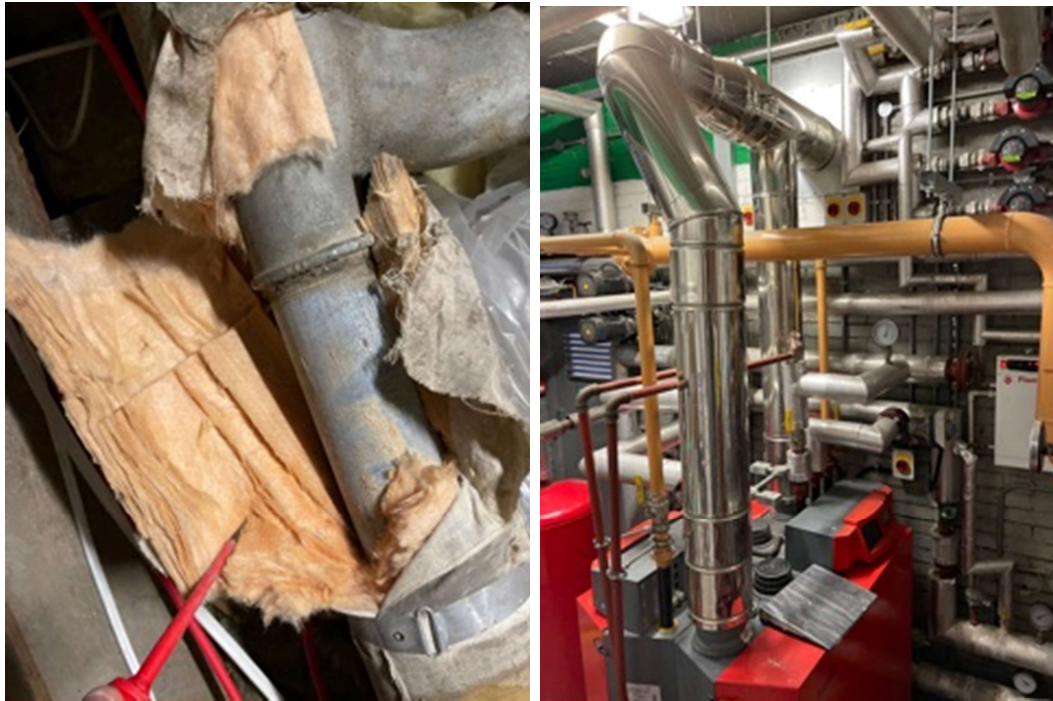
Please note that the pipe work throughout the building was insulated using modern mmmf and hammer clad insulation. Electrical services located on site were also of a modern type.

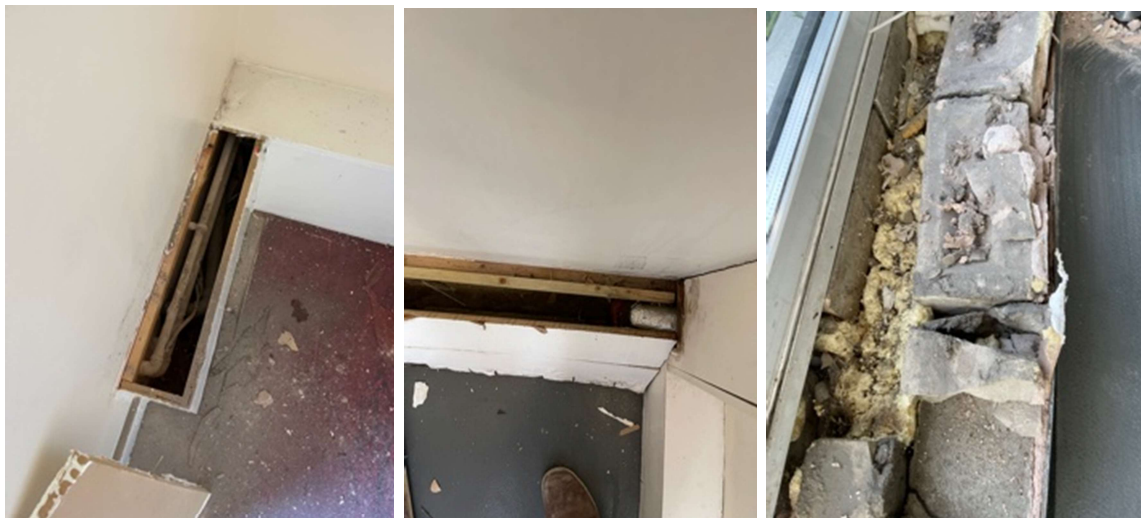
Please note that all boxing / ducting was inspected and no acms located. Window sills were timber with brick beneath and fibre glass insulation to cavity. Steel rsj's were located to ceiling boxings.

Floors and ceiling were concrete excluding third floor which has a plasterboard ceiling leading to the loft space. Loft space was insulated with fibre glass insulation.
