Report Title	Statement of Justification for Demolition	Ref.	MPI.22.382.RP02
---------------------	---	-------------	------------------------

Project/Site	163 Sumatra Road, London, NW6 1PN
CDS's Client	Magnet Investments Ltd
Prepared by	Roy M Lyle <i>CEng MStructE MSAICE</i>
Reviewed by	Simon R Smith <i>CEng FStructE FICE DipEM FFB</i>

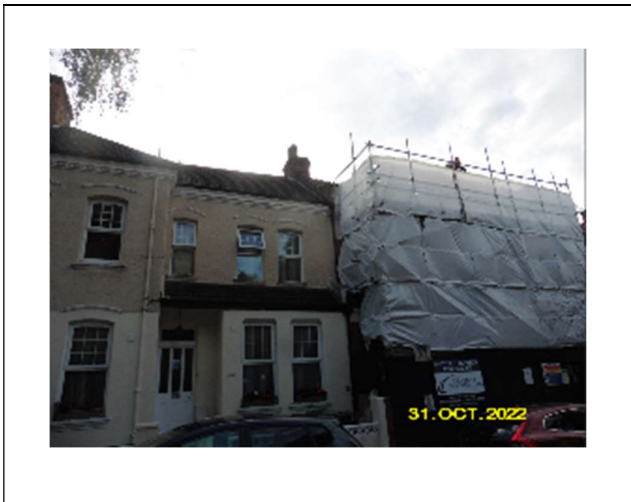
Front scaffold with No.165 seen on the left, note this scaffolding is fully sheeted and was restrained by a structure that had since been removed, leaving it inadequately restrained and dangerous.

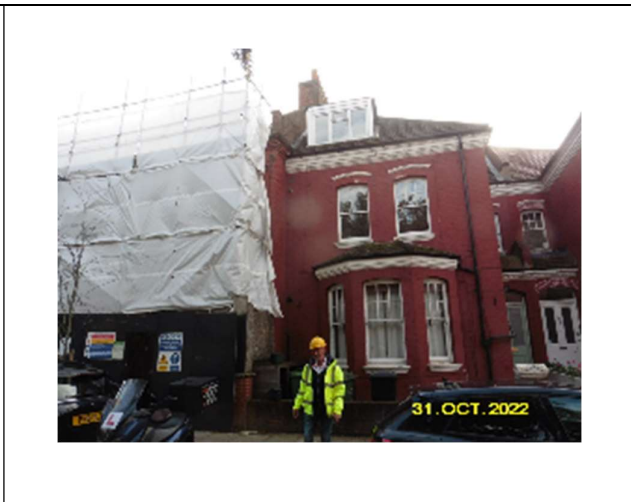
Front Scaffold with No. 161 on the right, note this scaffolding is fully sheeted and was restrained by a structure that had since been removed, leaving it inadequately restrained and dangerous.

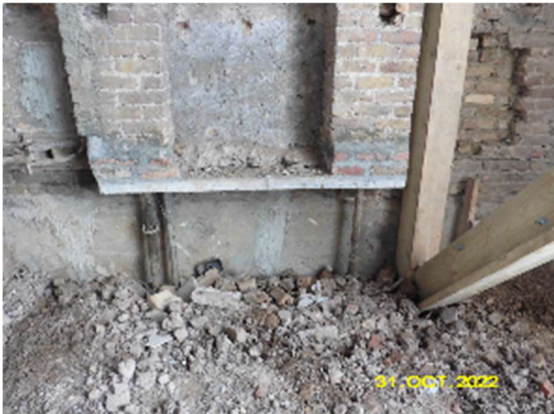
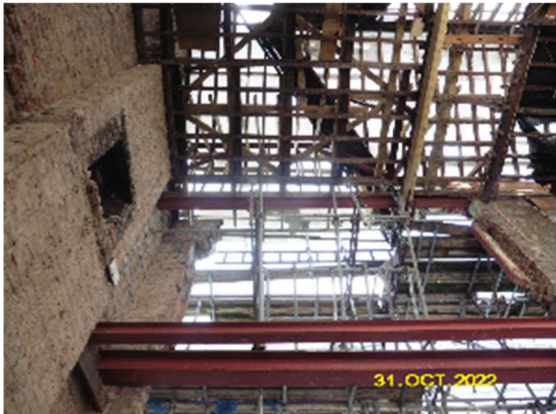
<p>Random placement of RMD slimshores between front façade and party walls.</p>	<p>Unorthodox timber framing, which was founded on shallow footings not allowing for further excavation to take place without wholesale alteration.</p>

<p>Fireplaces were found not to have been underpinned and randomly propped. Timber A frames were not supported at depth allowing for further excavation to take place.</p>	<p>Large multivolume space left with only the roof remaining and random permanent steel installed, a complete lack of lateral restraint to party walls. The roof was propped by scaffold which in turn was not laterally restrained.</p>

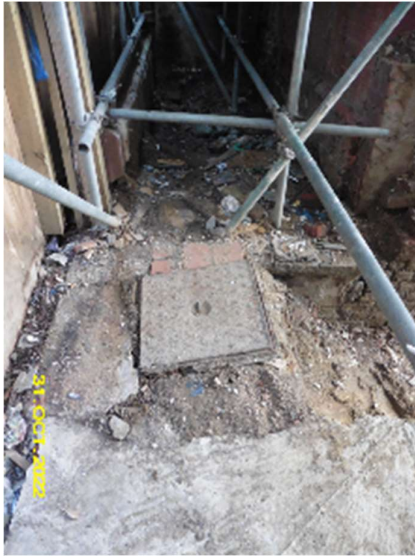
Scaffolding was found to lack baseplates and was placed on timber boards which had since begun to rot.

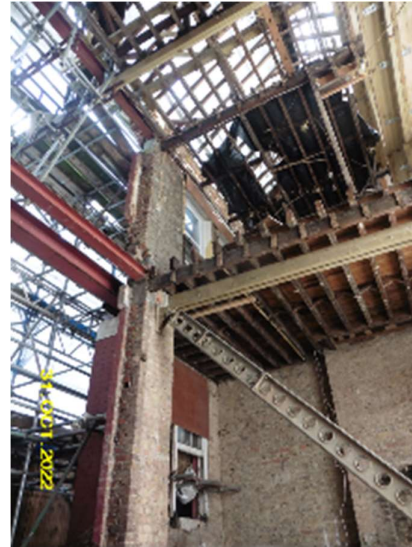
The remains of the front façade being restrained by a raking slimshore with shallow founding conditions, which would not permit the proposed excavation to take place.

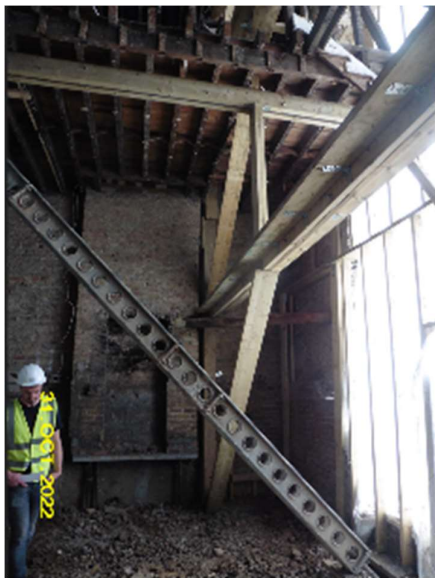
Unorthodox timber framing in place which was not founded at depth, which would allow for the proposed excavation to take place. Further raking RMD slimshores were not founded at depth

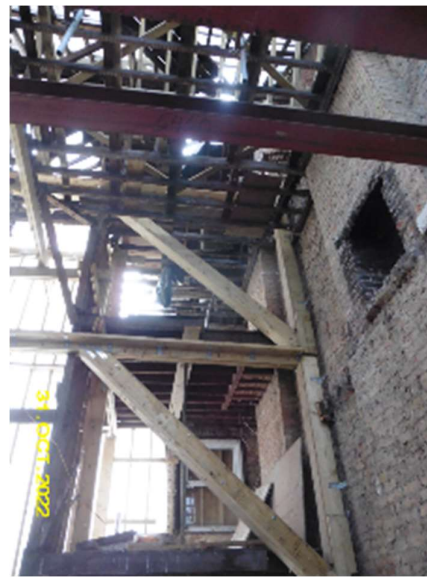
Unorthodox timber framing in place which was not founded at depth, which would allow for the proposed excavation to take place

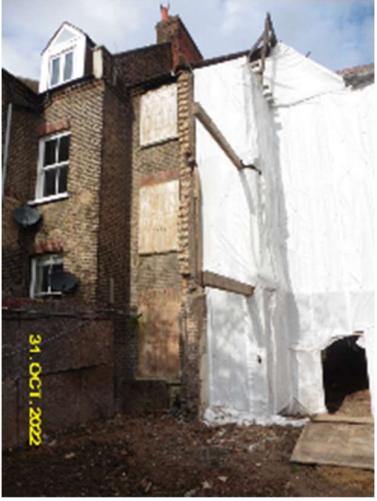
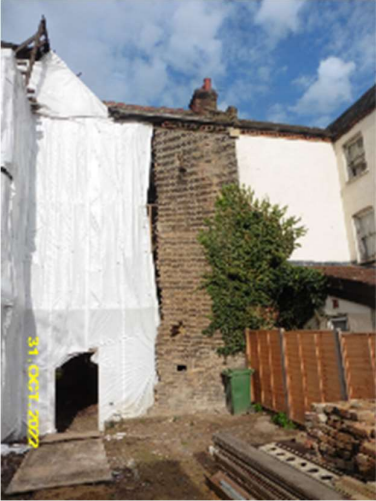
<p>Rear sheeted scaffold, with No.161 to the left. Scaffold is carrying the roof and originally restrained by an internal structure which is now almost completely removed.</p>	<p>Rear sheeted scaffold, with No.165 to the right. Scaffold is carrying the roof and originally restrained by an internal structure which is now almost completely removed.</p>
