## 34 Belsize Lane, NW3 Structural Report

2230268  
Issued for Information  
Revision P02  
22/03/24

### **34 Belsize Lane – Initial Site Visit Report**

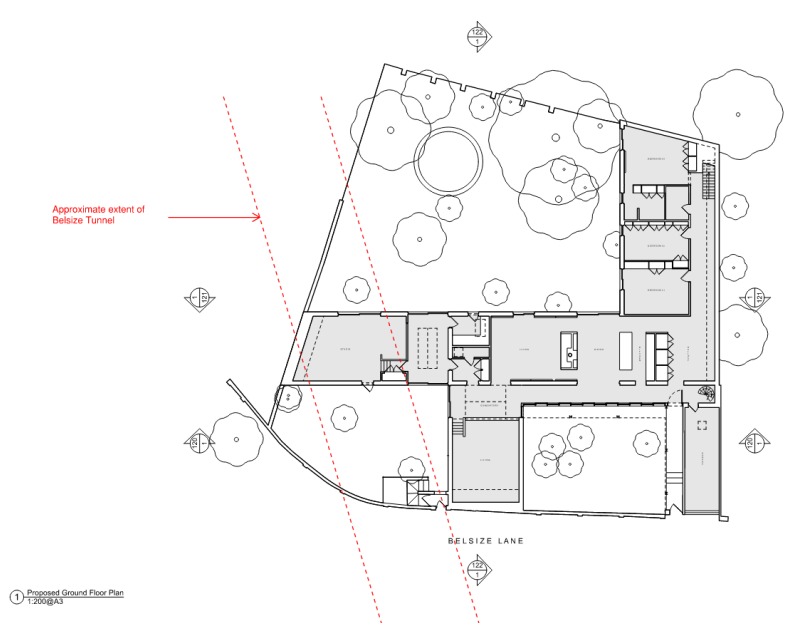
Figure 3: Approximate extent of Belsize Tunnel

We are aware that the Belsize Tunnel (Network Rail) runs under the south end of the site. Based on information we have from working on nearby sites, as well as information obtained from nearby planning applications, including a Network Rail archive drawing, it appears that the crown of the tunnel is approximately 19m below ground level on the site.

Given the depth of the tunnel and the relatively minor proposed works, where any new foundations proposed being shallow spread foundations at the other end of the site, we advise that the impact on the tunnel below the site will be negligible. Please see mark-ups in the appendix.

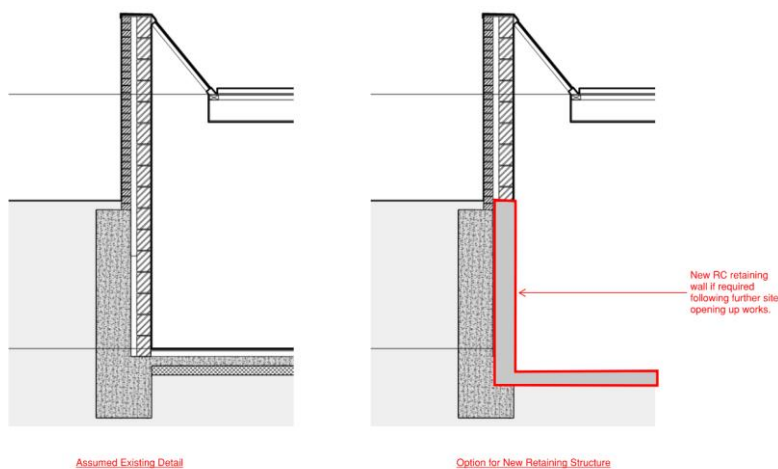
Figure 6: Party wall retaining detail

The party wall with the school shows signs of movement in the existing case with a horizontal crack approximately mid height up the wall. In the proposals this wall will likely need to be rebuilt partially. The extent of the remedial works will need to be confirmed following further investigation works on site.

It is assumed that a concrete retaining wall is present along this boundary to retain the soil from the adjacent site. The movement and cracking in the existing case may be due to the existing cavity filling up over they years and a horizontal pressure being exerted on the inner blockwork wall. It may also be caused by ground movement of the school playground producing a lateral force on the existing wall. The cause should be confirmed with further investigation works.

If a new retaining structure is required, we propose to construct a new reinforced concrete retaining wall in bound of the assumed existing retaining structure. The sequence of construction for any new retaining structure should be considered. It may be required that this is constructed in a hit and miss sequence.

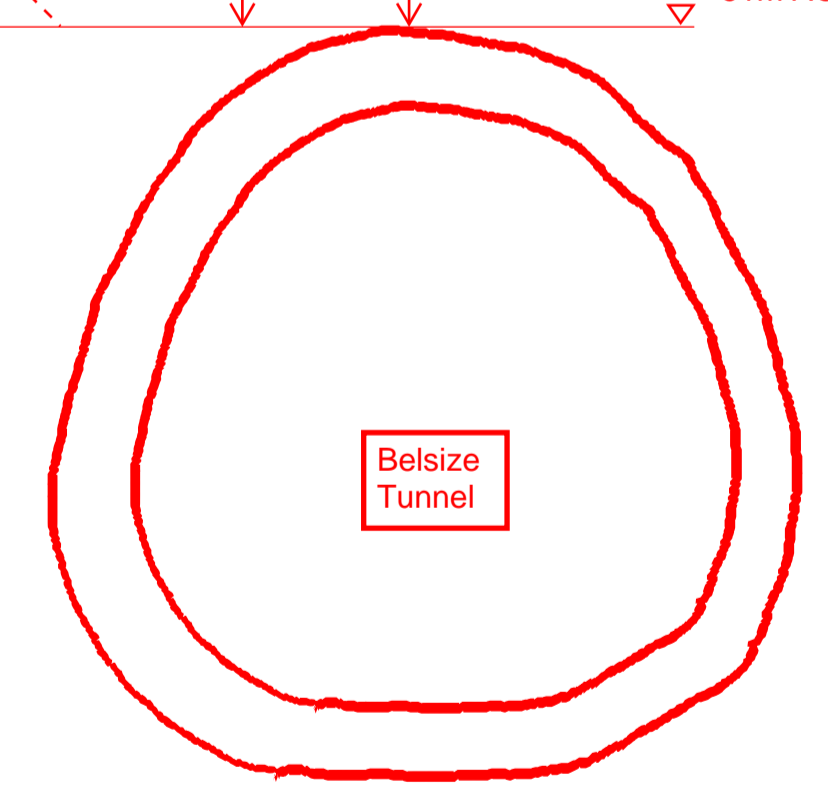
Overburden on Tunnel:  
 $19m \times 23kN/m^3$  (London Clay) =  $437kN/m^2$

Proposed Load of New Extension:  
 Single storey extension, allow  $15kN/m^2$  (conservative). This is the load at foundation level.

Additional Load at Tunnel Crown:  
 With 45 degree load spread at 19m depth,  $15kN/m^2 / (19m \times 2) = 0.4kN/m^2$

This equates to approximately **0.1% increase. Therefore, Negligible.**

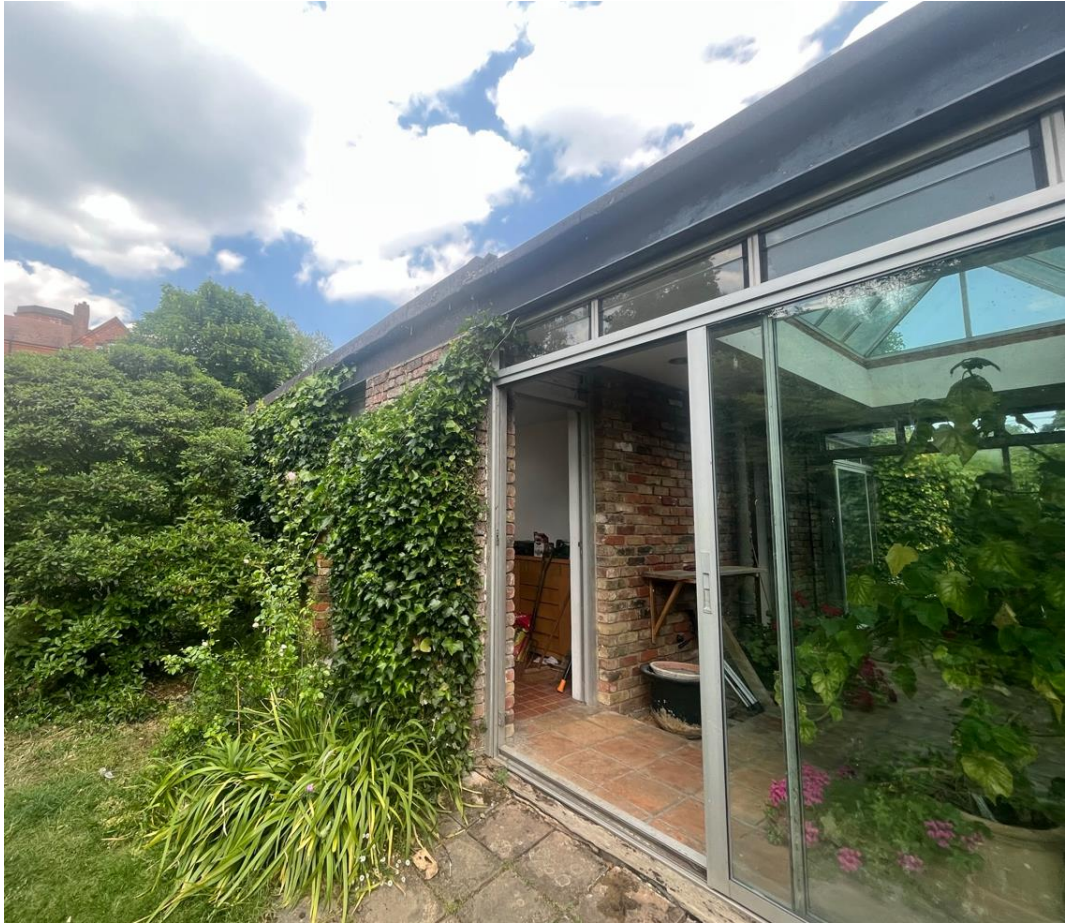
The steel perimeter roof beams appeared to be in reasonable condition with some localised corrosion. We would recommend that the steel sections are removed and re-finished to maintain corrosion protection. If they are not already, they should be galvanised due to their external condition. The existing steel sections, once retreated, can then be reinstated, and used as part of refurbishment proposals. In the existing condition the external exposed steels are not thermally isolated from outside to in. The proposals will need to be detailed to achieve this thermal separation. This will be a complex detail to realise and cannot be achieved with the steels, walls, and roof remaining in place.

Photo showing perimeter steel arrangement over door openings

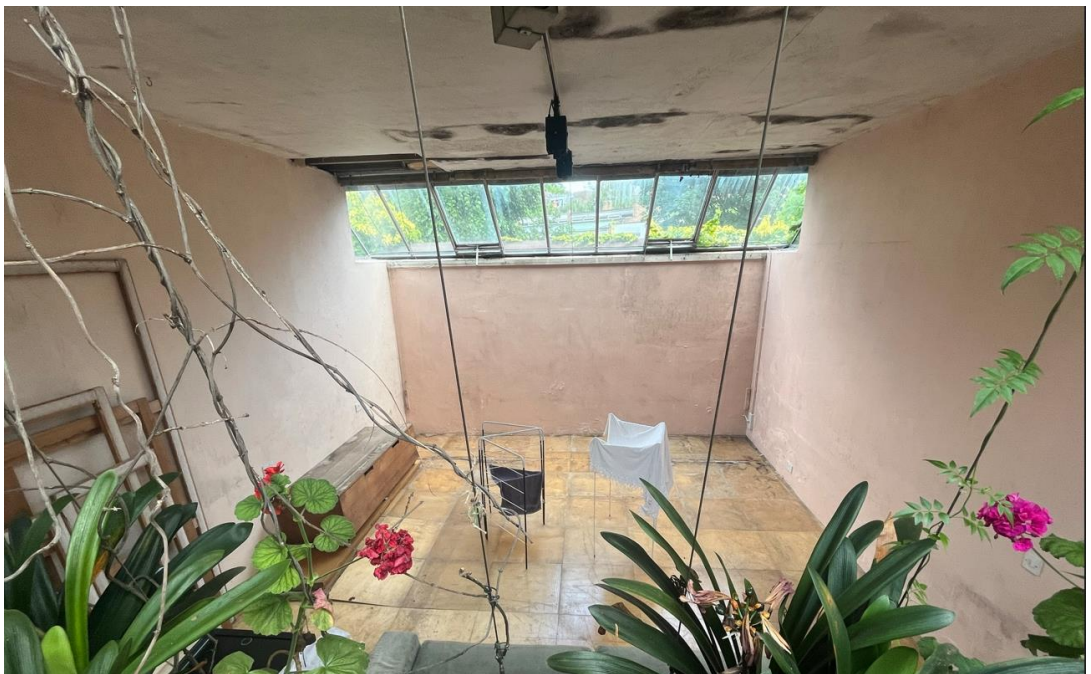
The ceiling/roof throughout are generally in poor condition. There are clear signs of damp throughout. It is assumed that the roof is constructed using timber joists. If this is the case the condition of the timbers exposed to moisture are likely to show signs of decaying.

Photo showing poor condition of roof

It is assumed that the existing roof will need to be replaced as there are clear signs of water ingress within the existing building and it is unlikely to meet modern insulation standards. This will likely require a new roof structure to be installed throughout.

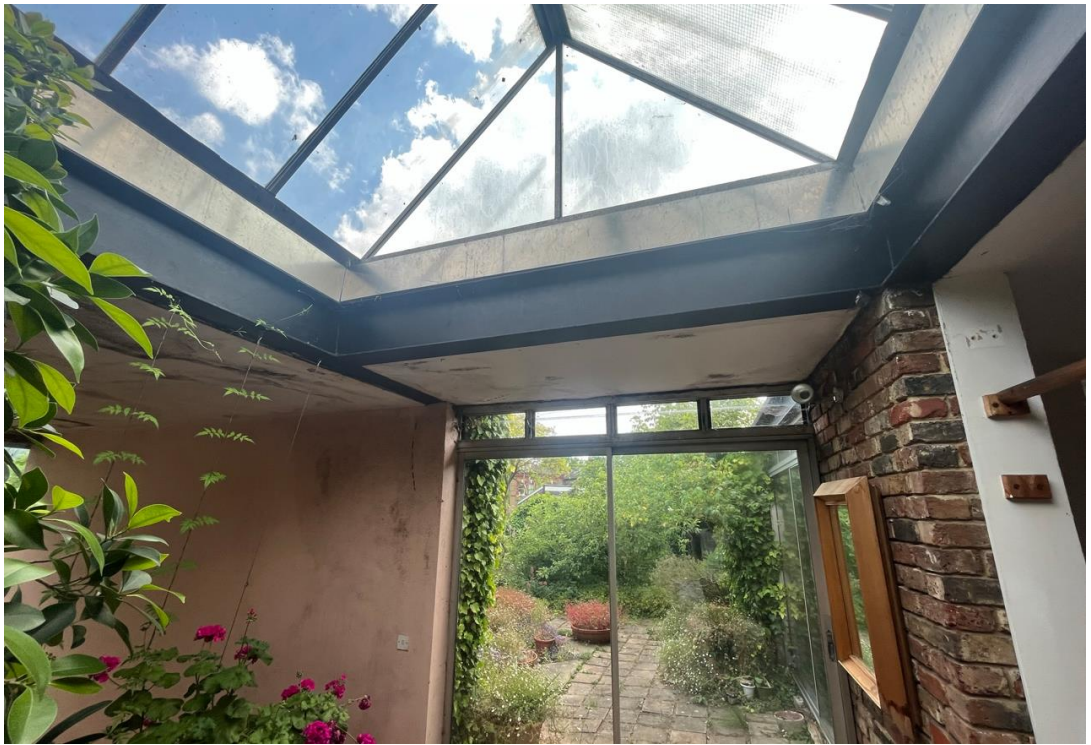
The perimeter brickwork also appears to be in poor condition with the mortar eroded away, almost entirely in some locations. A significant number of the perimeter walls also show signs of water ingress throughout the building.

Photo showing poor condition of roof and walls

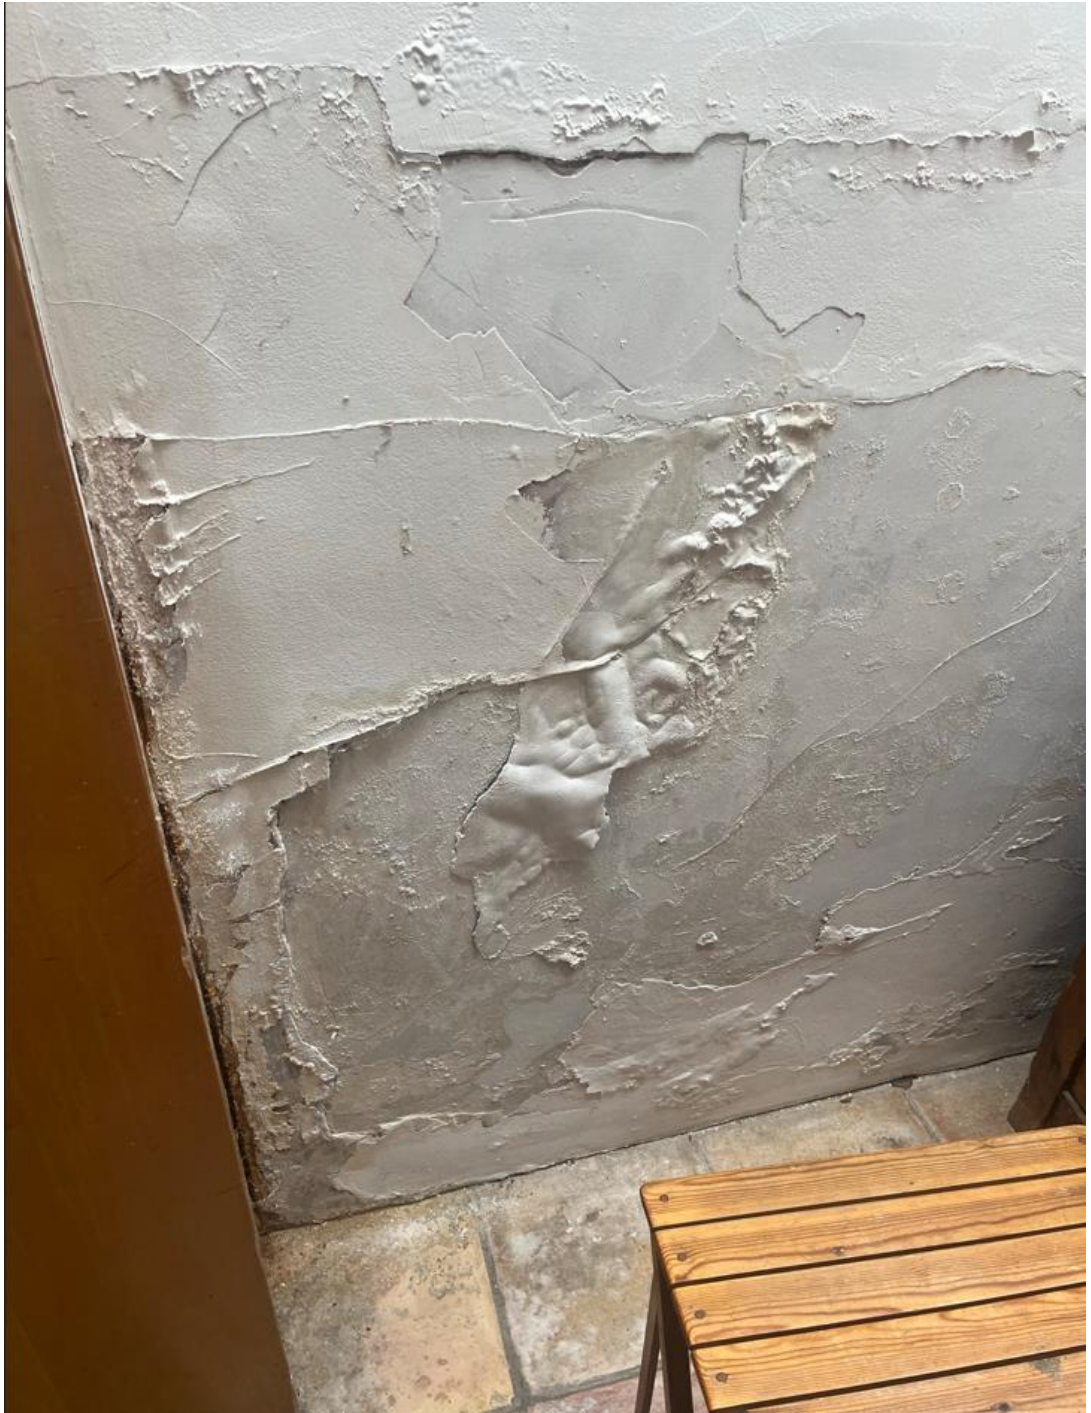
Photo showing poor condition of perimeter wall

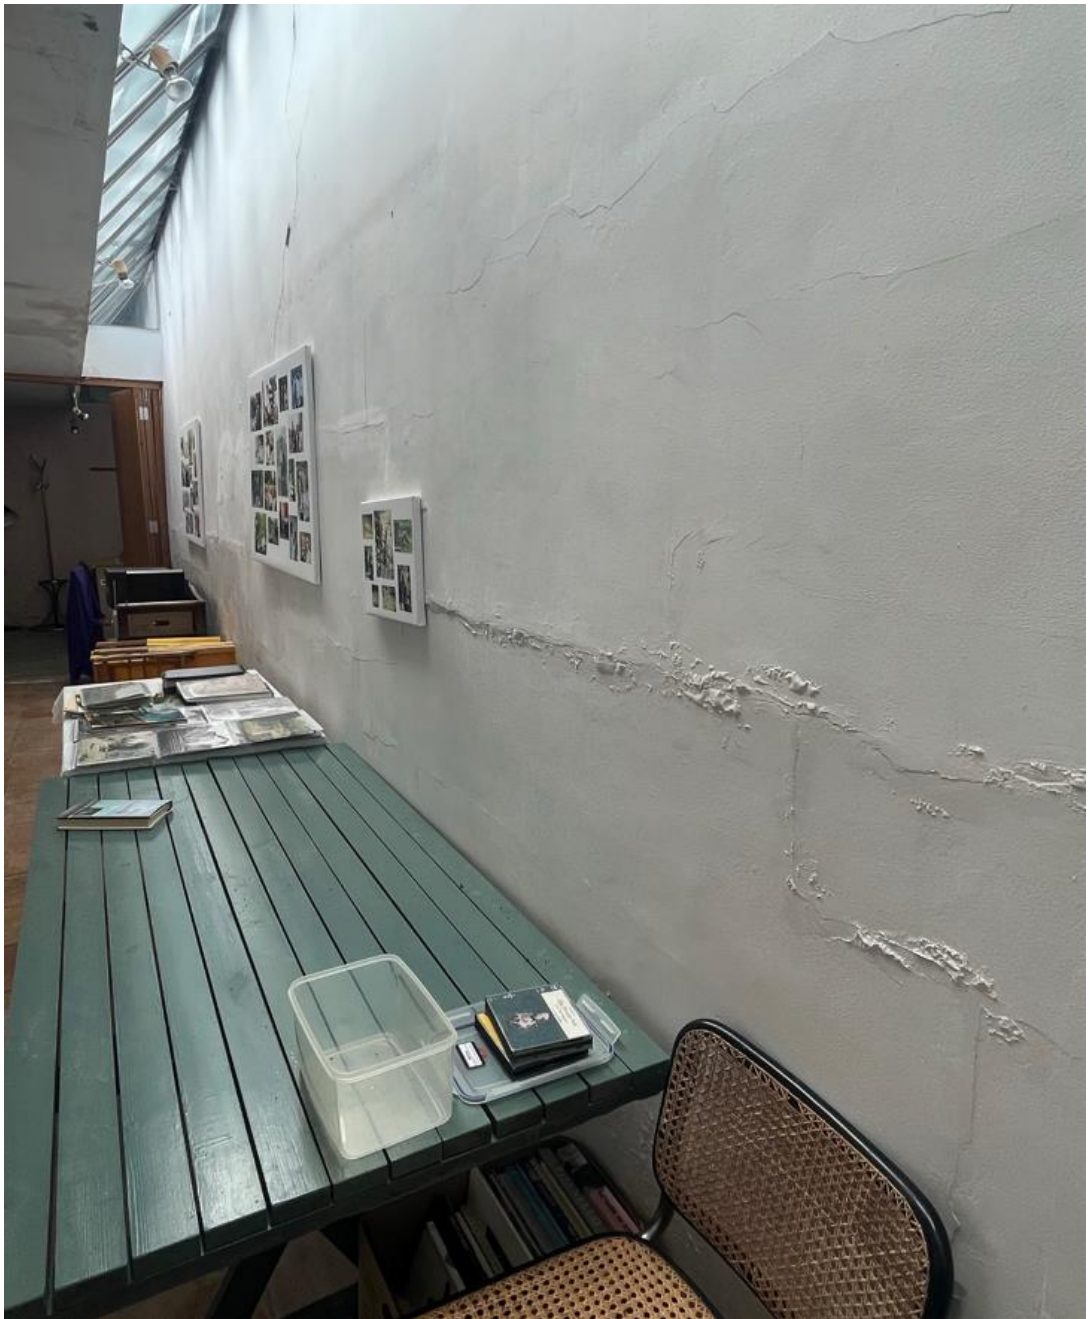
Along the perimeter wall adjacent to the school there is a significant crack along the length of the wall at approximately mid height. We believe this is likely due to retained soil behind the wall in between the property and the school. This should be explored and confirmed via targeted site investigations and the wall should be replaced. It is worth noting there is also signs of significant water ingress along this elevation.

Photo showing cracking to perimeter wall

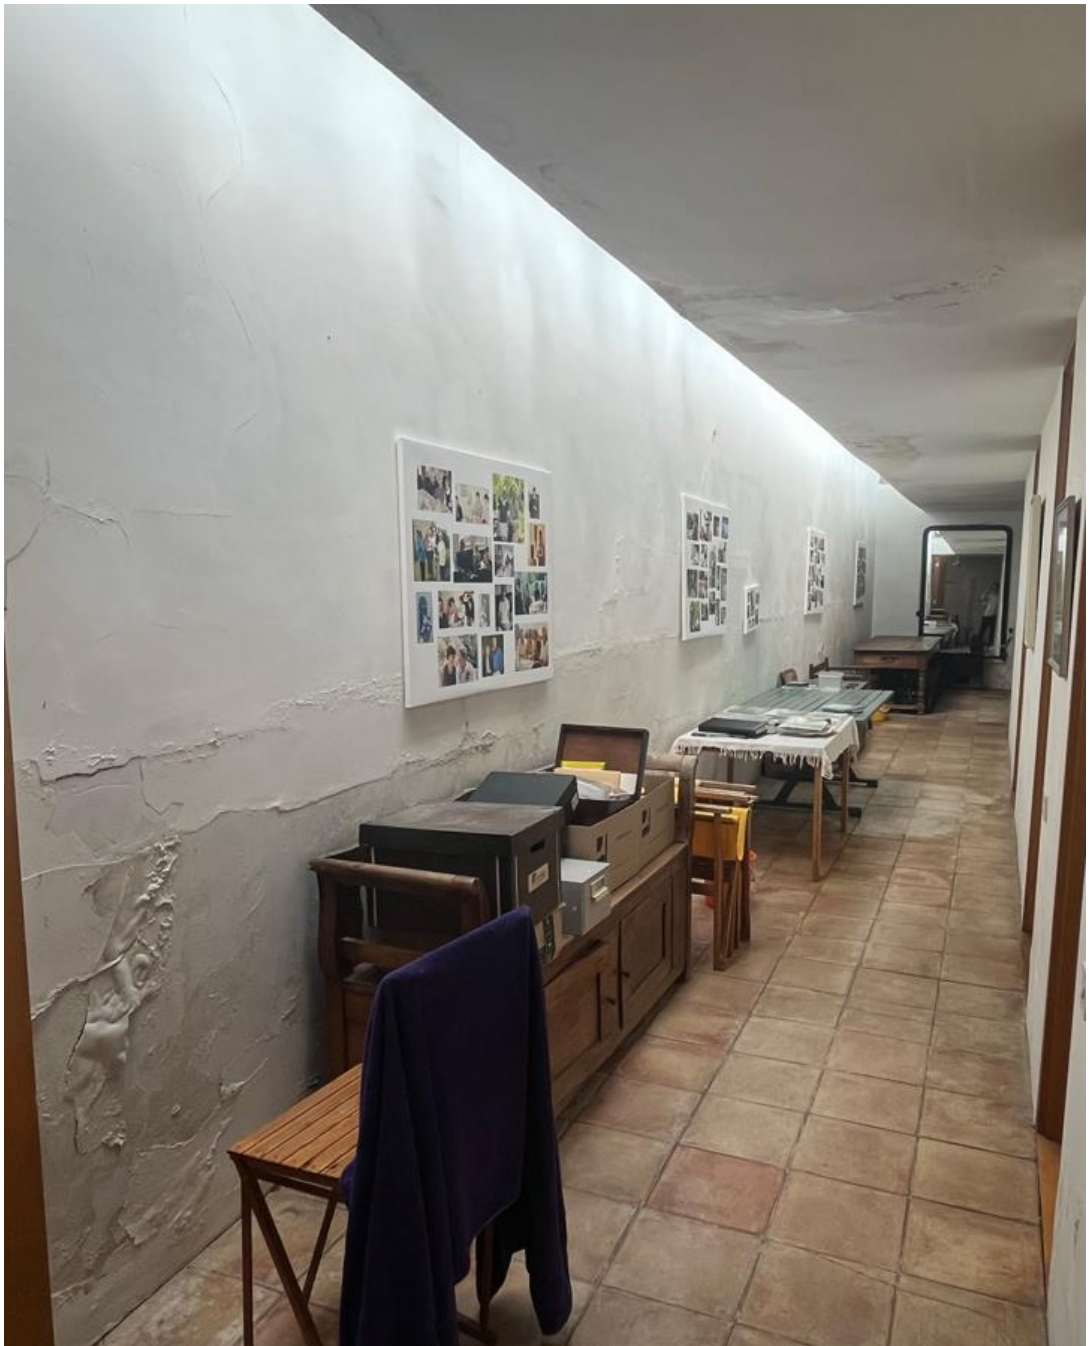
Photo showing cracking to perimeter wall
