50-52 MONMOUTH
STREET

DRAINAGE STRATEGY &
FLOOD RISK
ASSESSMENT

REPORT NO: 7930-FUR-ZZ-XX-RP-D-0901

Project Description: CCTV drainage condition survey

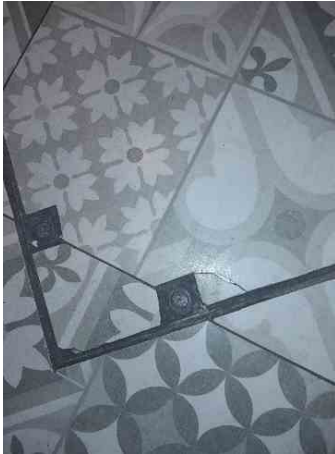
Manhole ouside female toilets cracked upon arrival (before lifitng)

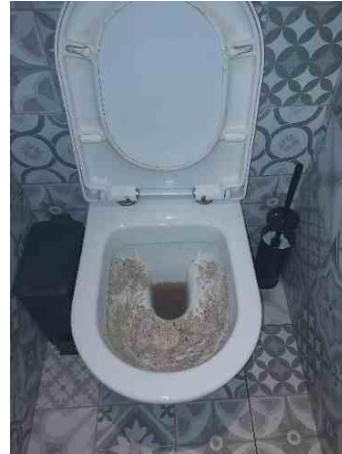
Female toilet blocked upon arrival

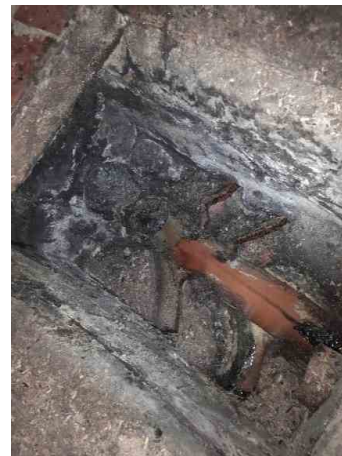
Unable to survey MH4 downstream due to seized rodding eye bung

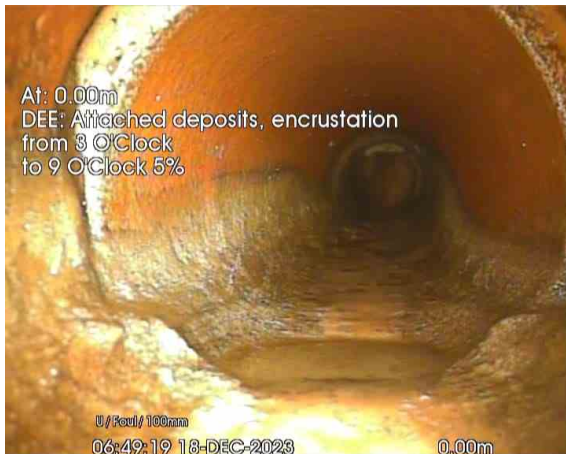
BR1X_452f3c4c-8cb3-4a56-8193-ee032e44716c_20240108_111213_254.jpg, 00:00:12, 0.00 m
Attached deposits, encrustation from 3 o'clock to 9 o'clock, 5% cross-sectional area loss

Throughout the CCTV survey, no major structural defects were identified within the belowground pipework, however a number of sections were found to be holding settled/attached deposits such as grease and encrusted scale and are recommended to be thoroughly cleaned/descaled.

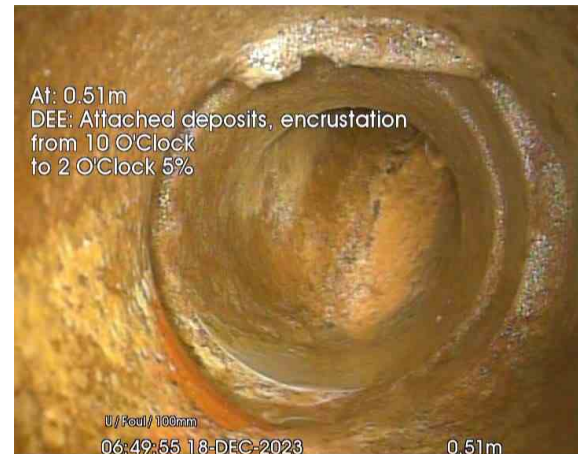
BR1X_0bcf15c4-733b-41c2-aded-04a98086fe49_20240108_11245_631.jpg, 00:00:39, 0.51 m
Attached deposits, encrustation from 10 o'clock to 2 o'clock, 5% cross-sectional area loss

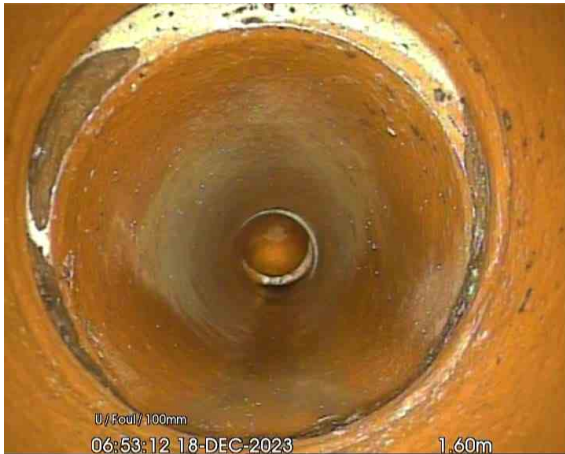
BR2X_f541e4ca-69e3-4271-a8e4-cf0b007e6738_20240108_1
14833_799.jpg, 00:00:47, 1.60 m
Joint displaced, medium

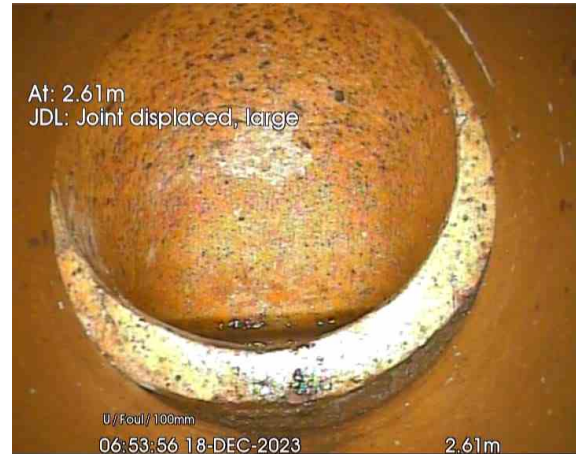
CCTV identified that Section 6 (BR2-MH3) has 2x large displaced joints which are restricting flow and require patch lining repair works.

BR2X_e39a5c13-c1fe-4e56-b267-fdbcd2ab4d19_20240108_1
15759_634.jpg, 00:01:15, 2.61 m
Joint displaced, large

Drainage team attend site alongside drain lining team to carry out the recommended remedial works identified.

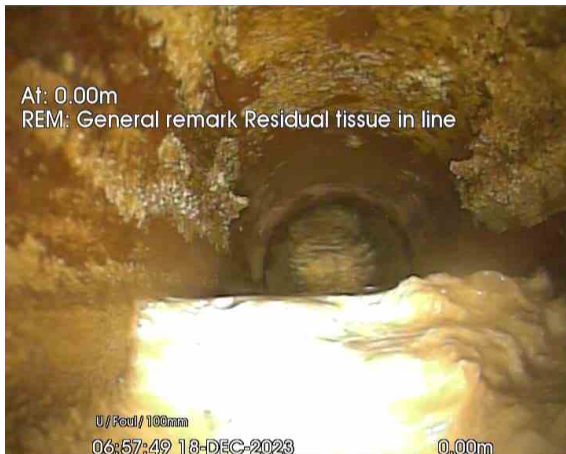
BR3X_e535855a-b95d-4030-aad8-14c0d10b1db9_20240108_121836_436.jpg, 00:00:09, 0.00 m
General remark, Residual tissue in line

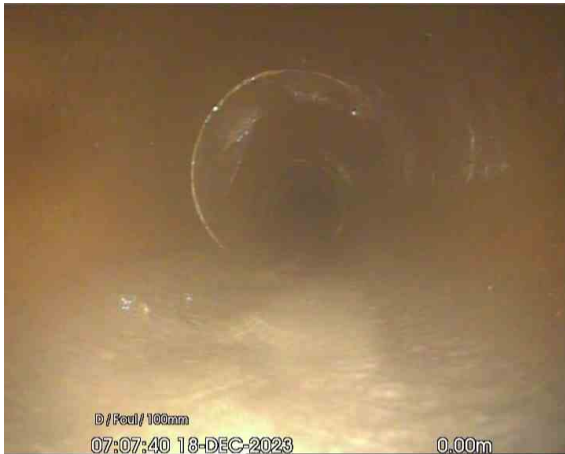
Attached deposits, encrustation from 4 o'clock to 8 o'clock, 5% cross-sectional area loss, start

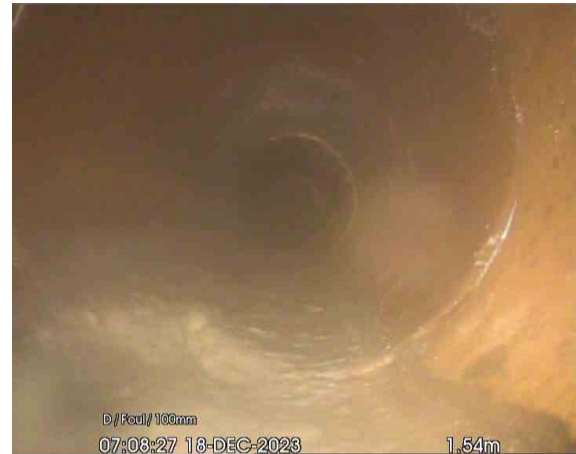
Crack, circumferential at joint from 10 o'clock to 5 o'clock

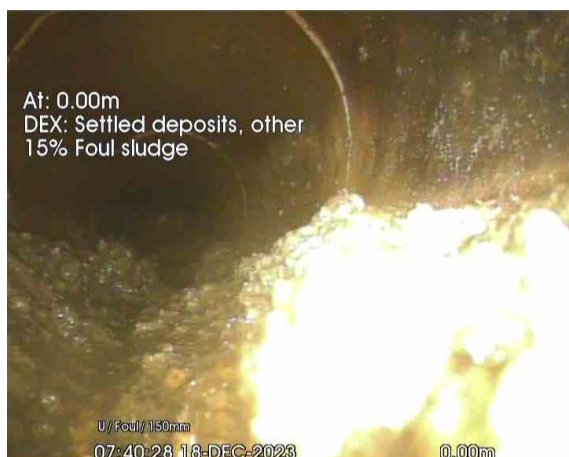
U_SX_4a8f41fa-14b3-43c2-9b1d-47b1ce1923f4_20240108_125222_899.jpg, 00:00:07, 0.00 m
Settled deposits, other, 15% cross-sectional area loss, start, Foul sludge

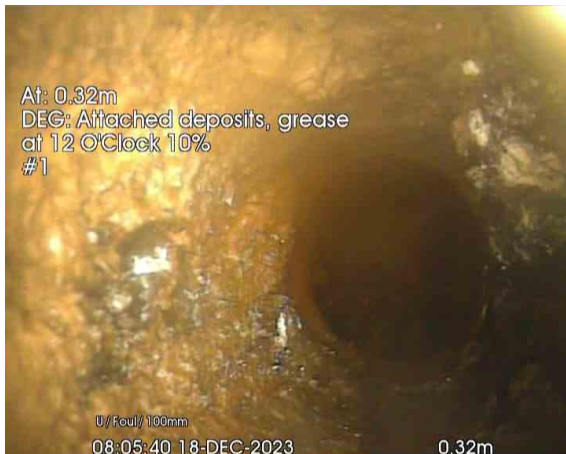
BR4X_cdec9da9-966c-43d6-b659-e4e94cae2322_20240108_131042_406.jpg, 00:00:25, 0.32 m
Attached deposits, grease at 12 o'clock, 10% cross-sectional area loss, start
