## Arboricultural Appraisal Report

### Subsidence Damage Investigation at:

49 and 49A Gloucester Crescent  
London  
NW1 7EG

CLIENT: Crawford & Company  
CLIENT REF: [REDACTED]  
MWA REF: [REDACTED]  
MWA CONSULTANT: Andy Clark  
REPORT DATE: 01/02/2024

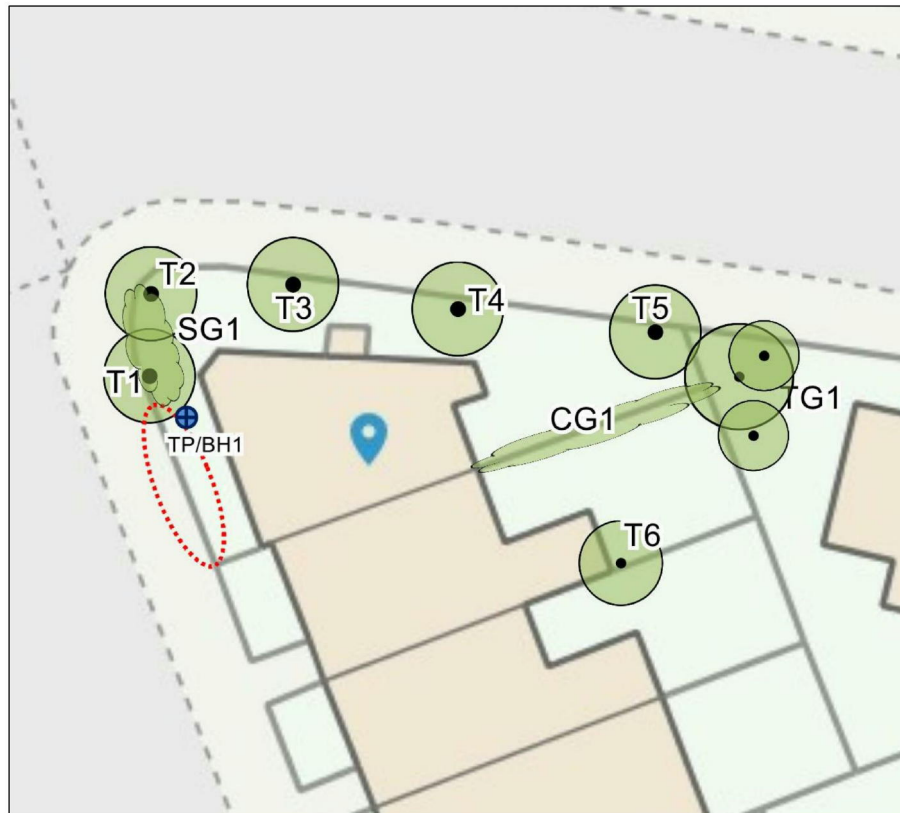
Site Plan

Approximate areas of damage
