## Arboricultural Consultancy for Aviva - Commercial

| Insured | | Address | 33 Belsize Park, London, NW3 4DX | | |
| Report Date | 06/04/2023 Revised: 02/11/2023 | | | | |

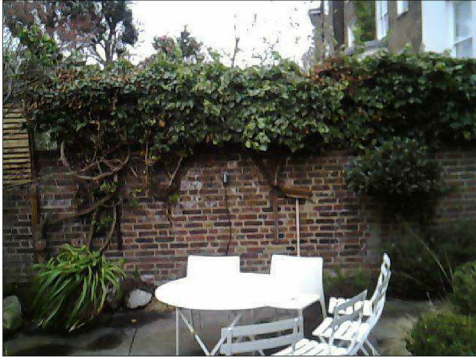
C1 - Ivy

| Tree No. | Species | Age Cat | Approx. Height (m) | Distance to Building (m) * | Ownership | Action | Requirement |
|---|---|---|---|---|---|---|---|
| C1 | Ivy | 1 | 3 | 9.5 | C - Insured | No action | No works. |

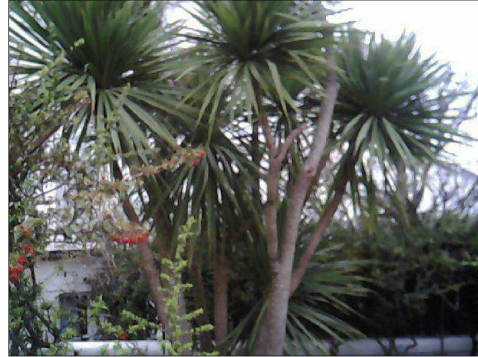
T2 - Cordyline

However, whilst not positively implicated by root analysis, the Cordyline (T2) cannot be discounted as contributing to the overall level of soil drying proximate to the area of damage and is therefore also considered to retain a contributory influence, albeit in a limited / secondary capacity when compared to the above.

| Tree No. | Species | Age Cat | Approx. Height (m) | Distance to Building (m) * | Ownership | Action | Requirement |
|---|---|---|---|---|---|---|---|
| T2 | Cordyline | 1 | 4 | 3.5 | C - Insured | Remove | Remove close to ground level and treat stump to inhibit regrowth. |

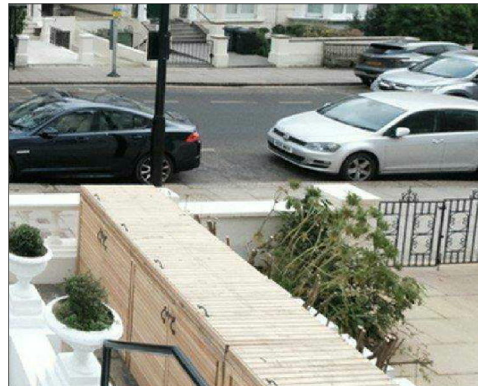
H4 - Privet (recently reduced)

Our survey of the site identified T3 (Maple) and H4 (Privet) which, in our opinion, will be the source of the Acer spp. & Ligustrum spp. roots recovered, and as such we have identified them as the primary cause of the current movement / damage.

| Tree No. | Species | Age Cat | Approx. Height (m) | Distance to Building (m) * | Ownership | Action | Requirement |
|---|---|---|---|---|---|---|---|
| H4 | Privet | 1 | 3.2 | 2 | C - Insured | Maintain as detailed | Remove unpruned section (house side of bin store (see site plan) close to ground level; do not treat stumps due to translocation risk. Where such a risk exists, we advise that any emergent regrowth is removed annually. Maintain pruned section (to rear of storage bins) at reduced dimensions by re-pruning back to points of previous reduction on a 2 year (max) cycle. |

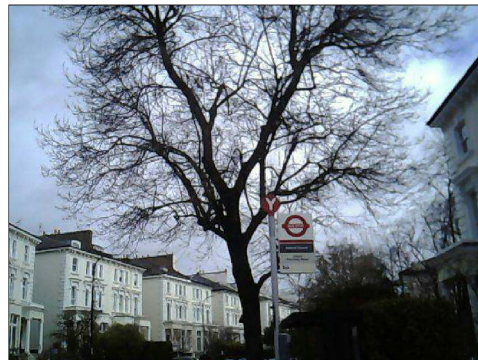
T4 - Ash

| Tree No. | Species | Age Cat | Approx. Height (m) | Distance to Building (m) * | Ownership | Action | Requirement |
|---|---|---|---|---|---|---|---|
| T4 | Ash | 1 | 22 | 22 | B - Local Authority | No action | No works. |
